Draft Scoping Report Lower Cox Brook Covered Bridge Town Highway 3 Bridge 11 over Cox Brook

Northfield BO CVBR(8)

January 24, 2026

Prepared for:
Vermont Agency of Transportation

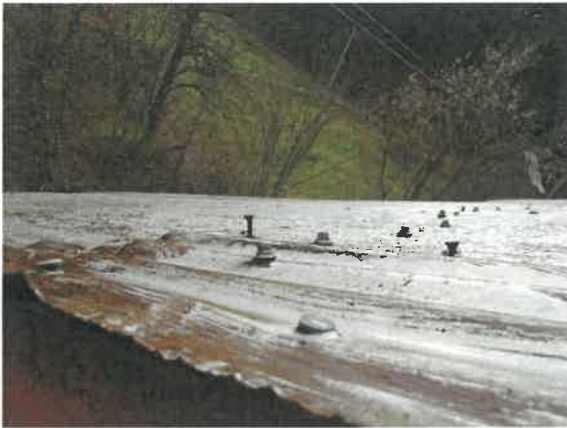
- Metal roof is in fair condition.
- There are rusting and leaks due to failing screw attachments of the metal roofing to the roof boards.

Metal Roof

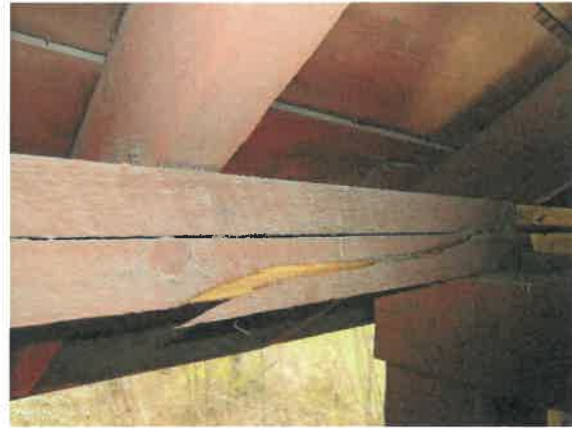
Splits and Breaks in Roof Boards and Rafters

- The metal roof is attached with nails, which allow water penetrations to underlying members.
- The roof boards and rafters exhibit through splits, breaks, insect damage, and rot. Rafters sit on two 2"x6" rafter support beams.
- The siding boards exhibit areas of faded paint. The siding is in good condition; however, removal and replacement will likely be required to provide access for the extensive truss member replacements.

The existing metal roof is in poor condition. It is attached to underlying members with nails, which allow water to seep into the bridge over time. During rehabilitation, the existing metal roof would most likely be damaged by the removal of certain truss and roof members and will need to be replaced. We recommend that the entire metal roof, all of the roof boards, 5 roof rafters (5%), 1 rafter support beam (8%) be replaced in-kind (Priority Treatment No.2) (PTN 2) due to condition. Roof boards are 1" thick Eastern Spruce, rafters are 2"x6" Eastern Spruce, and rafter support beams are 6"x6" Eastern Spruce. These roof framing recommendations apply to Alternatives 1 through 4.

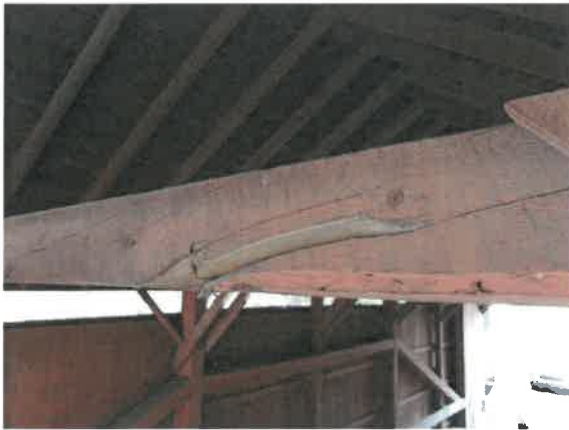
Split in Crossbeam

- Two crossbeams are split and show signs of impact damage. The cross beam at the south portal is broken.
- Crossbeams have been previously damaged from oversized vehicles and are not well connected to the vertical truss members.
- Some of the timber knee braces on the west truss have impact damage and splits.

- Replace both diagonal braces in-kind (PTN 2)
- Replace 2 crossbeams (29%) in-kind (PTN 2)
- Replace 7 knee braces (29%) in-kind (PTN 2)
- Strengthen all knee braces connections using lag bolts (PTN 3)

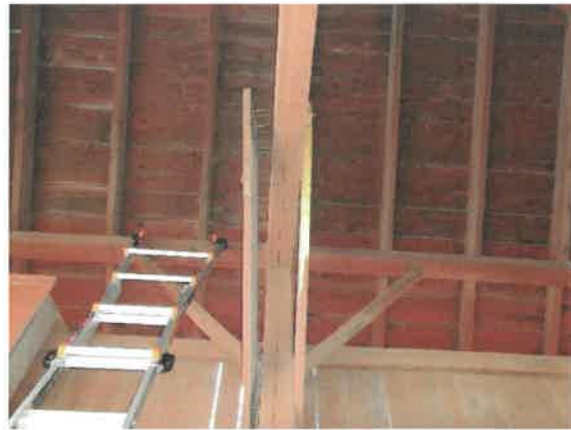
- The upper lateral bracing members exhibit splits, breaks, rot, and impact damage.
- The crossbeams have been hit by vehicles, causing impact damage and breaking the connection between the crossbeams and knee braces.
- The knee braces have been damaged from oversized vehicles, and some are not connected to the crossbeams or truss members.

Broken Connection at Crossbeam and Knee Brace

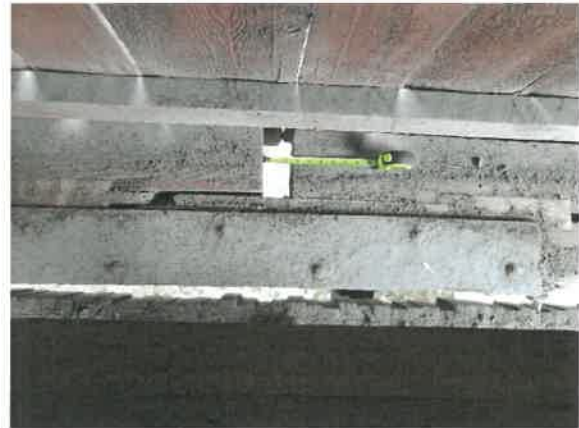
- There were no deficiencies noted at the time of inspection at bottom chord of the north truss.
- There is checking in the bottom chord of the south truss between nodes 5 and 6.
- There is a large gap of 2½" in Ply A of the bottom chord of the south truss at the splice location. Ply B is broken at the splice location, and the broken chord at Ply B has been repaired with an L-shaped steel plate and several bolts connecting both sides.

South Truss Splice at Bottom Chord

- Replace bottom chord in-kind between nodes 1 & 4 (PTN 2)
- Strengthen bottom splice connection (PTN 3)
- Epoxy repair deteriorated members (PTN 1)

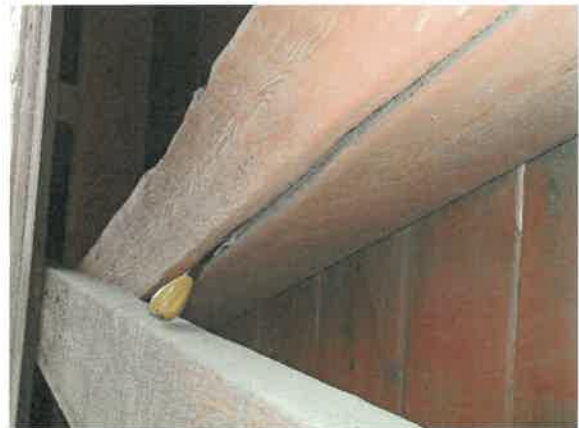
Southeast Diagonal Check at Bottom Chord

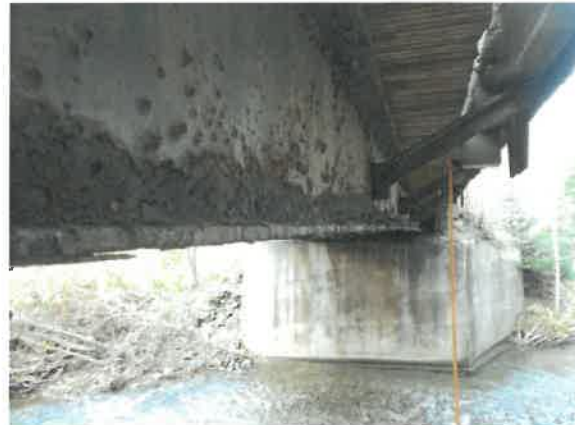
- The diaphragm between the northern interior and exterior beams (B3 and B4) at the east abutment has 100% section loss.
- The exterior beams had section loss that reduced flange thickness to $\frac{7}{16}$ " typical, with isolated areas only $\frac{3}{8}$ " thick. The top flange also had areas of section loss with a flange thickness of $\frac{1}{2}$ " throughout. The webs were in fair condition with some areas of rust and section loss. By inspection, it appears the web had approximately $\frac{1}{16}$ " section loss on both sides of the web.

Exterior Stringer

It is recommended that all stringers be replaced due to strength, age, and condition for Alternatives 1, 2, 3, and 4 (H15, HS15, H20, and HS20, respectively). The existing stringers have deteriorated beyond meaningful cleaning and repair work, and given their age, are due for replacement. It is recommended that the steel stringers be replaced with glulam beams (PTN 2). See Sections 5.d through 5.g of this report for additional details on each rehabilitation alternative.

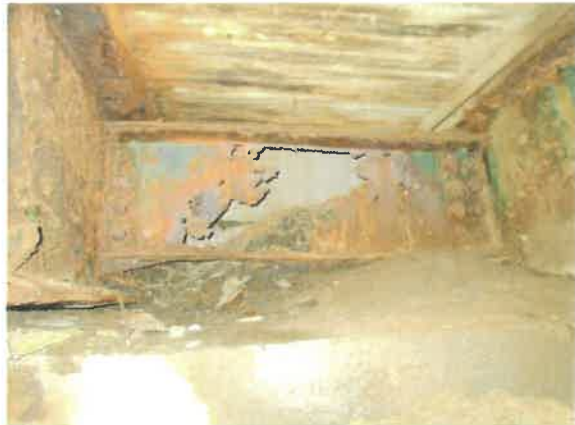
100% Section Loss in Diaphragm

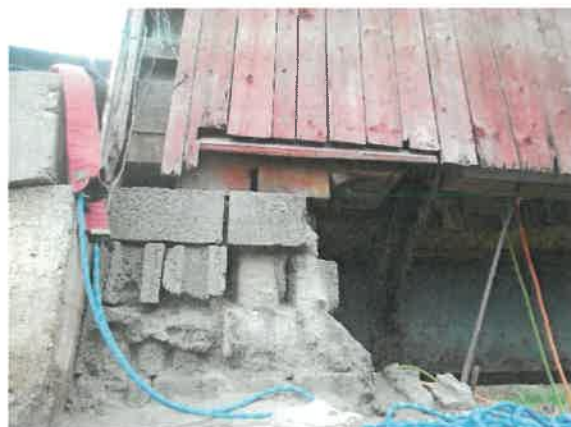
- The wooden bearing blocks exhibit extensive rot and need to be replaced.
- The CMU blocks are in poor condition and need to be replaced.

Timber Bearing and CMU Blocks

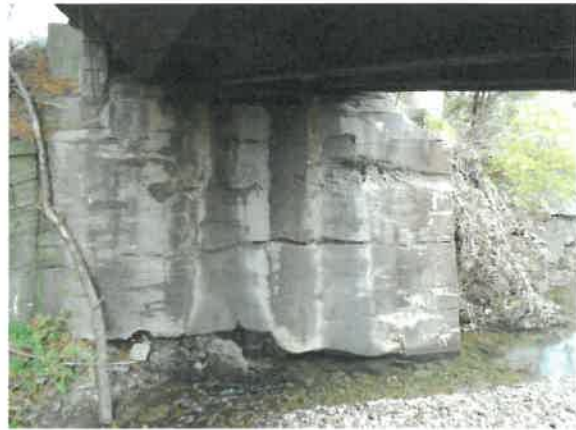
- Both abutments exhibit some areas of concrete spalling, delamination, efflorescence staining, and vertical, horizontal, and map cracking.
- At the spalled areas the concrete was not observed to contain rebar.
- The east abutment is in poor condition and needs to be replaced.

East Abutment

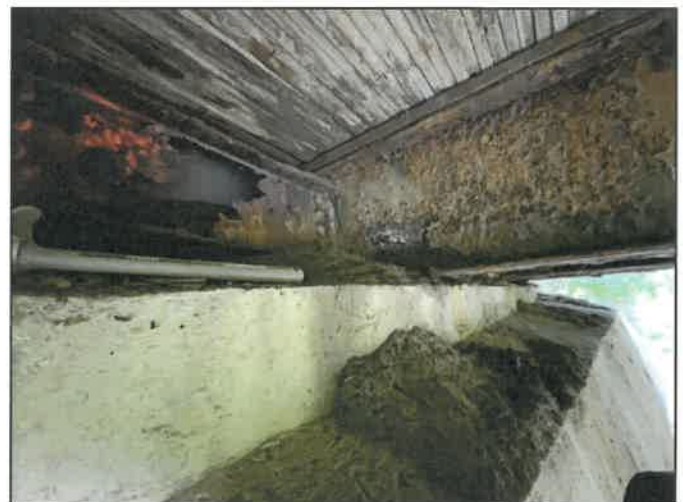
Abutment 2 beam ends

A project to clean and paint the beams should be considered as section loss in the beams continues increase.
