TOWN OF NORTHFIELD, VERMONT SELECT BOARD REGULAR MEETING Tuesday, June 23, 2026 COMMUNITY ROOM - 6:00 P.M.

Draft Scoping Report Upper Cox Brook Covered Bridge Town Highway 3 Bridge 10 over Cox Brook

Draft Scoping Report Lower Cox Brook Covered Bridge Town Highway 3 Bridge 11 over Cox Brook

Draft Scoping Report Northfield Falls Covered Bridge Town Highway 3 Bridge 15 over Dog River

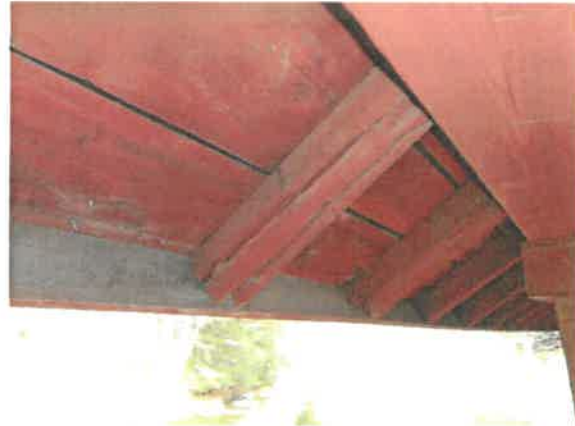
Splits and Breaks in Roof Boards and Rafters

- The metal roof ridge cap is attached to the roof boards with nails and screws and is not mechanically field-seamed or watertight. There is some moss growth under the roof ridge cap.
- The roof boards and rafters exhibit through splits, breaks, rot and insect damage. Rafters sit on a 3"x7" rafter support beam.
- The siding boards exhibit areas of faded paint. The siding is in good condition; however, removal and replacement will likely be required to provide access for the extensive superstructure member replacements.

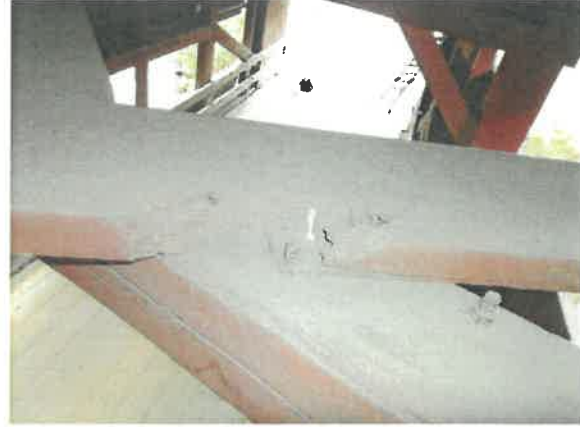
Broken Connection at Cross Beam and Diagonal

- Two cross beams exhibit splits. One of the split cross beams is also broken at a connection to a diagonal bracing member.
- Cross beams have been previously damaged from oversized vehicles and are not well connected to the vertical truss members.
- Some of the steel knee braces on the east truss have moderate section loss.

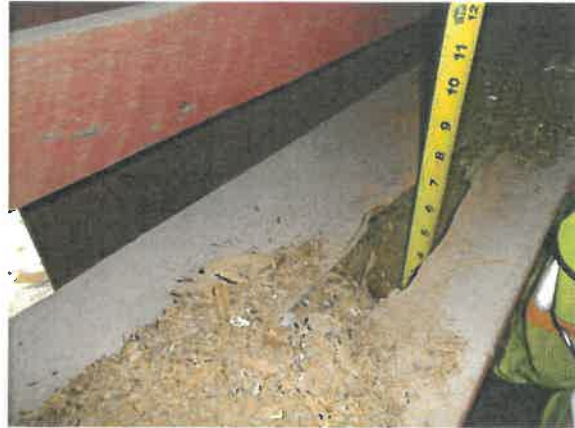
- The top chord of the east truss exhibits extensive rot and needs replacement due to its deteriorating condition. Refer to Appendix E for deteriorated chord members that were identified in need of replacement due to condition.
- The top chord of the west truss is in satisfactory condition with no deficiencies noted at the time of inspection.

East Truss Top Chord Rot

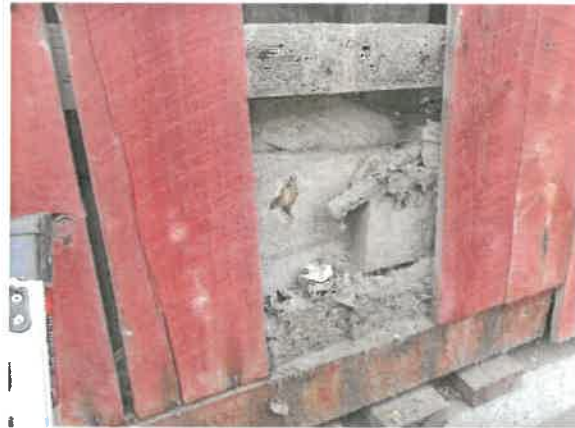
- The bottom chord on the west truss had excessive moisture at the north abutment, with readings up to 50% moisture.
- Ply B of the bottom chord of the east truss is split at the notch for the diagonal member bearing on the bottom chord at the south abutment.
- Both plies of the west truss bottom chord at the north abutment are rotted with up to 50% moisture content.
- The through bolt at node 7 West has extensive section loss with a reduced diameter of 0.6" remaining.

North End of the East Truss Bottom Chord to Diagonal

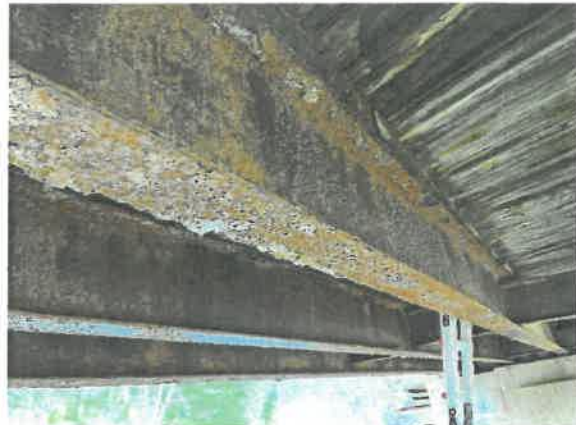
Interior Beam Rusting

- The runner boards are in good condition.
- The flanges are clipped at the abutments to accommodate the skewed centerline of bearing.
- The exterior beam on the west side (B1) has areas of section loss at the north abutment and at midspan that has been repaired using steel plates. The plate at the abutment does not appear to be welded. There is section loss up to ½" along the bottom flange for the entire length of the beam.

- The western interior beam (B2) has heavy laminar corrosion at both faces of the bottom flange along the entire length of the beam. There is a hole in the web at the south abutment up to 18" wide x 4" tall.

- The eastern interior beam (B3) has heavy laminar corrosion at both faces of the top and bottom flanges along the entire length of the beam.
- The exterior beam on the east side (B4) has areas of section loss at the north abutment up to ½" and has heavy laminar corrosion at both faces of the top and bottom flanges along the entire length of the beam.

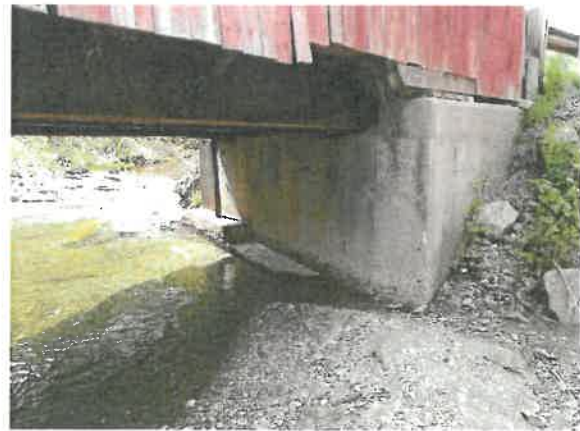
North Abutment

- Both abutments exhibit some areas of concrete spalling, delamination, exposed rebar, efflorescence staining, and vertical, horizontal, and map cracking.
- At the spalled areas the concrete was observed to contain rebar.

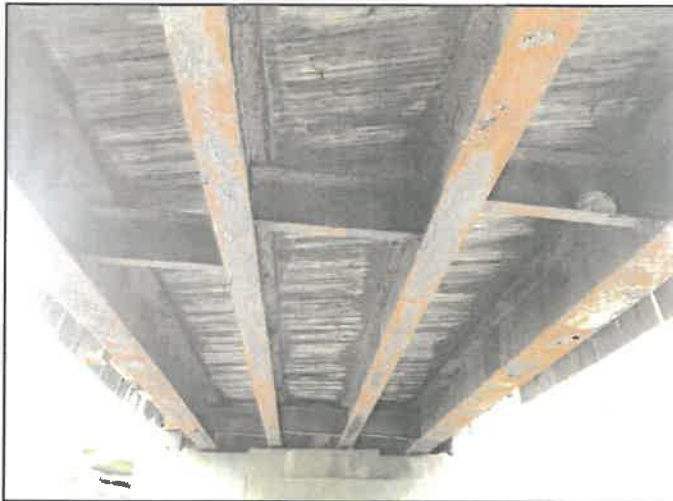
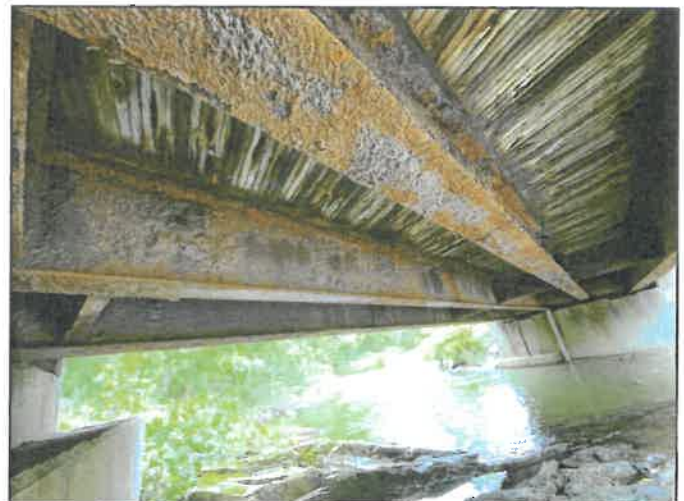
Due to the continued section loss across the length of the beams a future project to replace the beams should be considered.

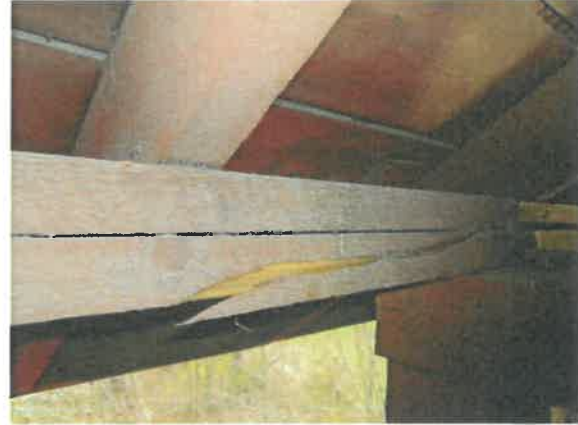
Splits and Breaks in Roof Boards and Rafters

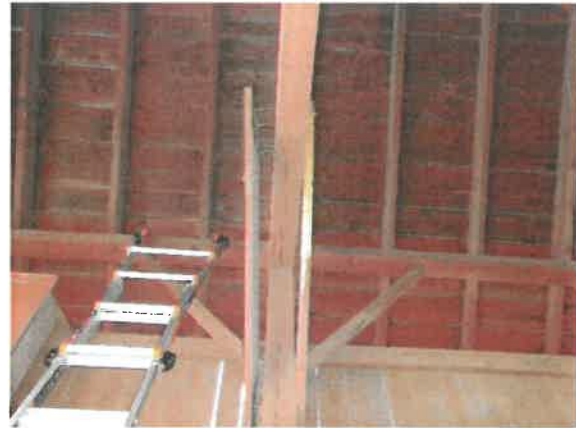
Broken Connection at Crossbeam and Knee Brace

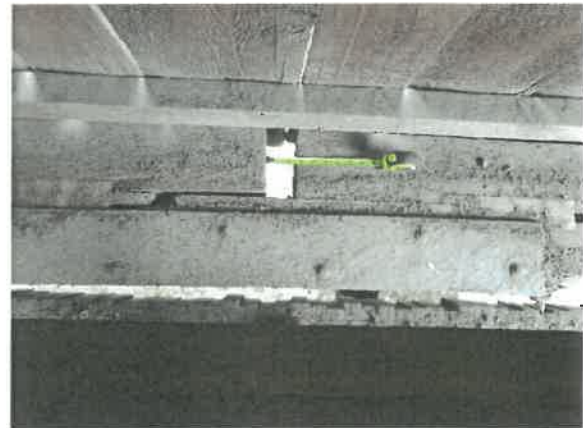
- There were no deficiencies noted at the time of inspection at bottom chord of the north truss.
- There is checking in the bottom chord of the south truss between nodes 5 and 6.
- There is a large gap of 2½" in Ply A of the bottom chord of the south truss at the splice location. Ply B is broken at the splice location, and the broken chord at Ply B has been repaired with an L-shaped steel plate and several bolts connecting both sides.

South Truss Splice at Bottom Chord

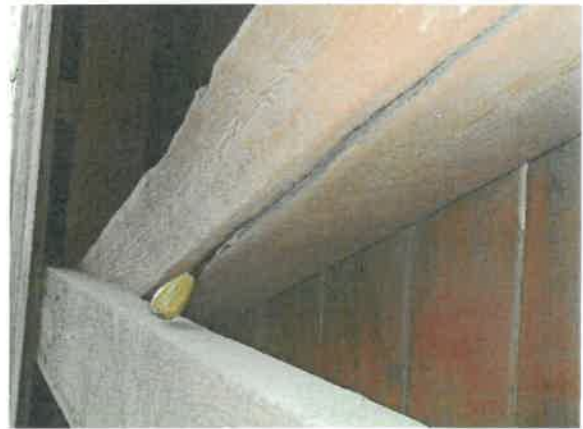
Southeast Diagonal Check at Bottom Chord

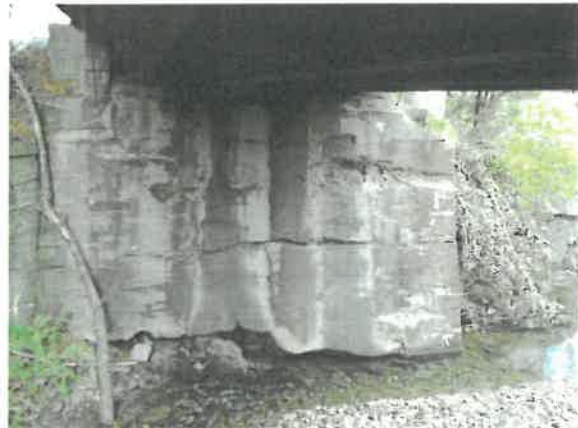
East Abutment

- Both abutments exhibit some areas of concrete spalling, delamination, efflorescence staining, and vertical, horizontal, and map cracking.
- At the spalled areas the concrete was not observed to contain rebar.
- The east abutment is in poor condition and needs to be replaced.

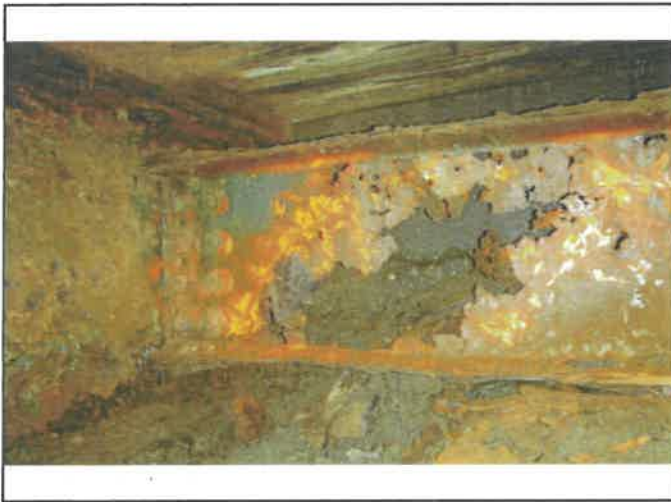
Steel repairs are needed

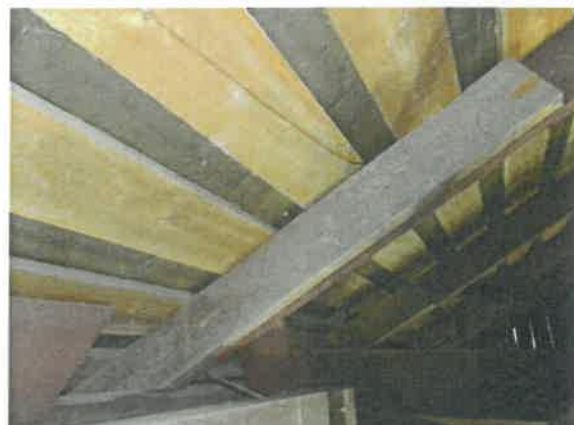
Split in Roofboard and Spliced Rafters

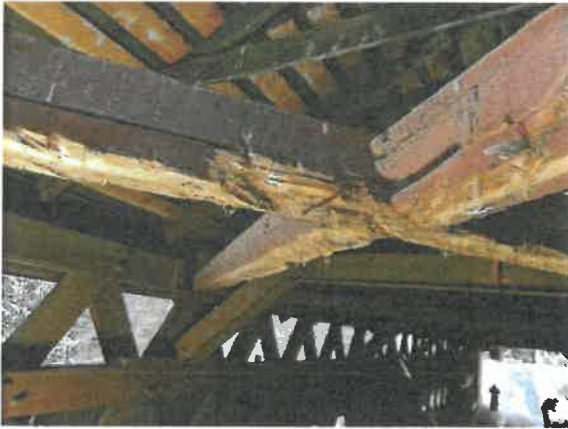
Impact Damage in Diagonal Bracing

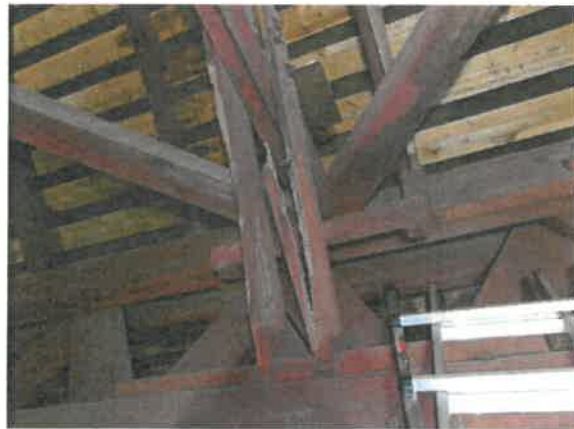
Broken Connection at Crossbeam and Knee Brace

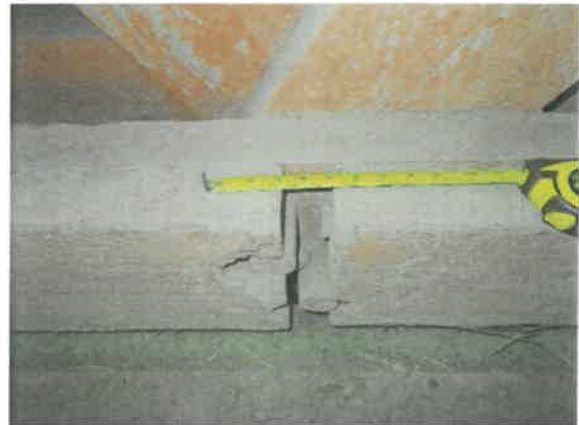
- Many lattice members exhibit splitting, checking, full width section loss, cracks around trunnels, impact damage, insect infestation, and rot.
- Multiple top lattice tails are split with varying lengths. Multiple tail splits extend past the trunnel connections in chord 1.
- Multiple lattice bottom tails are split and extend past the trunnel connections in chord 4.
- The lattice lower tails are cut at the pier and abutments for the sleeper beam and bearing.

Gap in Chord 3 at Trunnels

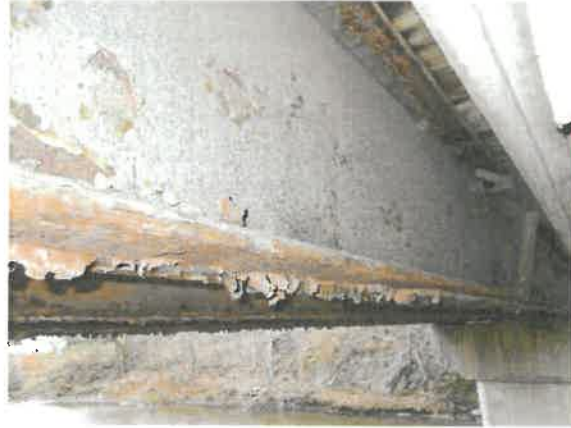
Exterior Stringer

- The runner boards exhibit areas of minor wear with sand debris build up at roadway shoulders.
- The beams exhibit significant corrosion along the bottom flange and paint failure of the webs.
- The truss lower lateral bracing connection to chord 4 exhibits moderate corrosion.
- The exterior stringers had section loss that reduced flange thickness to $\frac{7}{16}$ " in isolated areas. The top flange also had areas of section loss with a flange thickness of $\frac{7}{16}$ " throughout. The webs were in fair condition with areas of paint failure and rust. By inspection, it appears the web had approximately $\frac{1}{16}$ " section loss on both sides of the web ($\frac{1}{8}$ " total).
- Access was limited for the interior stringers. By inspection from the exterior stringers, it appeared the interior stringers had the same amount of section losses exhibited in the exterior stringers.

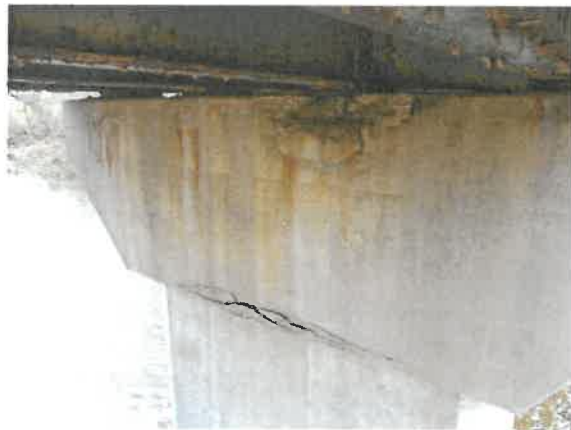
Concrete Spalling at Stringers Bearings

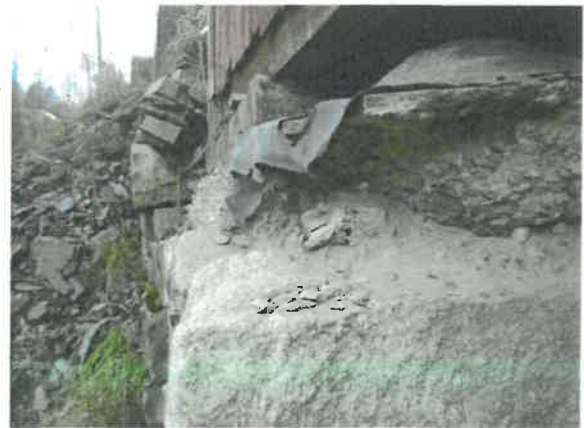
West Abutment Beam Seat

- The east abutment exhibits significant concrete spalling, efflorescence staining, delamination, and vertical, horizontal, and map cracking. The southeast beam seat corner has a large spall, and the concrete is coming loose from the structure. The concrete appears to be of poor quality with large round aggregates used.
- The west abutment masonry exhibits voids up to 5' deep. The concrete beam seat cap concrete has significantly deteriorated.
- The southwest wingwall is comprised of dry laid stacked stones which have failed, and the wall is no longer vertical.
- At the spalled areas, the concrete was observed to contain round river stones with no fractured faces, which significantly reduces the concrete strength and durability.
- The east abutment is in poor condition and needs to be replaced. The west abutment beam seat and backwall is in poor condition and needs to be replaced.

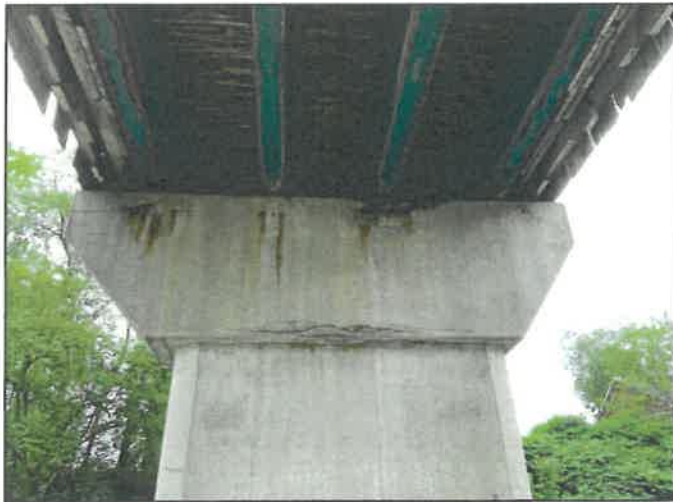
Pier cap

Patching repairs are needed.
