Upper, Lower, and Northfield Falls Covered Bridges

Northfield BO CVBR(7)(8)(9)

Bridges No. 10 and 11 over Cox Brook
Bridge No. 15 over Dog River

Alternatives Presentation

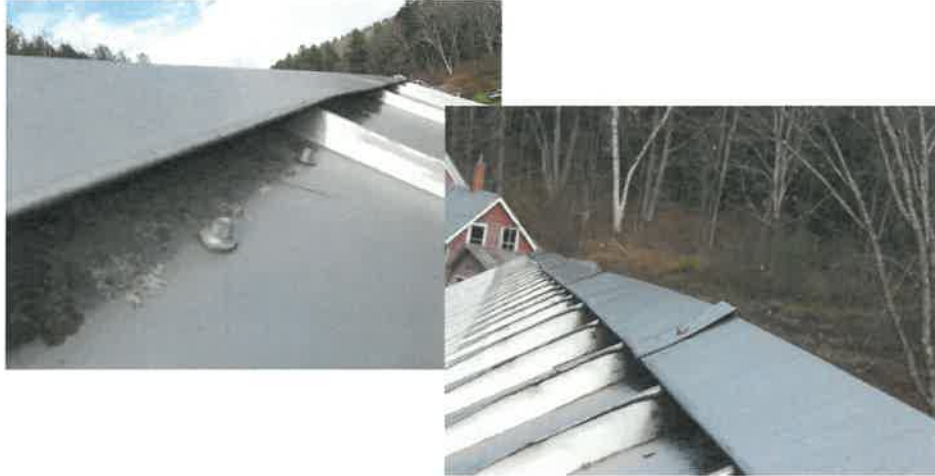
Metal Roof

- Leaks
- Screw Attachment

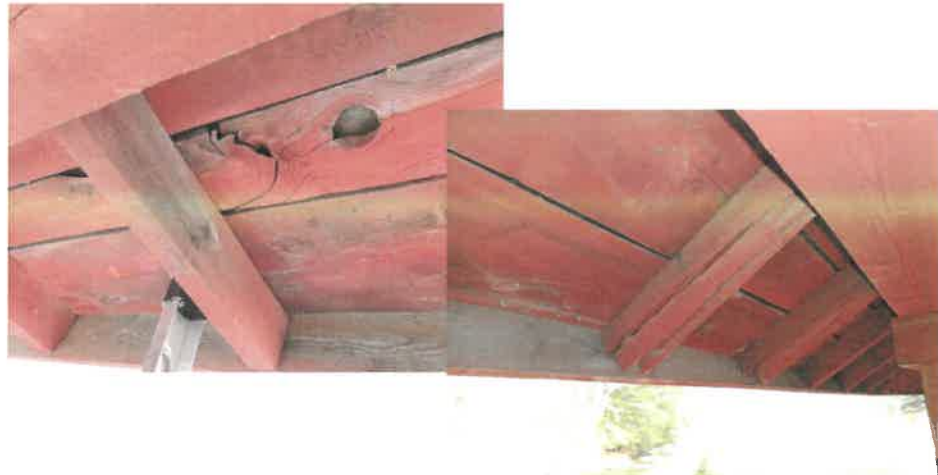
Roofboards & Rafters

- Splits
- Breaks
- Rot

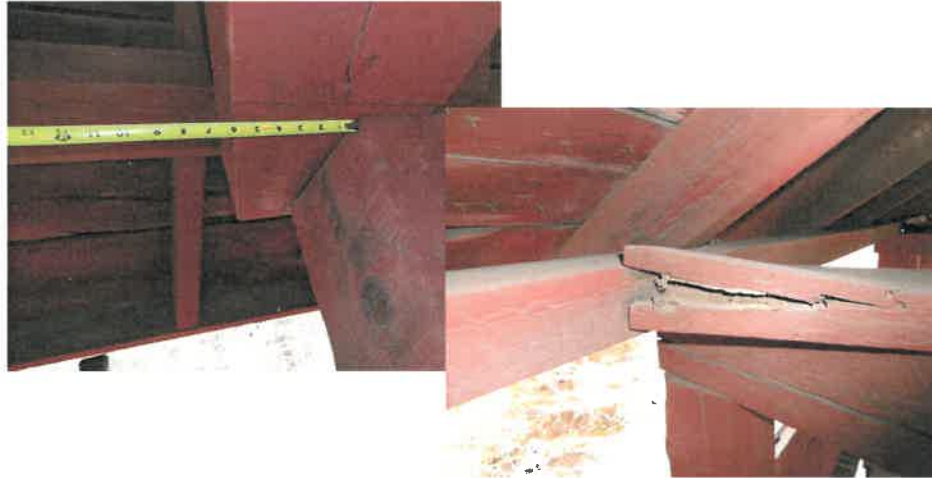
Upper Bracing Members

- Splits
- Breaks
- Rot
- Impact Damage

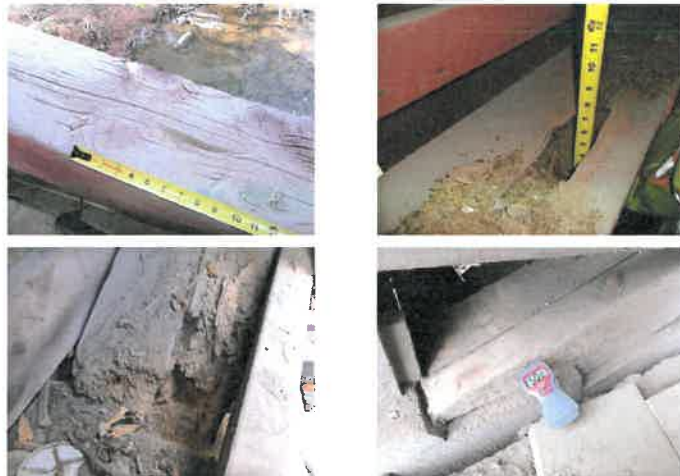
Truss Members

- Splits
- Breaks
- Rot
- Weathering
- High Moisture Content

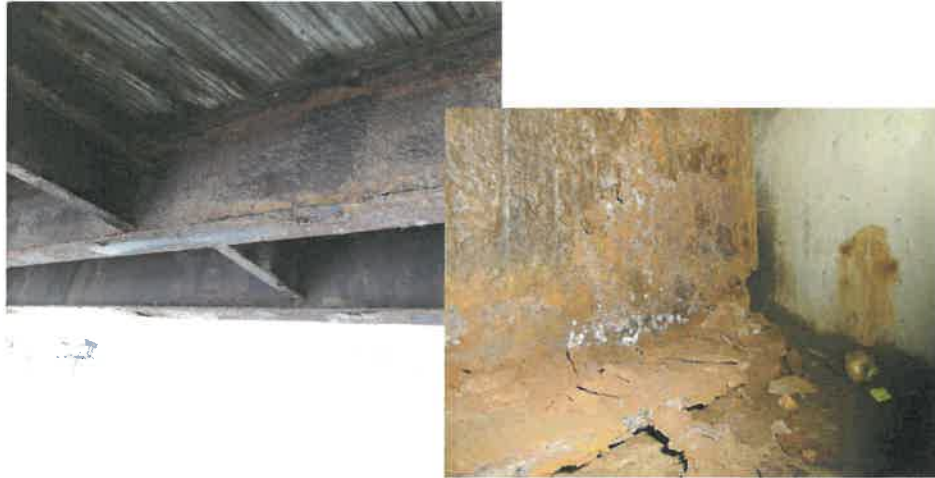
Steel Beams

- Rust Holes
- Advanced Corrosion

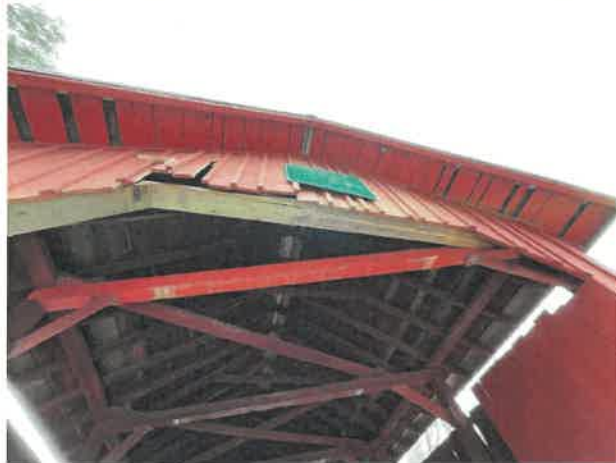
Portals

- Breaks
- Impact Damage

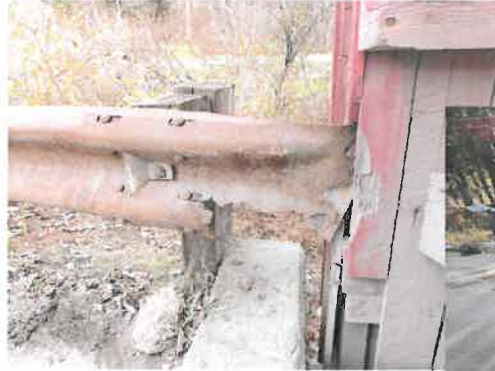
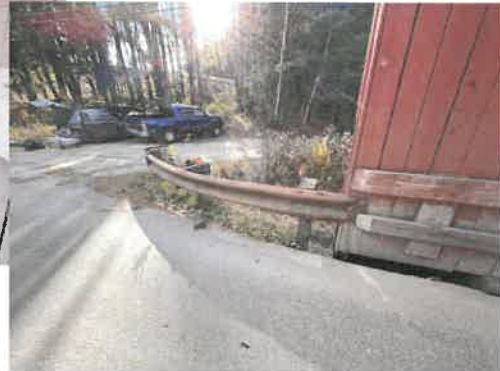
Approach Railing

- Extensive Corrosion
- Rust Holes
- Rotted Wood Posts
- Impact Damage

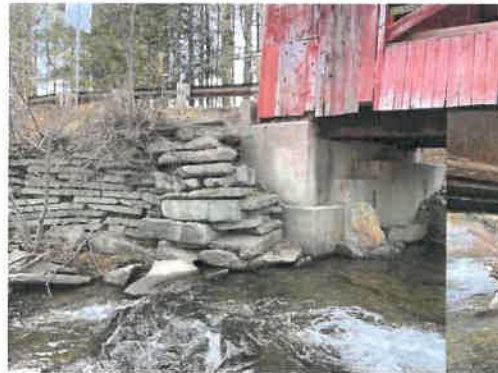
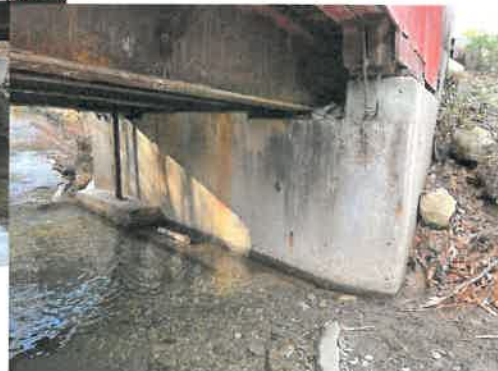
Abutments

- Voids
- Spalling
- Exposed Rebar

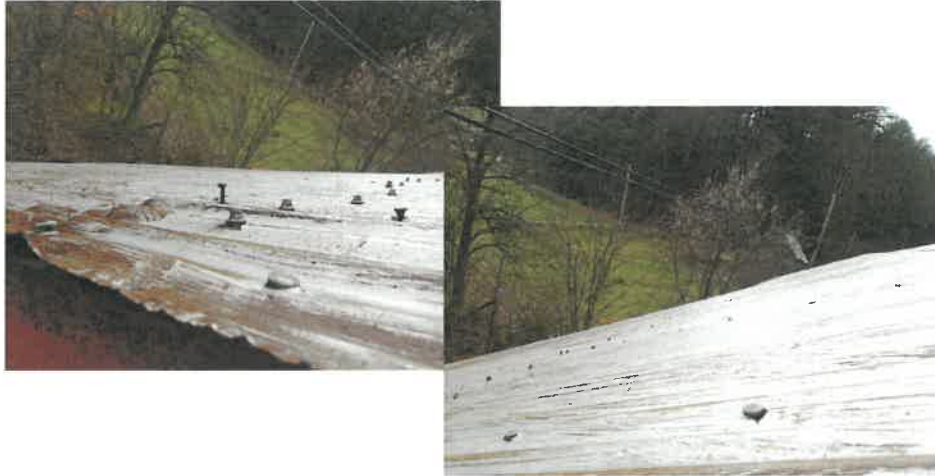
Metal Roof

- Rusting
- Leaks
- Nail Attachment

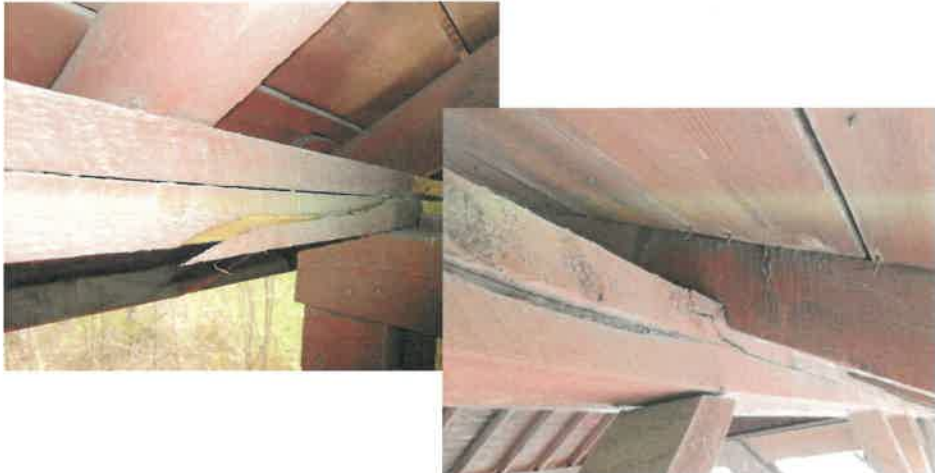
Roofboards, Rafters & Rafter Support Beam

- Splits
- Breaks
- Rot
- Insect Damage

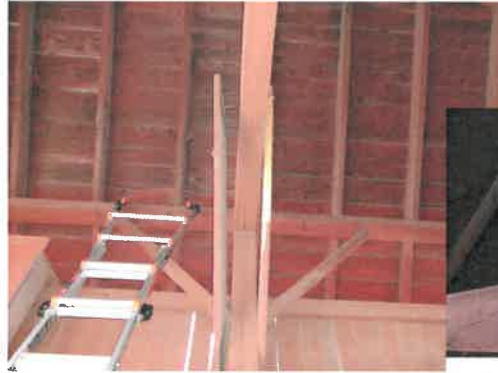
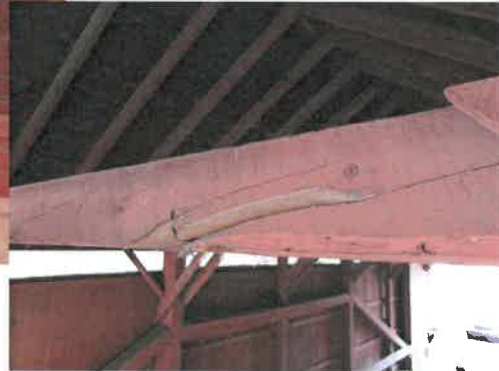
Upper Bracing Members

- Splits
- Breaks
- Rot
- Impact Damage

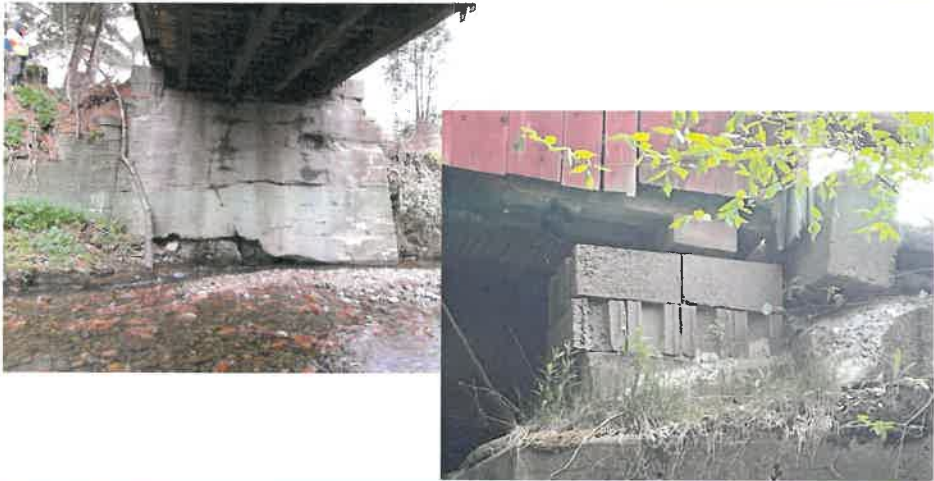
Abutments

- Voids
- Spalling
- Exposed Rebar
- CMU Truss Bearings

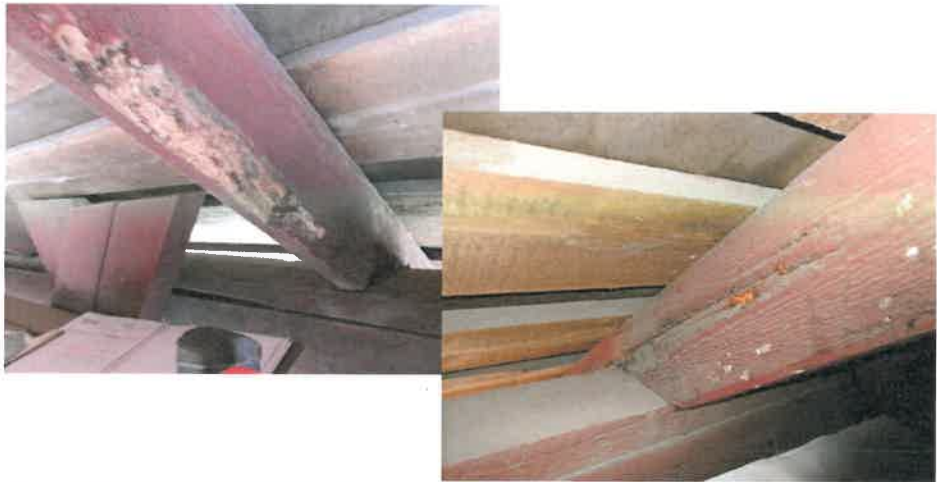
Roofboards & Rafters

- Splits
- Breaks
- Rot
- Insect Damage

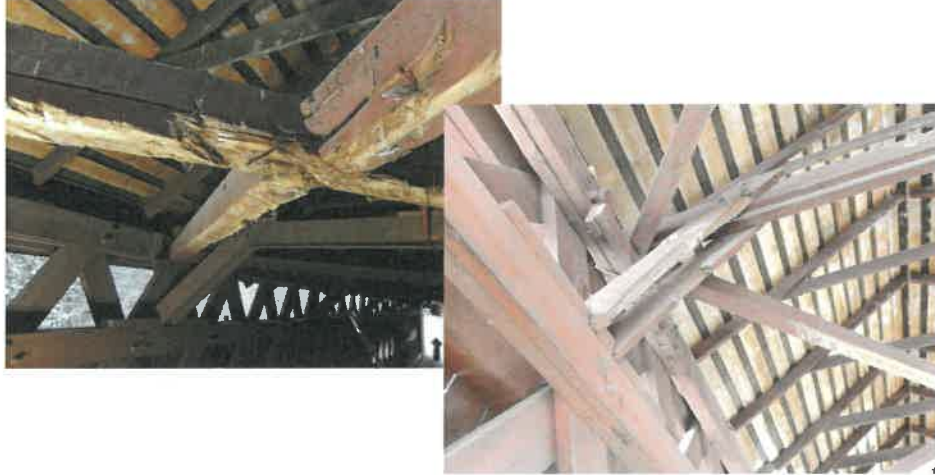
Upper Bracing Members

- Splits
- Breaks
- Rot
- Impact Damage

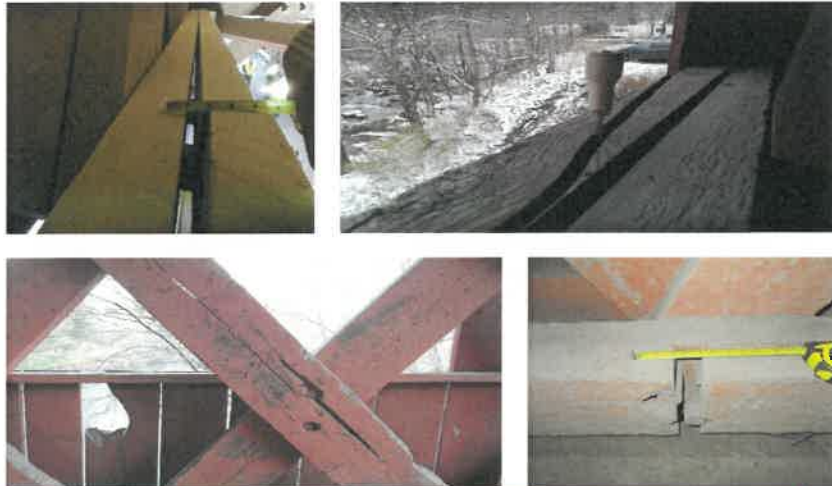
Truss Members

- Splits
- Breaks
- Rot
- Misalignment
- High Moisture Content

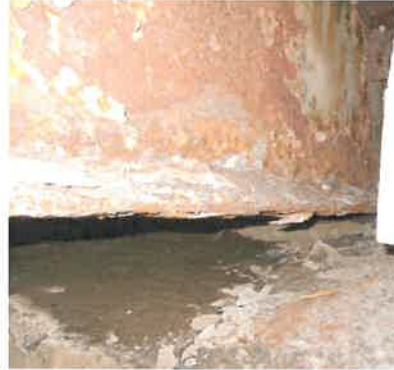
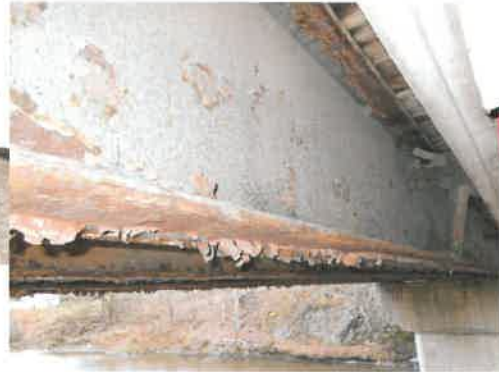
Steel Beams

- Rusting
- Advanced Corrosion

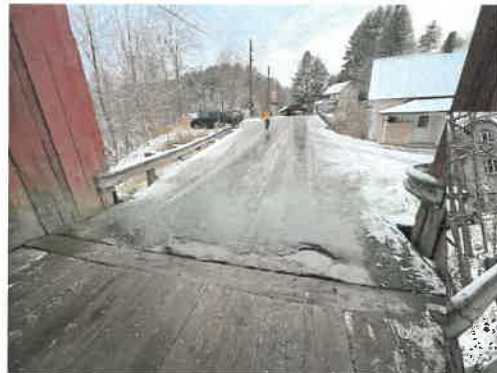
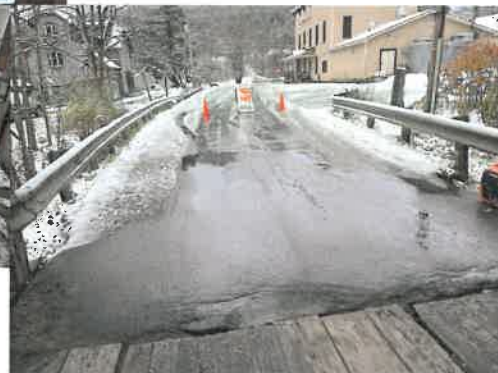
- Drainage Issues
- Ponding
