Draft Scoping Report Northfield Falls Covered Bridge Town Highway 3 Bridge 15 over Dog River

Northfield BO CVBR(9)

January 24, 2026

Prepared for:
Vermont Agency of Transportation

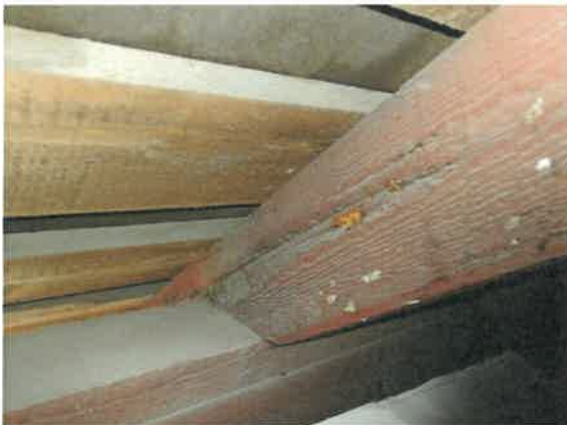
Split in Rafter

- The metal roof is in fair condition.
- The rafters exhibit spits, breakage, and dry rot throughout. Some split and broken members have been sistered to new members.
- The rafter support beam exhibits rotting in few locations.
- The roofboards are overall in satisfactory condition with some splits.
- The siding boards exhibit areas of faded paint. The siding is in good condition; however, removal and replacement will likely be required to provide access for the extensive truss member replacements.

The existing standing-seam metal roof is in fair condition though the ridge cap is attached with nails and screws which allow water to seep into the bridge over time. During rehabilitation, the existing metal roof would most likely be damaged by the removal of certain truss and roof members and will need to be replaced. We recommend that the entire metal roof, all roof boards, and 14 roof rafters (20%) be replaced in-kind (Priority Treatment No. 2) (PTN 2) due to condition. Roof boards are 1" thick Eastern Spruce and rafters are 2"x6" Eastern Spruce. These roof framing recommendations apply to Alternatives 1 through 4.

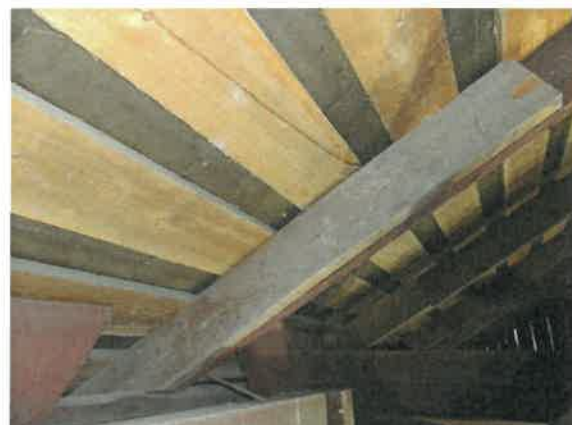
Split in Roofboard and Spliced Rafters

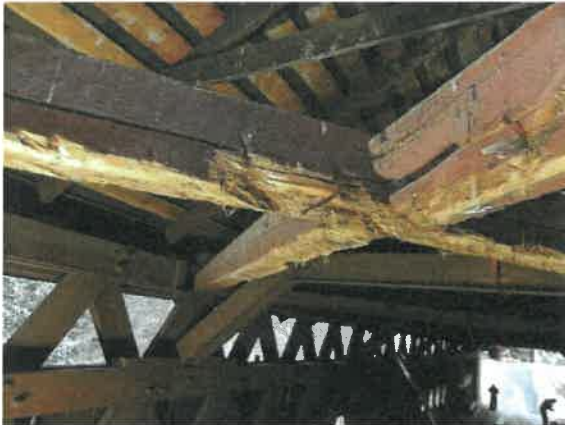
Impact Damage in Diagonal Bracing

- The cross beams exhibit significant impact damage from vehicles and dislodged and twisting in one location.
- Diagonal bracing members exhibit significant impact damage from vehicles, breakage, twisting and multiple are missing.
- Crossbeams have been previously damaged from oversized vehicles and are not well connected to the vertical truss members.
- The knee braces exhibit significant impact damage from vehicles and breakage.

- Replace all diagonal braces in-kind (PTN 2)
- Replace 1 crossbeams (11%) in-kind (PTN 2)
- Repair knee brace connections (PTN 1)

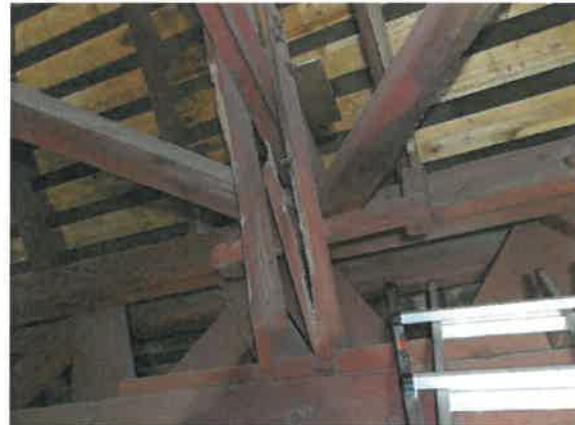
Broken Connection at Crossbeam and Knee Brace

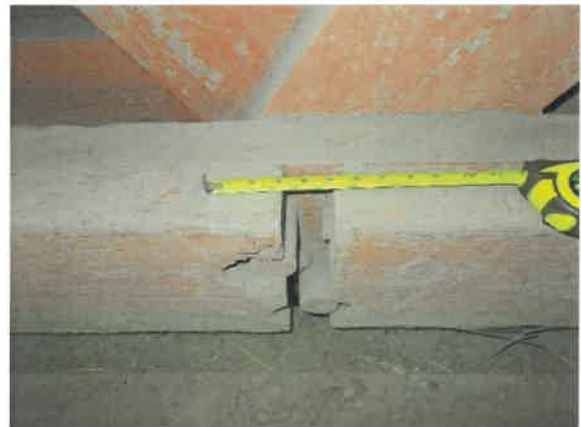
Gap in Chord 3 at Trunnels

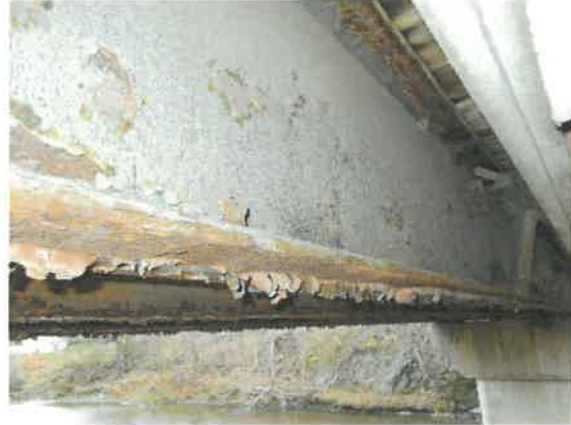
- The runner boards exhibit areas of minor wear with sand debris build up at roadway shoulders.
- The beams exhibit significant corrosion along the bottom flange and paint failure of the webs.
- The truss lower lateral bracing connection to chord 4 exhibits moderate corrosion.
- The exterior stringers had section loss that reduced flange thickness to $\frac{7}{16}$ " in isolated areas. The top flange also had areas of section loss with a flange thickness of $\frac{7}{16}$ " throughout. The webs were in fair condition with areas of paint failure and rust. By inspection, it appears the web had approximately $\frac{1}{16}$ " section loss on both sides of the web ($\frac{1}{8}$ " total).
- Access was limited for the interior stringers. By inspection from the exterior stringers, it appeared the interior stringers had the same amount of section losses exhibited in the exterior stringers.

Exterior Stringer

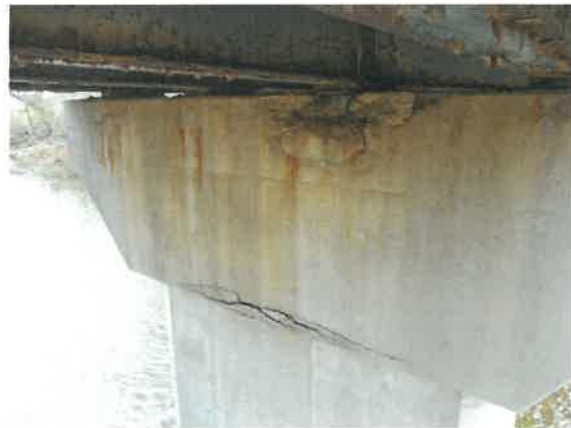
Concrete Spalling at Stringers Bearings

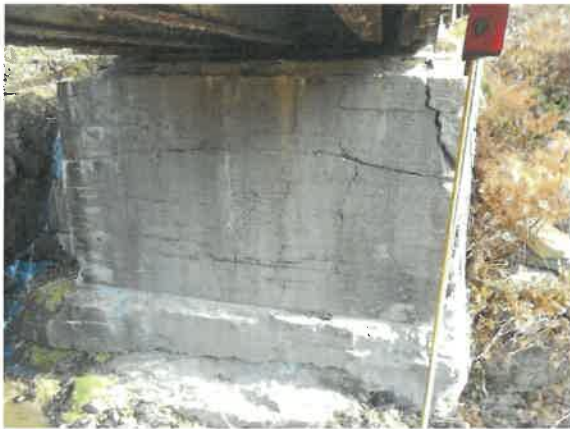
East Abutment Elevation

- The east abutment exhibits significant concrete spalling, efflorescence staining, delamination, and vertical, horizontal, and map cracking. The southeast beam seat corner has a large spall, and the concrete is coming loose from the structure. The concrete appears to be of poor quality with large round aggregates used.
- The west abutment masonry exhibits voids up to 5' deep. The concrete beam seat cap concrete has significantly deteriorated.
- The southwest wingwall is comprised of dry laid stacked stones which have failed, and the wall is no longer vertical.
- At the spalled areas, the concrete was observed to contain round river stones with no fractured faces, which significantly reduces the concrete strength and durability.
- The east abutment is in poor condition and needs to be replaced. The west abutment beam seat and backwall is in poor condition and needs to be replaced.

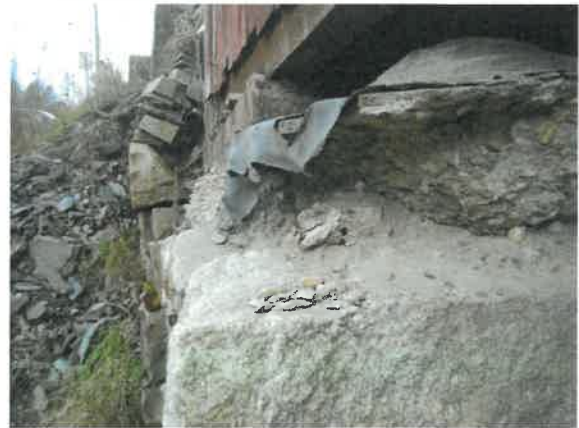
West Abutment Beam Seat

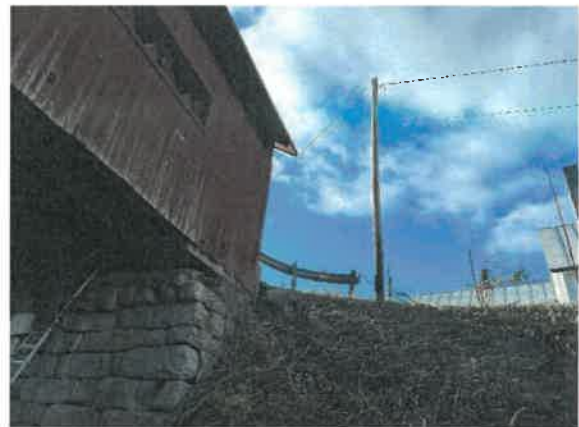
Guy Wire Attached to NW Corner of Bridge

An aerial utility relocation will be needed. Utility relocation plans will be determined once design plans are available.

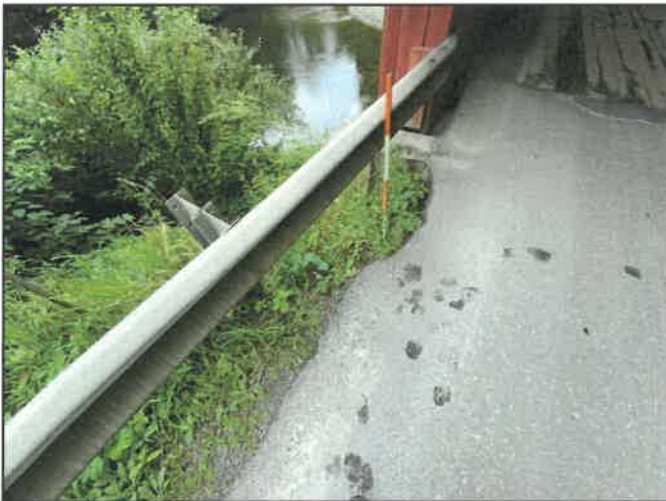
Erosion of the upstream embankment along the abutment 1 approach has caused the erosion of the asphalt in the shoulder area. Preventive repairs are needed so erosion doesn't extend further into the roadway. The structure should be considered for a paint project with extensive cleaning of the beams. Abutment 1 and the pier cap are in need of concrete repairs due to cracked and spalled out areas that extend up to and have undermined small portions of the neighboring bearings; see maintenance reports.

Upstream abutment 1 shoulder area

A means of retaining the approach roadway should be considered with added roadway fill.
