Draft Scoping Report Upper Cox Brook Covered Bridge Town Highway 3 Bridge 10 over Cox Brook

Northfield BO CVBR(7)

January 24, 2026

Prepared for:
Vermont Agency of Transportation

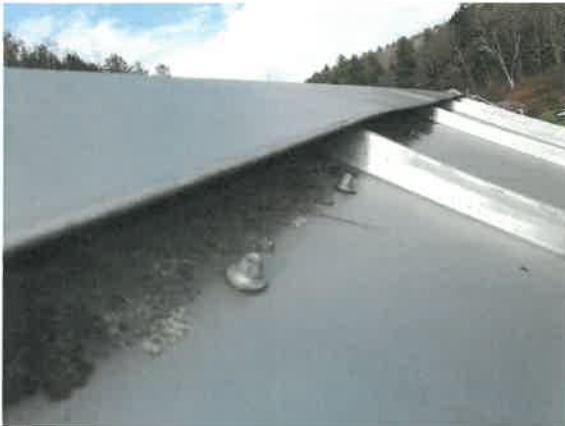
Roof Ridge Cap

- The metal roof ridge cap is attached to the roof boards with nails and screws and is not mechanically field-seamed or watertight. There is some moss growth under the roof ridge cap.
- The roof boards and rafters exhibit through splits, breaks, rot and insect damage. Rafters sit on a 3"x7" rafter support beam.
- The siding boards exhibit areas of faded paint. The siding is in good condition; however, removal and replacement will likely be required to provide access for the extensive superstructure member replacements.

The existing standing-seam metal roof is in fair condition, although the ridge cap is attached with nails and screws which allow water to seep into the bridge over time. During rehabilitation, the existing metal roof would most likely be damaged by the removal of certain truss and roof members will need to be replaced. We recommend that the entire metal roof, all roofboards, and 14% of the rafters be replaced in-kind (Priority Treatment No. 2) (PTN 2) due to condition. Roof boards are 1" thick Eastern Spruce and rafters are 2"x6" Eastern Spruce. These roof framing recommendations apply to Alternatives 1 through 5.

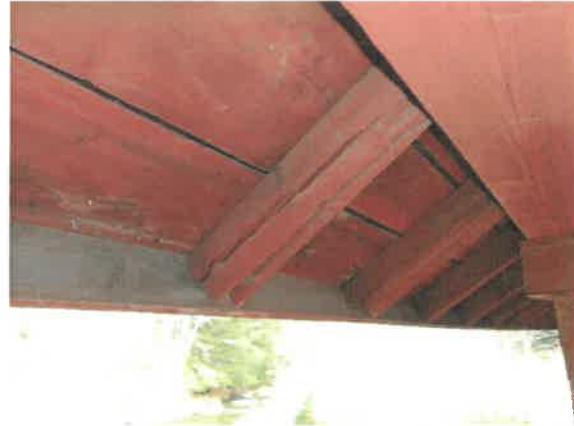
Splits and Breaks in Roof Boards and Rafters

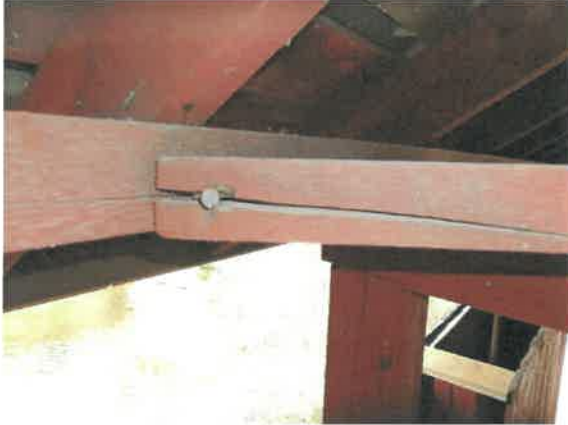
Split in Cross Bream

- Two cross beams exhibit splits. One of the split cross beams is also broken at a connection to a diagonal bracing member.
- Cross beams have been previously damaged from oversized vehicles and are not well connected to the vertical truss members.
- Some of the steel knee braces on the east truss have moderate section loss.

- Replace all seven upper bracing members in-kind (PTN 2).
- Replace two cross beams in-kind due to condition (PTN 2).
- Replace all steel knee braces with timber knee braces (PTN 2).

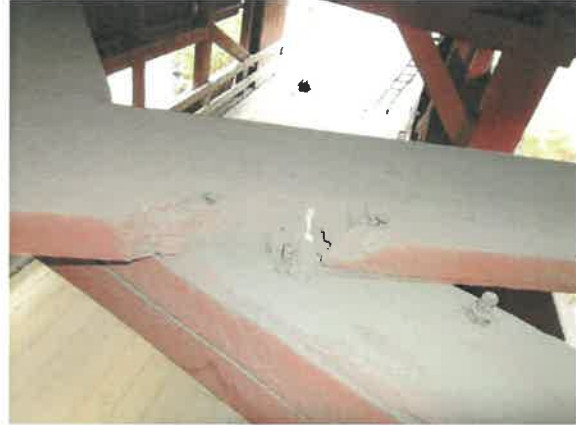
Broken Connection at Cross Beam and Diagonal

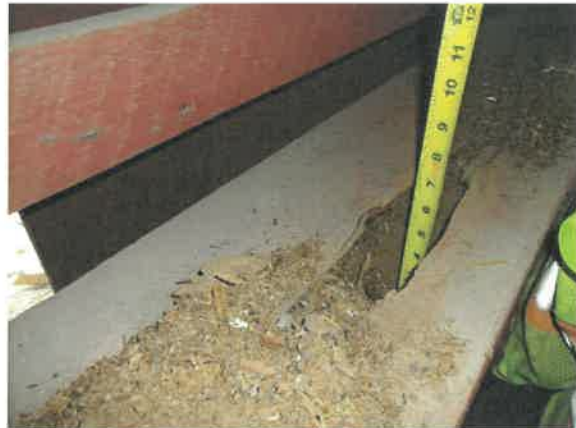
- The top chord of the east truss exhibits extensive rot and needs replacement due to its deteriorating condition. Refer to Appendix E for deteriorated chord members that were identified in need of replacement due to condition.
- The top chord of the west truss is in satisfactory condition with no deficiencies noted at the time of inspection.

East Truss Top Chord Rot

- Replace verticals at nodes 1E and 8E in-kind (PTN 2)
- Replace end portion of diagonal in-kind at node 8E (PTN 2)
- Replace top chord in-kind between nodes 4E and 6E (PTN 2)
- Replace vertical post in-kind at Node 5E between top and bottom chord (PTN 2)
- Replace bottom chord in-kind at node 8E (PTN 2)
- Replace sleeper slab in-kind at node 2E (PTN 2)
- Strengthen vertical to bottom connections (PTN 3)
- Epoxy repair deteriorated members (PTN 1)

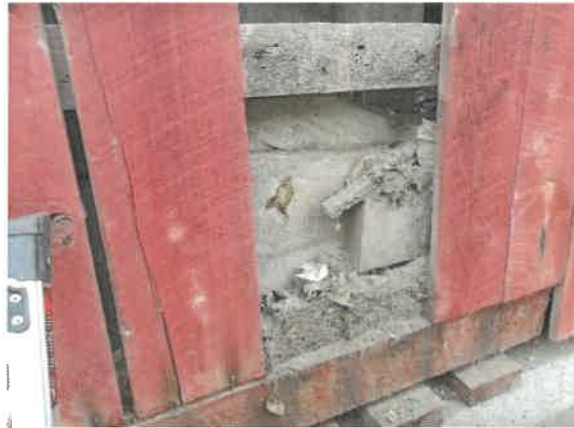
- The bottom chord on the west truss had excessive moisture at the north abutment, with readings up to 50% moisture.
- Ply B of the bottom chord of the east truss is split at the notch for the diagonal member bearing on the bottom chord at the south abutment.
- Both plies of the west truss bottom chord at the north abutment are rotted with up to 50% moisture content.
- The through bolt at node 7 West has extensive section loss with a reduced diameter of 0.6" remaining.

North End of the East Truss Bottom Chord to Diagonal

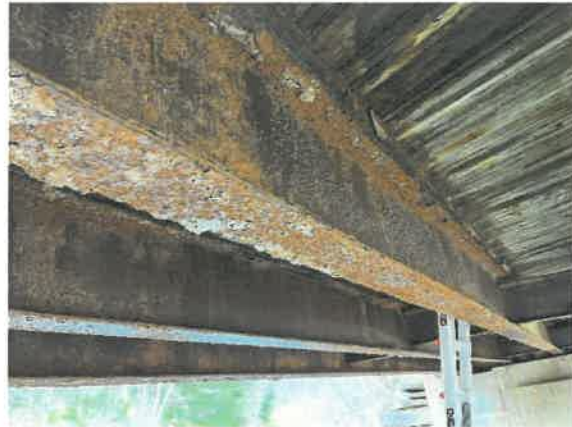
Interior Beam Rusting

- The western interior beam (B2) has heavy laminar corrosion at both faces of the bottom flange along the entire length of the beam. There is a hole in the web at the south abutment up to 18" wide x 4" tall.

- The eastern interior beam (B3) has heavy laminar corrosion at both faces of the top and bottom flanges along the entire length of the beam.
- The exterior beam on the east side (B4) has areas of section loss at the north abutment up to ¼" and has heavy laminar corrosion at both faces of the top and bottom flanges along the entire length of the beam.

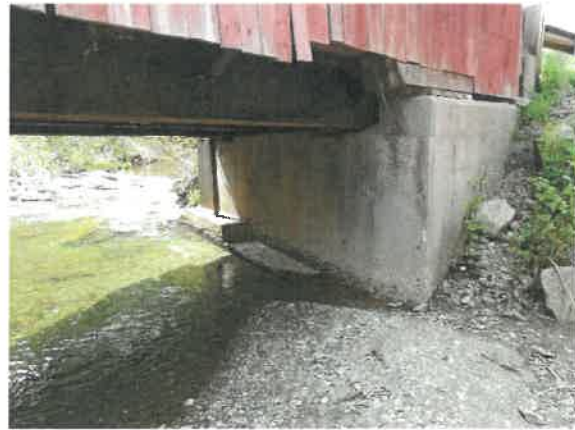
- Both abutments exhibit some areas of concrete spalling, delamination, exposed rebar, efflorescence staining, and vertical, horizontal, and map cracking.
- At the spalled areas the concrete was observed to contain rebar.

North Abutment

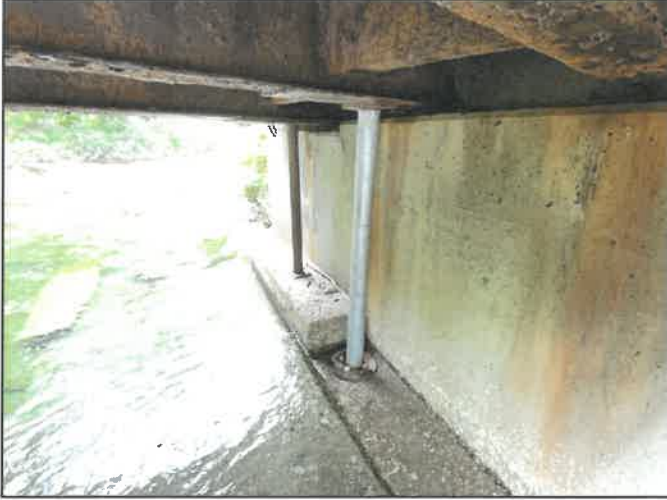
Abutment 2 beam ends

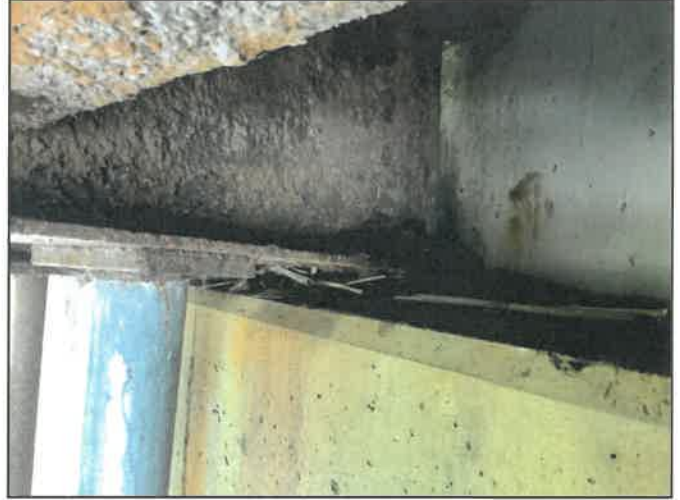
Due to the continued section loss across the length of the beams a future project to replace the beams should be considered.

Beam 2 abutment 2 end
