Dog River

River Corridor Plan

Roxbury, Northfield, Berlin & Montpelier,
Vermont
April 8, 2009

Prepared by: Bear Creek Environmental, LLC

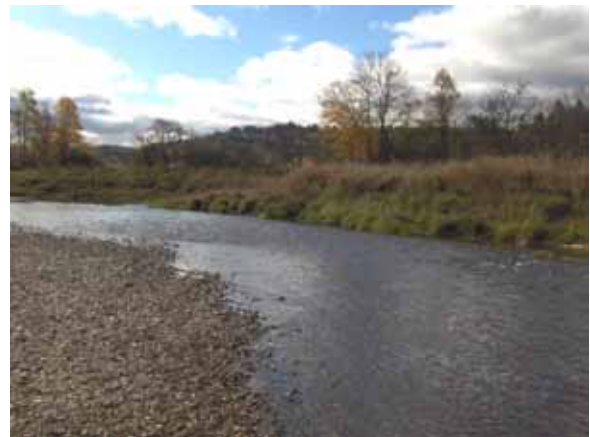
Figure 5.1: Large side bar and steep riffle on Dog River near recreation fields off Dog River Road

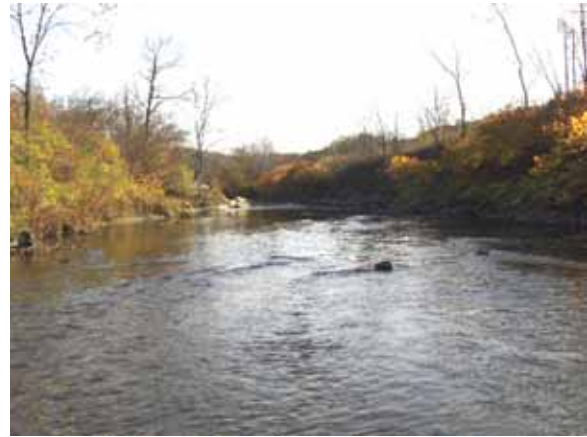
Figure 5.2: Straightened segment of channel along railroad bed upstream of Nelson Drive Bridge

The RGA rated in the fair category as some minor historic degradation has occurred, likely associated with channelization activities to accommodate the encroaching railroad bed, and because aggradation and planform adjustment are major active processes. M01-B was on the border between a "C" and a "B" channel with an entrenchment ratio of 2.3. Additionally some plane bed features were noted as a result of extensive channel straightening. The RHA also scored in the fair category due to limited refuge habitat, extensive channelization, and poor bank and riparian vegetation on the west side of the channel. This segment had numerous deep pools and abundant woody debris cover.

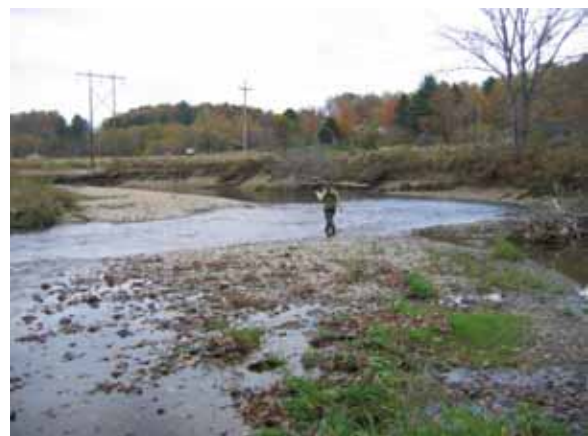
Figure 5.3: Large point bar and steep riffle with no riparian buffer on east bank near Dog River Road intersection with Route 12

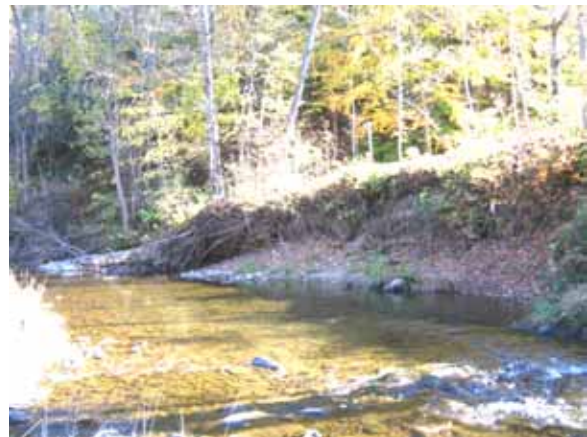
Figure 5.4: Eroding banks and limited riparian vegetation near Browns Mill Road

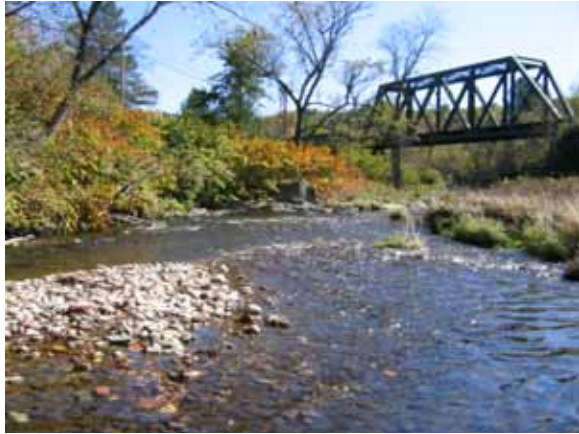
Figure 5.5: Diagonal bar, bank armoring and railroad bridge near where railroad crosses Route 12

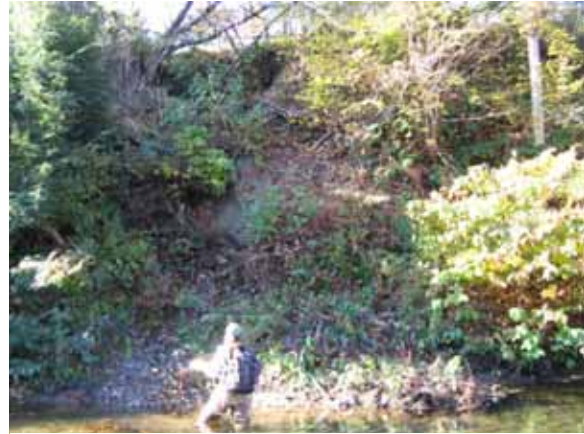
Figure 5.6: Mass failure on right bank near M's RV dealership on Route 12

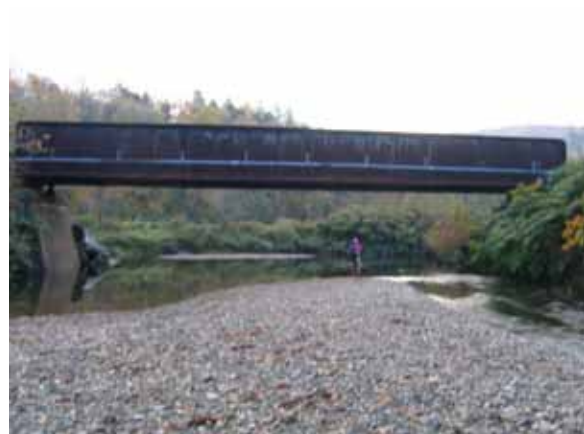
Figure 5.8: Major deposition and planform adjustment downstream of undersized railroad bridge

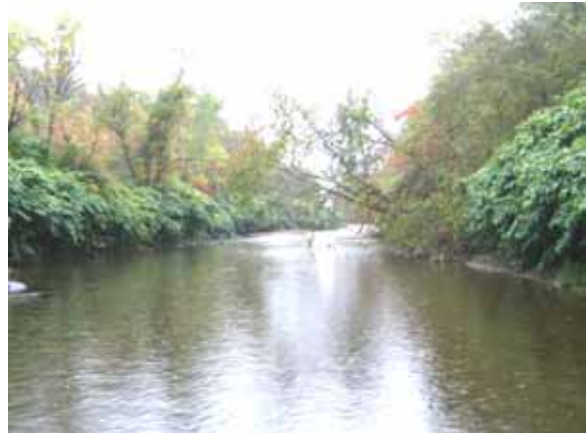
Figure 5.9: Straight, confined channel with invasive near bank vegetation located upstream of confluence with Muzzy Brook

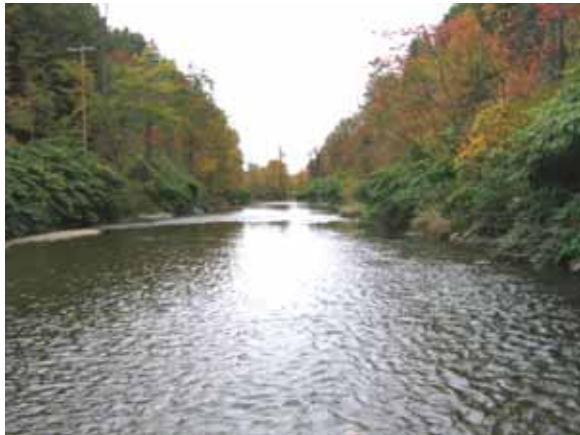
Figure 5.10: Straightened channel with invasive near bank vegetation and no riparian buffer where valley walls open up along Route 12

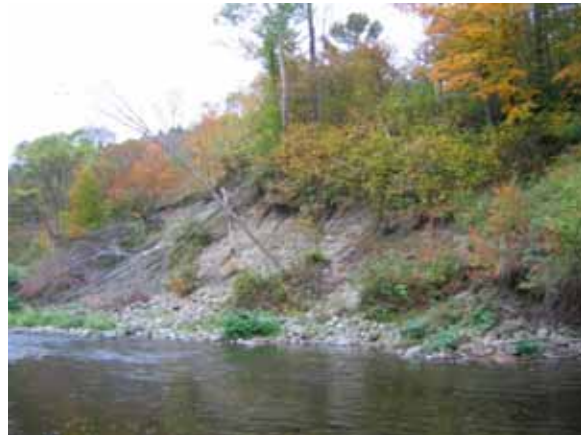
and planform adjustments. There is one mass failure on the east bank at the upper end of this segment (Figure 5.11).

Figure 5.11: Mass failure on right bank where straightened segment begins downstream of Chase Brook confluence

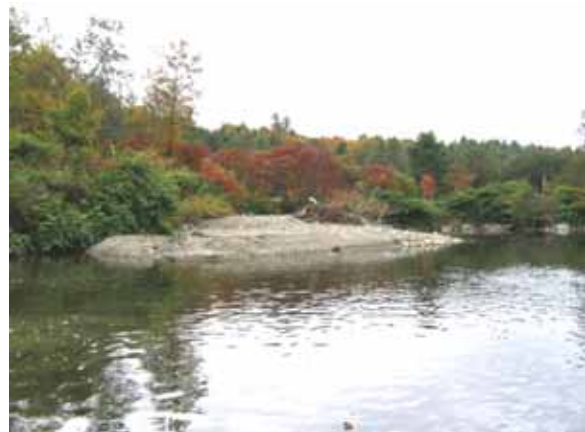
Figure 5.12: Large delta bar at confluence with Chase Brook

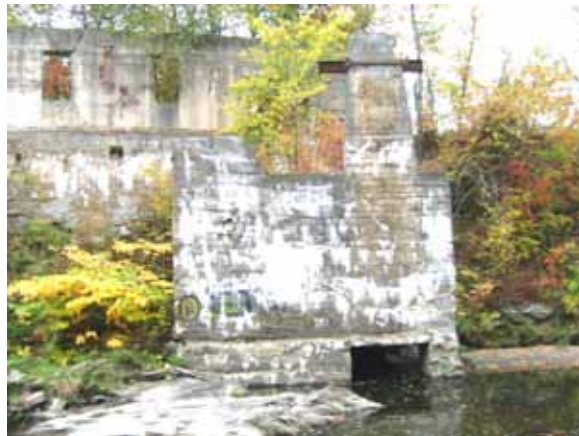
Figure 5.14: Old mill structure channel constriction downstream of Route 12 bridge near Berlin Volunteer Fire Department

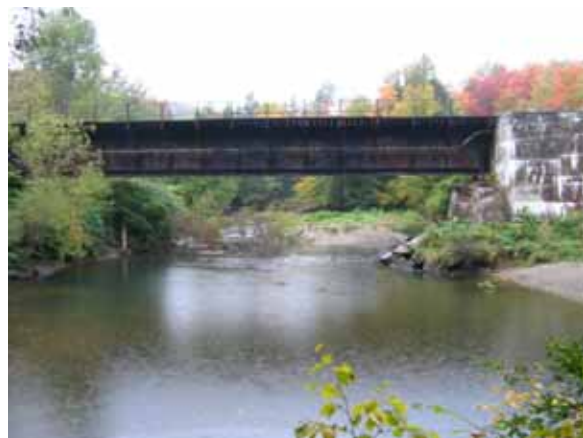
Figure 5.17: Large pool above waterfall and mid channel accumulation upstream of railroad bridge near Route 12 and Pine Hill Drive

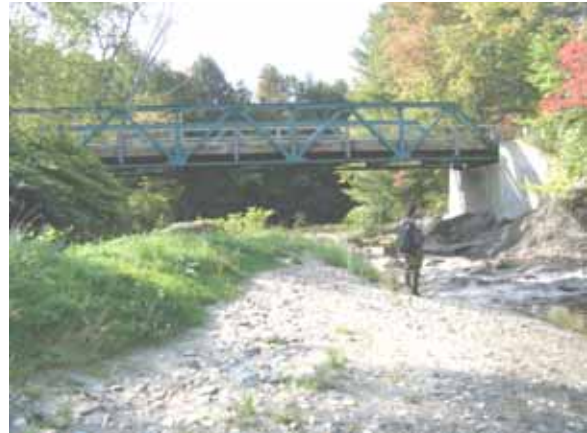
Figure 5.18: Deposition above bedrock constriction near Lovers Lane Bridge

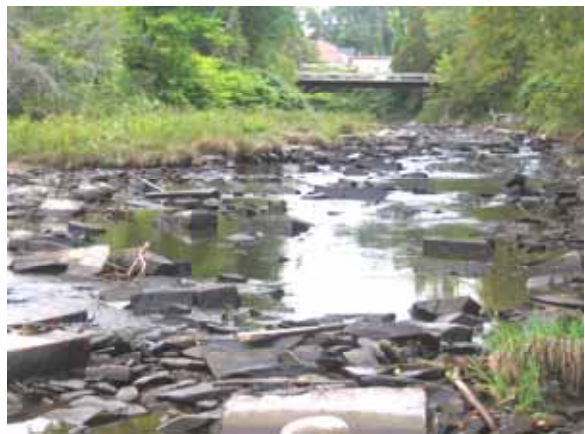
Figure 5.30: Granite tailings in channel downstream of footbridge behind Mobil Station on N. Main Street

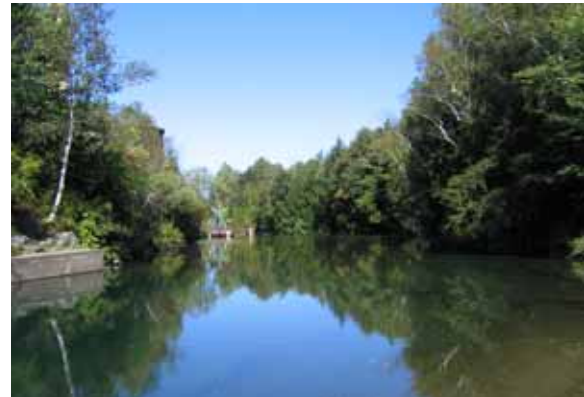
Figure 5.32: Impounded channel above Northfield Mills dam near Belknap Street

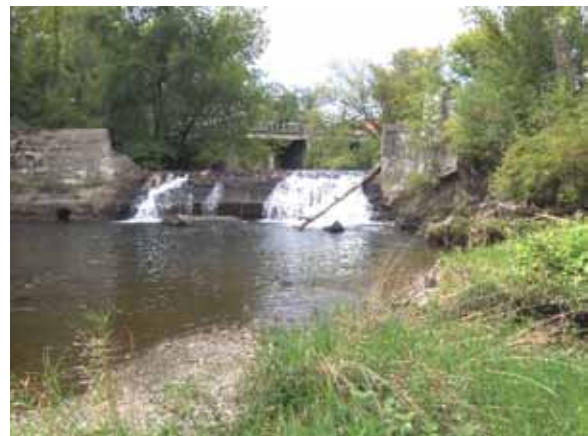
Figure 5.33: Breached dam located downstream of Main Street bridge in downtown Northfield

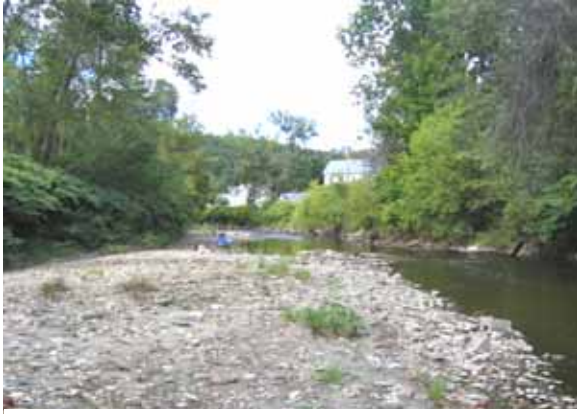
Figure 5.34: Residential development within corridor, invasive bank vegetation and large side bar near the intersection of Water Street and Carpenter Street

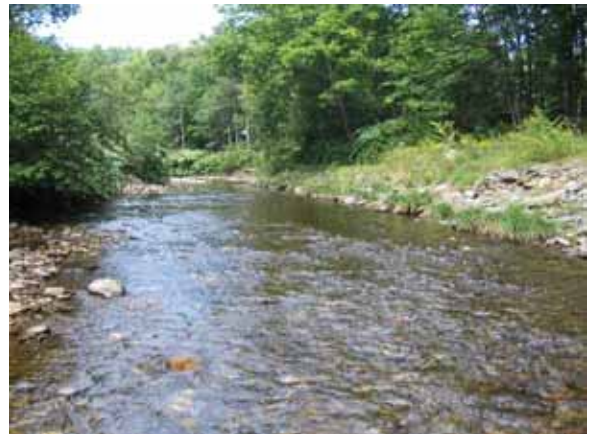
Figure 5.39: Straightened channel with limited near bank vegetation and riparian buffer near end of Expansion Drive.

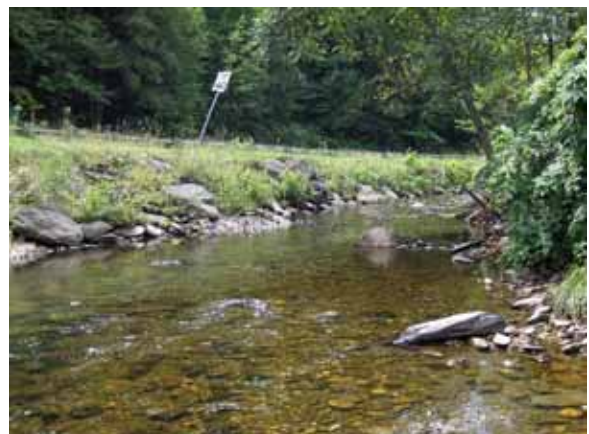
Figure 5.40: Straightened channel with no riparian buffer along Route 12A near Stony Brook Road

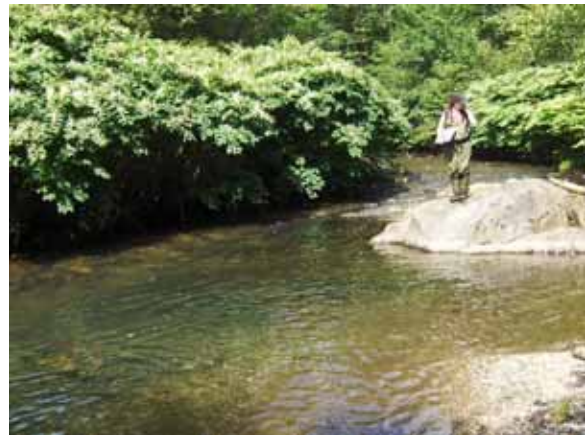
Figure 5.41: Invasive vegetation on near bank and deep pool just below start of golf course at Northfield Country Club along Route 12A

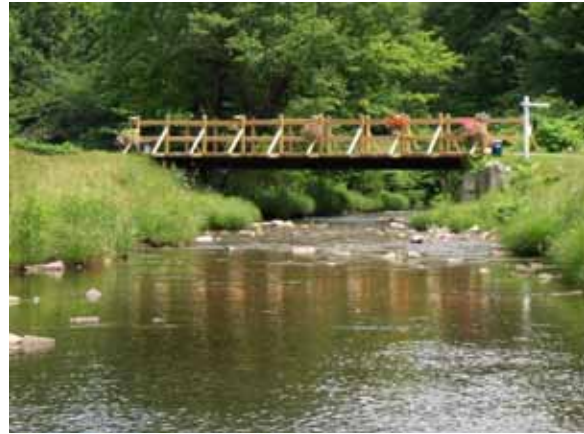
Figure 5.42: Straightened channel through golf course at Northfield Country Club with no riparian vegetation and bridge

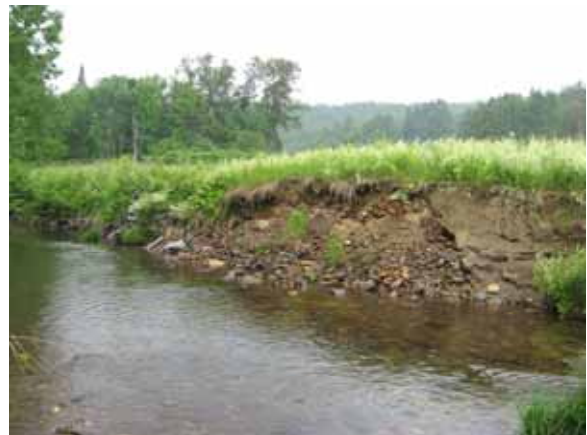
Figure 5.45: Agricultural field lacking riparian buffer and eroding banks near Little Northfield Road and Route 12A

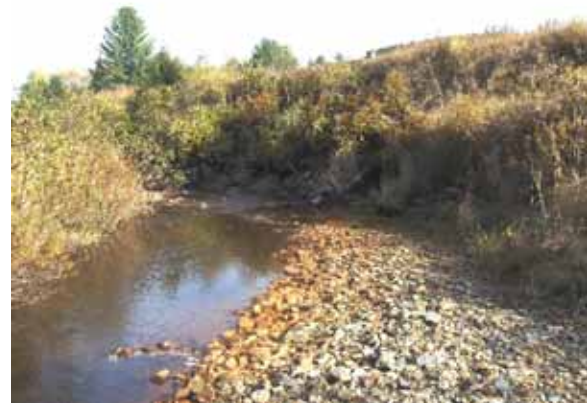
Figure 5.50: Straightened channel along railroad bed lacking riparian vegetation downstream of Rabbit Hollow Road

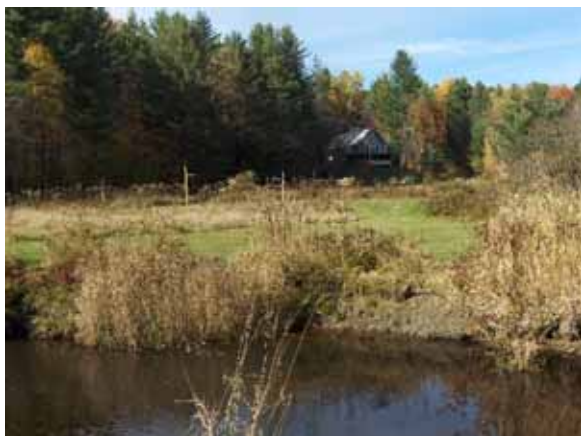
Figure 5.51: Lack of riparian buffer and bank erosion along residential property on Rabbit Hollow Road

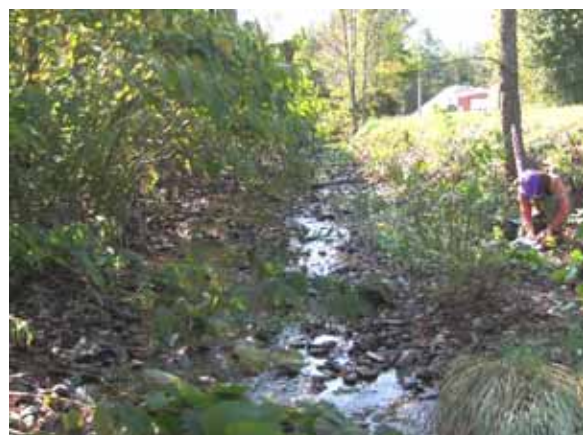
Figure 5.57: Straightened channel lacking riparian buffer with low width to depth ratio upstream of Warren Mountain Road Bridge

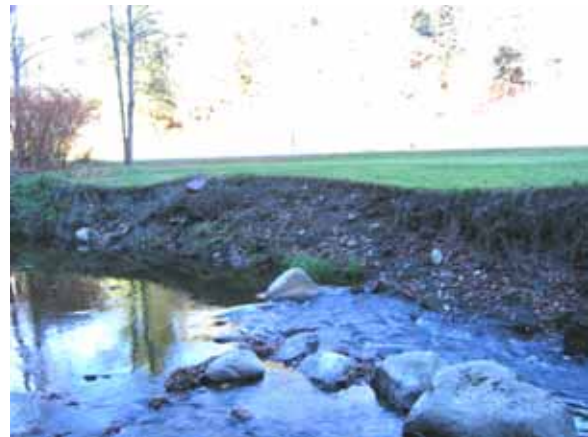
Figure 5.59: Bank erosion along maintained yard with Cox Brook Road in background upstream of second covered bridge on Cox Brook Road

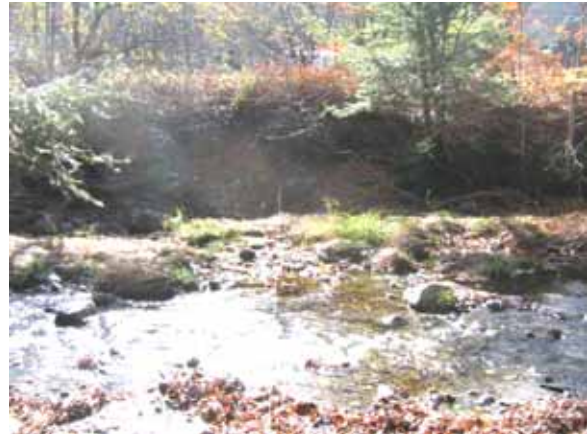
Figure 5.60: Incised channel and flood chute looking at south bank downstream of driveway bridge off Cox Brook Road below Jerry Road

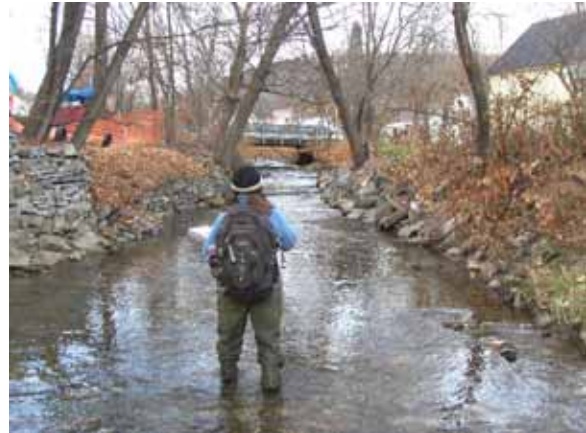
Figure 5.62: Straightened channel with bank armoring and lacking riparian buffers near the intersection of Traverse Street and Union Street

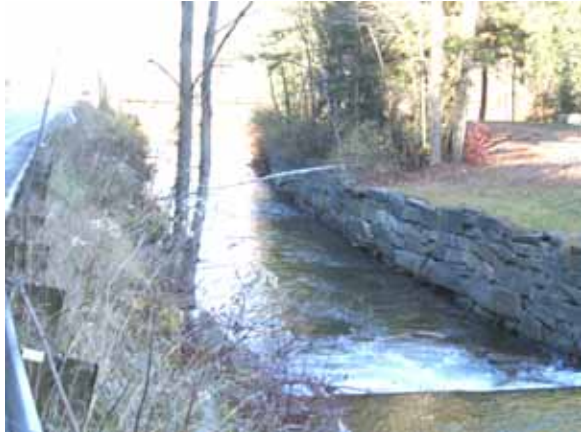
Figure 5.63: Straightened channel with armoring on both banks and small dam along Lovers Lane near the intersection with Route 12A

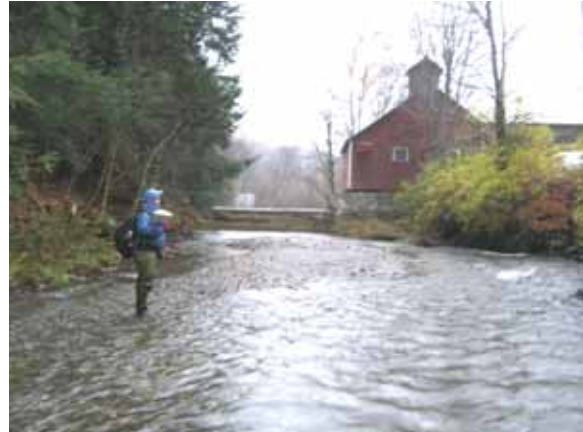
Figure 5.64: Mid channel accumulation upstream of breached dam near the intersection of Route 12 and Lovers Lane

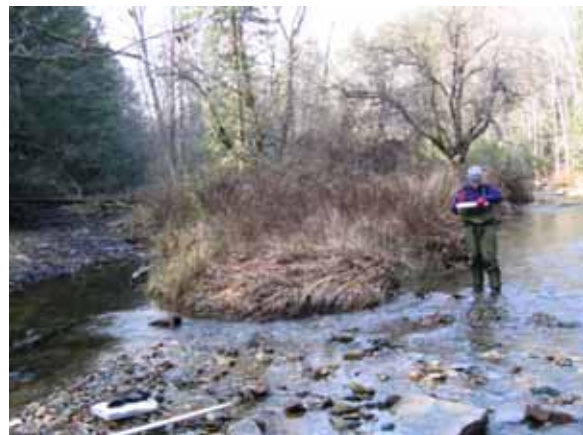
Figure 5.67: Lower end of large channel avulsion with active flood chute near intersection of Smith Hill Road and Stony Brook Road

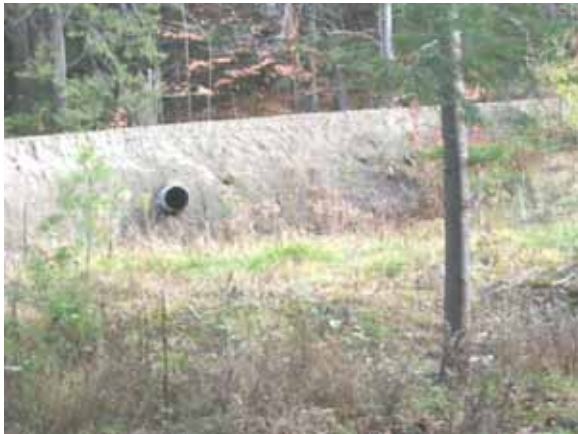
Figure 5.68: Stormwater outfall in loose road material that can easily wash into channel downstream of Stony Brook Road Bridge.

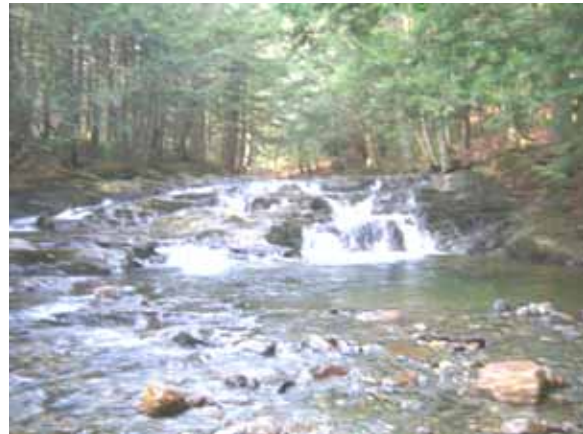
Figure 5.69: One of many large bedrock grade controls obstructing fish passage below Stony Brook Road covered bridge.

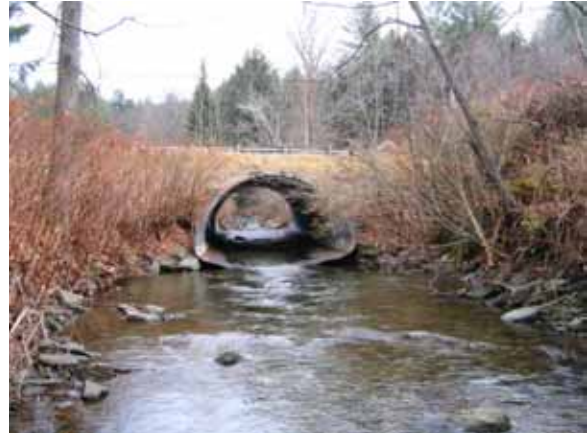
Figure 5.70: Undersized culvert and straightened channel at Route 12A near Little Northfield Road

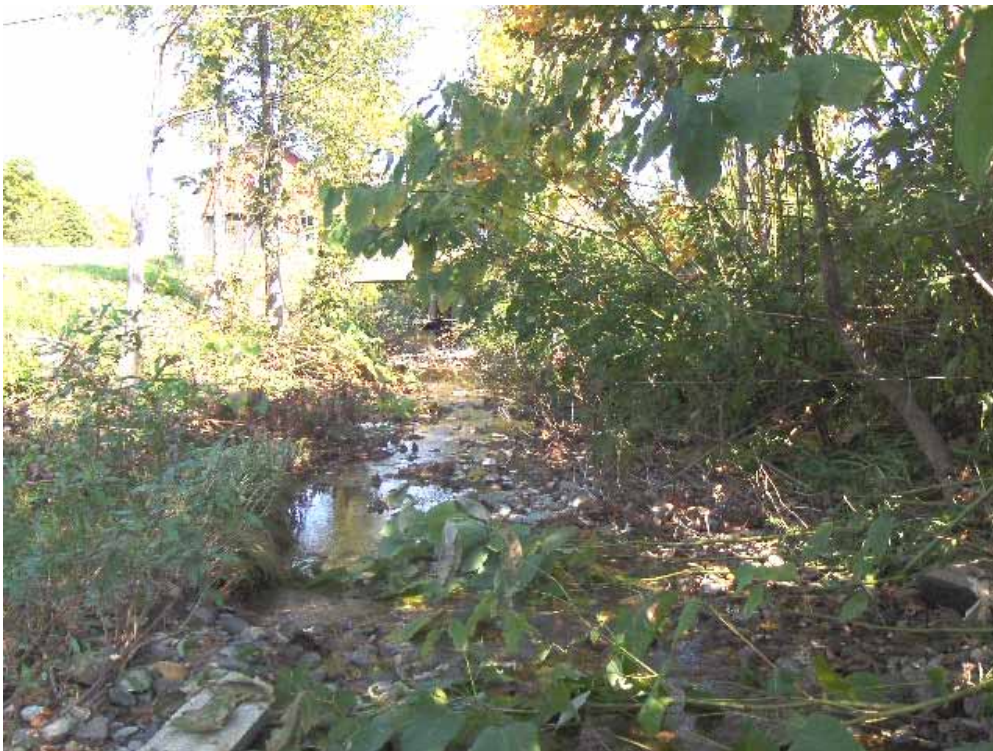
Figure 5.78: Segment M21-D received a habitat rating of poor due to channelization, channel encroachments, lack of riparian vegetation and little refuge habitat.
