Dog River

River Corridor Plan

Roxbury, Northfield, Berlin & Montpelier,
Vermont
April 8, 2009

Prepared by: Bear Creek Environmental, LLC

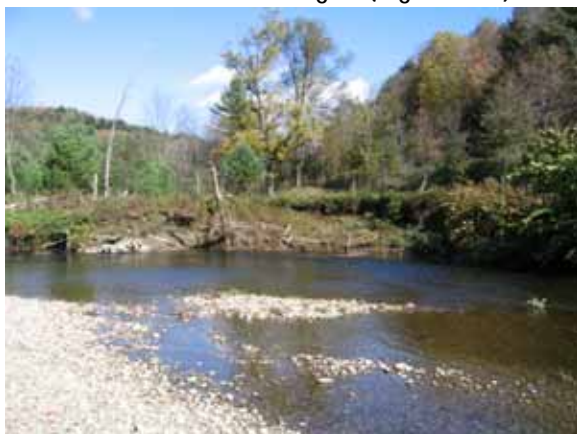
Figure 5.7: Bank erosion, lack of riparian buffer, invasive species and major deposition near Crozier Road intersection with Route 12

The RGA rated in the fair category as a result of major planform adjustment and aggradation occurring within M04. This reach is a “C” channel that has not undergone any historic degradation. The RHA ranked in the fair category as well due to limited refuge habitat, historic channelization, and limited bank and riparian vegetation. This reach has several deep pools and moderate woody debris cover.

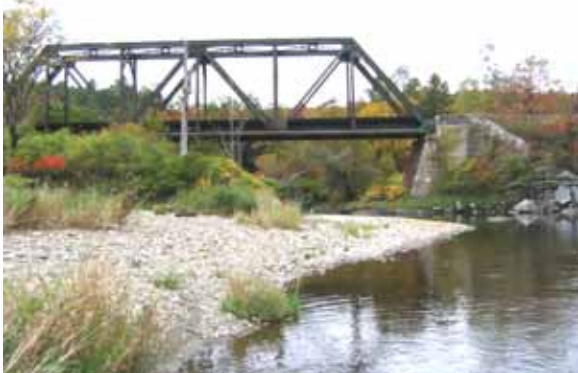
Figure 5.13: Mid channel accumulation below undersized railroad bridge near West Berlin Cemetery

The RGA ranked in the fair category due to major changes in planform and aggradation in this segment. M07-A is a “Bc” channel that has not incised historically but is naturally moderately entrenched and has a low slope. The RHA scored in the fair category due to limited refuge habitat, invasive bank vegetation and inadequate riparian buffers on the east bank. This segment has a few deep pools and nice woody debris cover. There is some conserved land within the river corridor in this segment (Dog River Natural Area, owned by the Berlin Conservation Commission) near the Berlin Volunteer Fire Department.

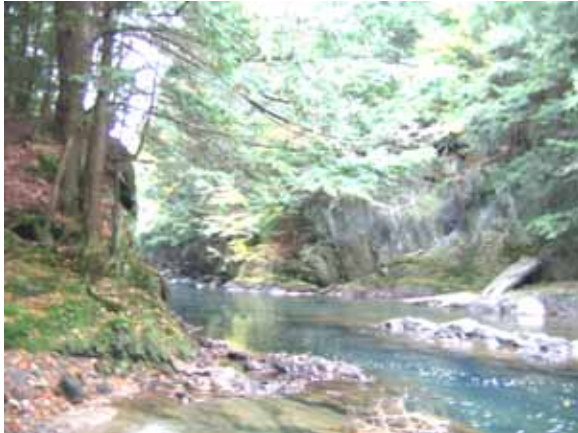
There is healthy near bank and riparian vegetation on both sides of the channel. This segment has large deep pools and is dominated by bedrock on both the bed and the banks (Figure 5.15). A very large waterfall exists at the upper end of the segment (Figure 5.16). The RGA and RHA were not evaluated for this segment. M07-B is a "Gc" channel by reference that is entrenched in a narrowly confined valley with a low slope.

Figure 5.15: Bedrock gorge near Route 12 and Gordon Drive

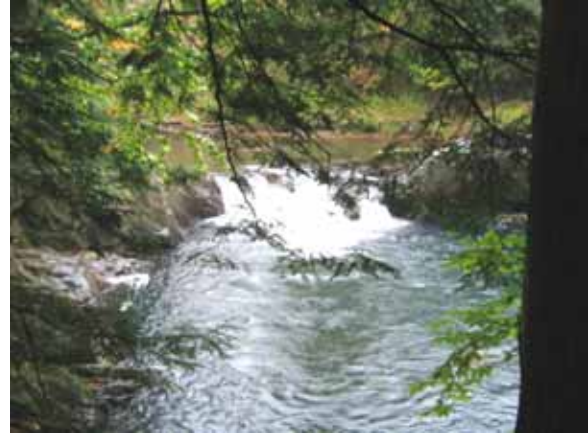
Figure 5.16: Large waterfall at upper end of gorge near Route 12 and Gordon Drive

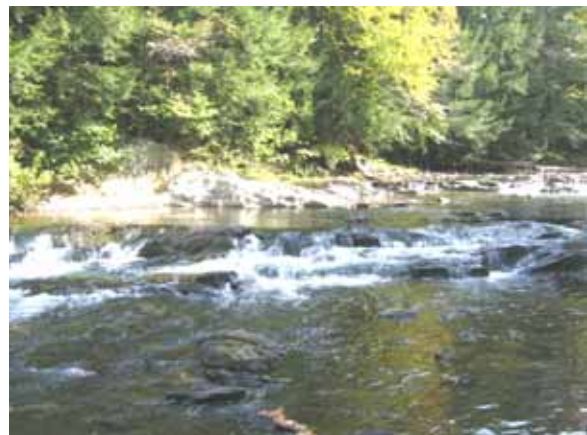
Figure 5.19: Bedrock grade control and good near bank vegetation near USGS gauging station

The RGA rated in the good category due to very minor aggradation and channel widening. M08-B is a “Bc” channel that has not historically incised and is in a naturally semi-confined valley with a low slope. The RHA ranked in the fair category due to lack of refuge habitat, limited woody debris cover, numerous obstructions (grade controls) and limited buffer width on the west bank due to the gravel mine. This segment has a few deep pools and good near bank vegetation.

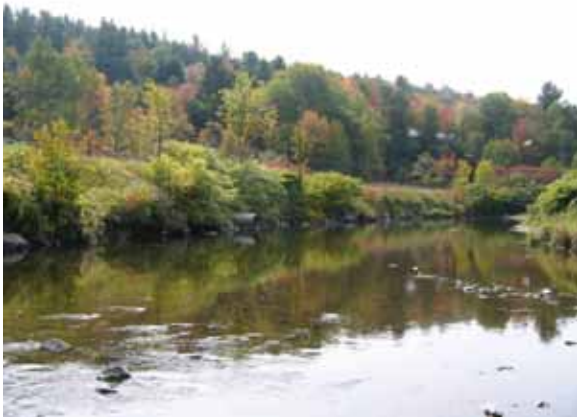
Segment M09-A begins about 500 feet upstream from the last railroad bridge in Berlin and continues to a large dam near the MWT Products site on Mill Street. Route 12 runs within the east corridor commonly in this segment (Figure 5.20), while the railroad runs along the west side of the corridor; both restrict floodplain access. In areas where the channel is immediately adjacent to one of these encroachments, typically the channel has been straightened, the banks have been armored and riparian vegetation is lacking. Areas of extensive bank erosion are also common, particularly on the west bank (Figure 5.21). In general the riparian buffer is greater than 100 feet on the west bank and greater than 50 feet on the east bank with localized areas of buffers less than 25 feet that are in need of buffer enhancement. Near bank vegetation is primarily invasive species on both banks. Numerous flood chutes indicate active planform adjustment is occurring within this segment.

Figure 5.20: Route 12 running adjacent to channel with no riparian buffer near pull off by "Welcome to Berlin" sign on Route 12

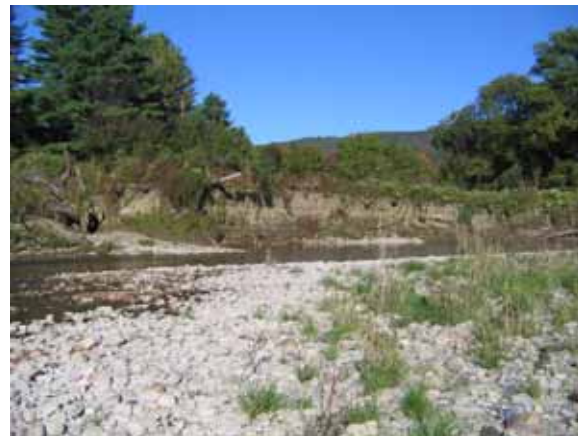
Figure 5.21: Extensive bank erosion on west bank near Berlin-Northfield town line

The RGA ranked in the fair category as a result of an over-wide channel and minor aggradation and planform adjustment. M09-A is a "C" channel that has not historically incised. The channel does not appear to have been significantly impacted by the dam in M09-B. The RHA rated in the fair category also because of limited refuge habitat, limited woody debris cover, an over-wide channel with a lot of exposed substrate, and invasive near bank vegetation. This segment has a few deep pools and a generally healthy riparian buffer on the west side of the channel.

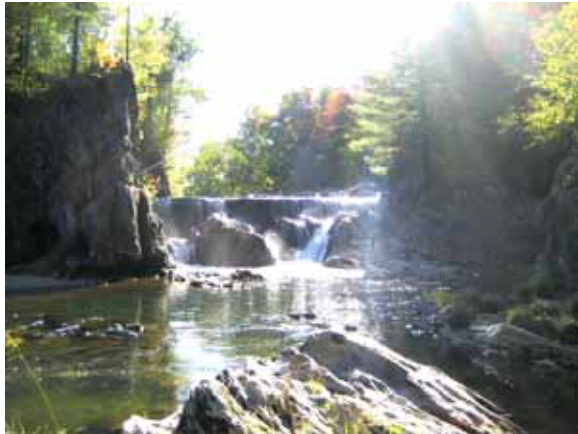
Segment M09-B begins at a large dam near the MWT Products site on Mill Street and continues upstream to the confluence with Cox Brook. This segment also has numerous grade controls and the dam is located on top of a large bedrock grade control making it a potential structure to consider removing in the future (Figure 5.22). The riparian land use characteristics of this

Figure 5.22: Dam and bedrock near MWT Products on Mill Street

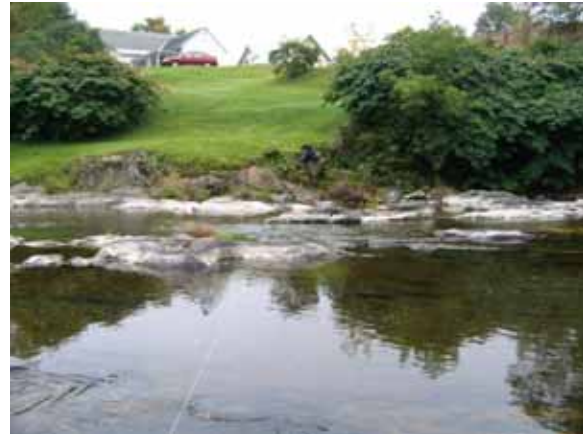
segment include the industrial brownfields site located within the east corridor and multiple residential properties with maintained lawns within both sides of the river corridor (Figure 5.23). The east bank in general is lacking a high quality riparian buffer with a significant portion of the segment having less than 25 feet of buffer, and most near bank vegetation consisting of invasive species. The west bank has a better riparian buffer than the east, but still has some areas that could be improved. Minor aggradation is occurring within this segment as evidenced by one large side bar that begins below the confluence with Cox Brook and continues for a distance below the Cox Brook Road covered bridge. This aggradation appears to be related to the undersized bridge.

Figure 5.23: Residential yard lacking riparian buffer with invasive near bank vegetation on east bank near Mill Street

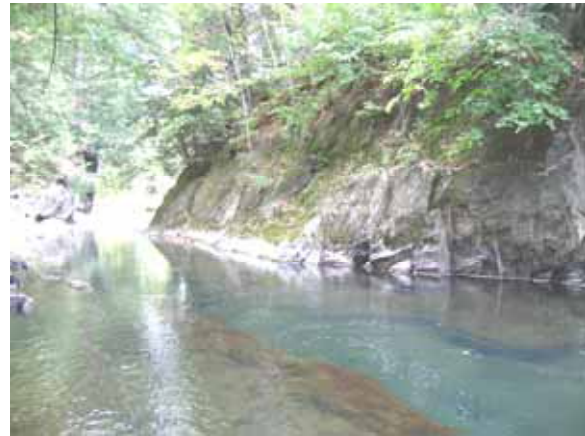
The RGA ranked in the good category with only minor aggradation and widening impacting the score. M10-A is an “F” channel that is entrenched in a narrowly-confined valley. The RHA scored in the fair category due to limited refuge habitat, lack of woody debris cover, bankfull obstructions (grade controls) and limited riparian area on the east bank.

Figure 5.24: Steep banks and deep pools downstream of Slaughterhouse Road Bridge

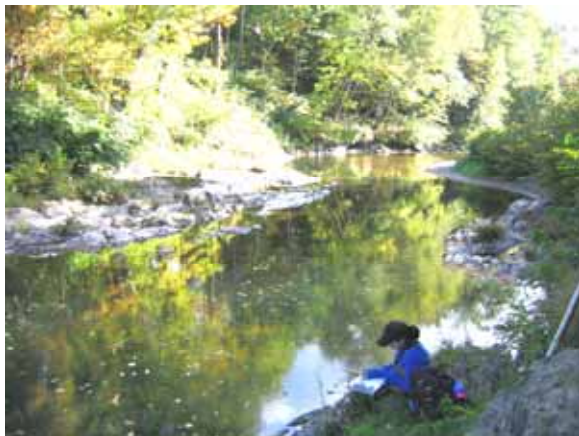
Figure 5.25: Deep pool and scour above bedrock constriction and Slaughterhouse Road Bridge

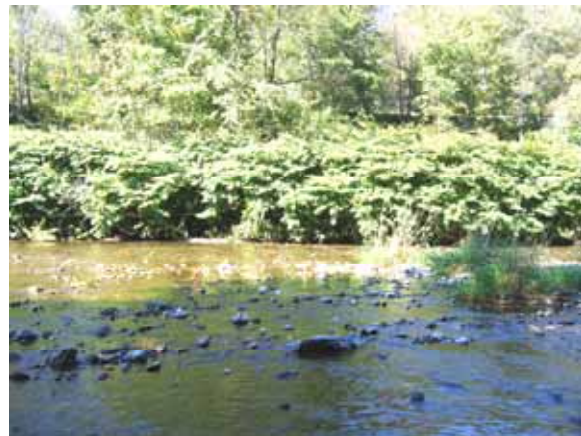
Figure 5.26 Invasive Japanese Knotweed along west bank with railroad bed in background upstream of Slaughterhouse Road Bridge

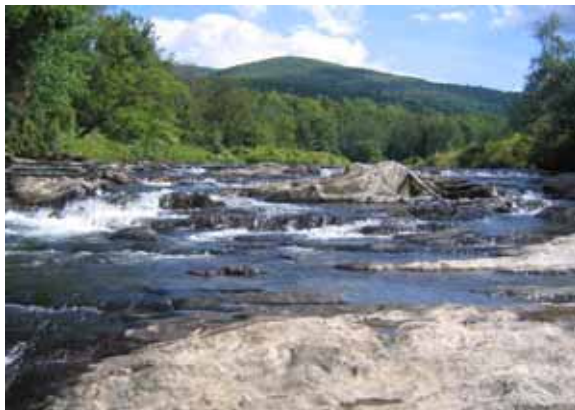
Segment M11-A begins just downstream of the N. Main Street Bridge and continues upstream to a large ledge grade control at the downstream end of the segment just above the bridge near the Grand Union (Figure 5.27). There is also a cement weir in the channel upstream of the bedrock grade control. A housing development is located within the floodprone width of this segment on the west side of the channel where the bank is reinforced with extensive bank armoring. The west bank also has many areas with little to no riparian buffer, while the east side of the channel generally has a buffer of greater than 100 feet. Near bank vegetation includes invasive Japanese knotweed (Figure 5.28).

Figure 5.27: Large ledge grade control located upstream of the N. Main Street bridge near the Grand Union

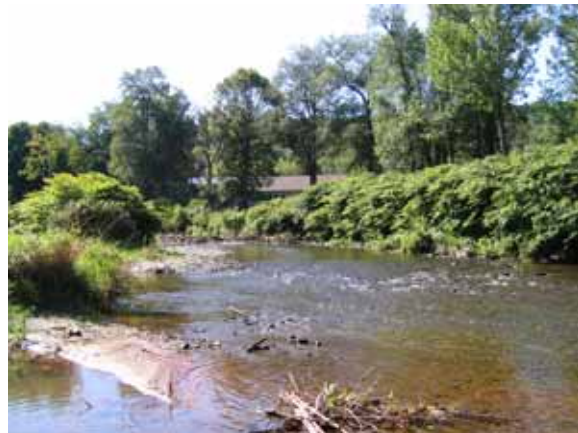
Figure 5.28: Invasive near bank vegetation and lack of riparian buffer near the Dogwood Glen housing development off N. Main Street

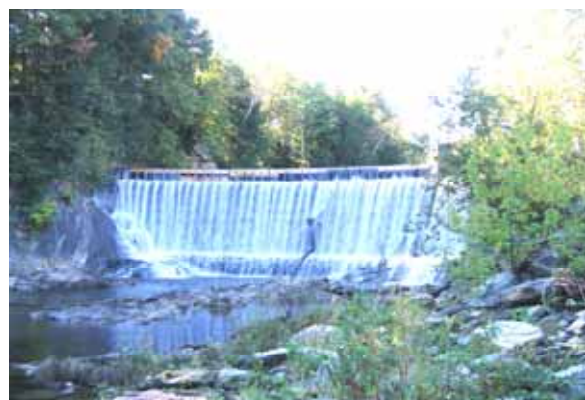
The RGA ranked in the fair category due to extreme historic degradation and minor widening and planform adjustment. M11-C is an "F" channel as a result of extreme historic incision due to being sediment starved below the large hydroelectric dam in M11-D (Figure 5.31). The channel no longer has access to its floodplain as a result of this incision and has undergone a stream type departure from its reference "C" stream

Figure 5.31: Northfield Mills hydroelectric dam near Belknap Street

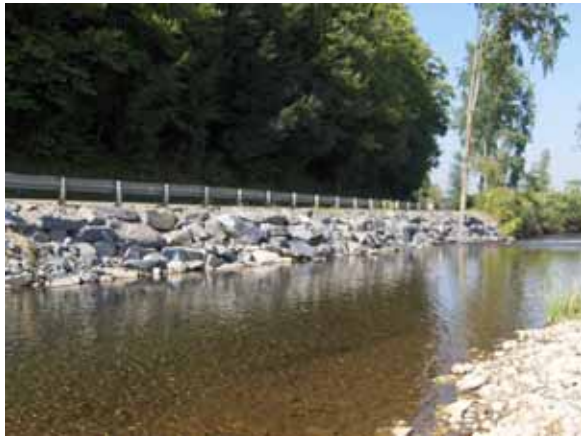
Reach M13 begins at the confluence with Union Brook near Wall Street and runs through Norwich University's athletic fields to just below a railroad crossing. This reach has been extensively channelized and armored (Figure 5.35). Much of this reach could use riparian buffer enhancement. Bank erosion was also common on both stream banks. Residential land uses, including Norwich University, dominate the riparian corridor. Near bank and riparian vegetation include invasive species. Many houses have been built right along the banks of the river on Water Street within the floodprone width (Figure 5.36). These properties have a reported history of flooding, and several stormwater inputs were mapped within this reach. Aggradation and planform adjustment are major processes in this reach with numerous large depositional bars, steep riffles, and channel migration features.

Figure 5.35: Channelized section of Dog River with extensive rip rap and no riparian buffer along Water Street near Norwich University

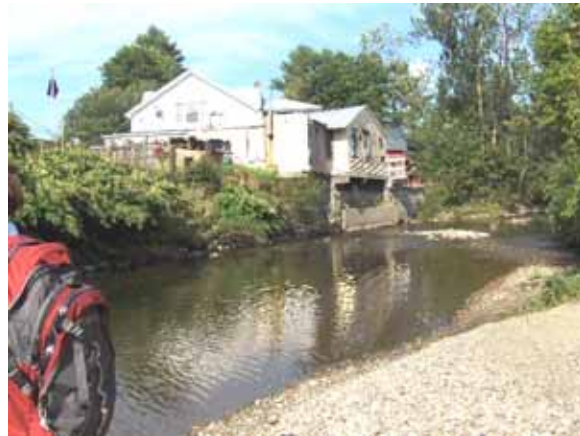
Figure 5.36: Houses built along Dog River on Water Street near intersection with Western Avenue

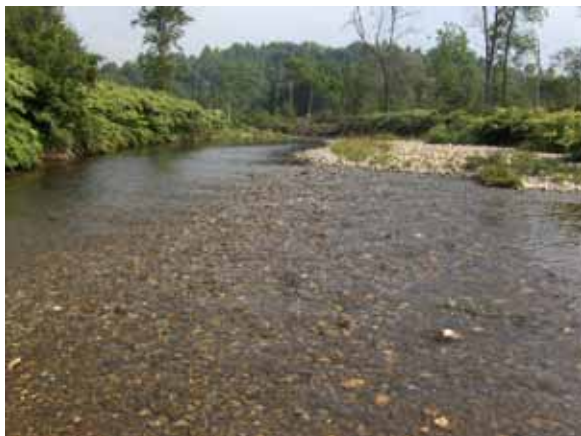
Reach M14 begins just below a railroad bridge below the Northfield Town Wellfield and ends at the confluence with Sunny Brook near Fairground Road. Multiple steep riffles, diagonal bars and flood chutes indicate increased aggradation and planform adjustment in this reach (Figure 5.37). Riparian land uses on the west side of the channel is primarily forest, while residential land use dominates the east side of the channel (Figure 5.38). The riparian buffer is less than 25 feet wide in many places along the east bank and both the near bank and riparian vegetation include invasive species on both sides of the channel. The railroad crosses the channel at the lower end of the reach via a bridge located well above the channel, with one pier in the middle of the channel causing major deposition to the west of the pier. This reach has been considerably straightened and minimally armored.

Figure 5.37: Large diagonal bar and invasive bank vegetation near downstream end of Northfield Town Wellfield

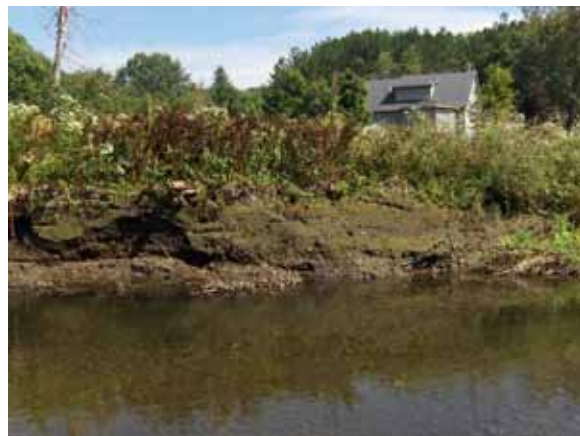
Figure 5.38: Residential property lacking bank vegetation downstream of confluence with Sunny Brook

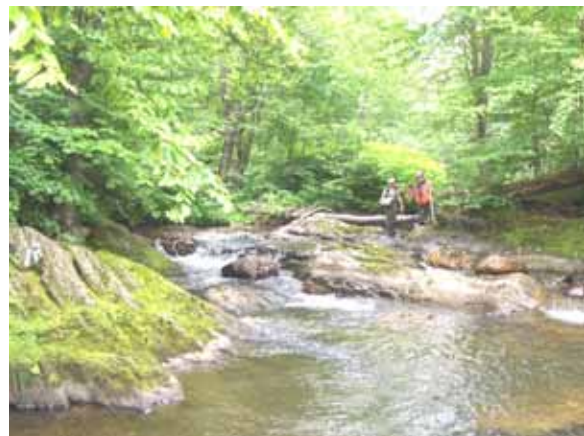
Segment M17-C begins where the riparian buffer improves at the upper end of the golf course at Northfield Country club and continues to above Freeman Road. The golf course is within the riparian corridor on the northwest side of the channel but a riparian buffer of 26-50 feet exists between the channel and the golf course. There is a healthy riparian buffer of greater than 100 feet on the southeast side of the channel. The vegetation is generally comprised of large deciduous trees and native herbaceous species with some minimal invasive species noted on the near bank. One rejuvenating tributary was mapped within this segment where the mainstem has incised historically, and a well developed juvenile floodplain has developed in some places. Two bedrock grade controls were mapped in this segment (Figure 5.43).

Figure 5.43: Ledge grade control with deep pool and healthy near bank vegetation near the intersection of Freeman Road and Route 12A

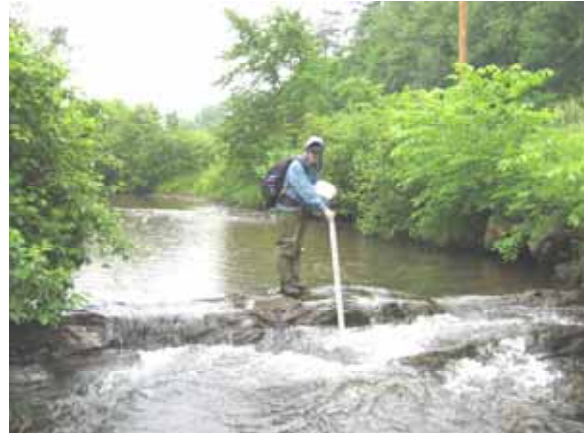
Segment M18-A begins upstream of the intersection of Route 12A and Freeman Road and continues for about 985 feet along Route 12A to the first major bend the river takes away from the road. This segment has numerous ledge grade controls and the channel slope is steeper than the rest of the reach (Figure 5.44). Route 12A runs very close to the north bank of the channel along the entire segment and a riparian buffer is absent on that side. The south side of the channel has a healthy riparian buffer of greater than 100 feet. Near bank vegetation includes some invasive species on both banks. This segment has been extensively straightened to run adjacent to the road and the north bank has been heavily armored.

Figure 5.44: Ledge grade control, invasive vegetation and lack of riparian buffer along Route 12A near sharp bend upstream of Freeman Road

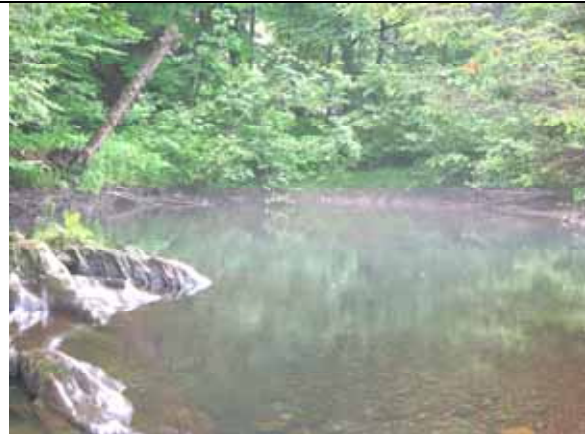
(including one very large and deep pool at a sharp bend) and adequate near bank and riparian vegetation (Figure 5.46).

Figure 5.46: Large, deep pool at sharp bend downstream of Little Northfield Road

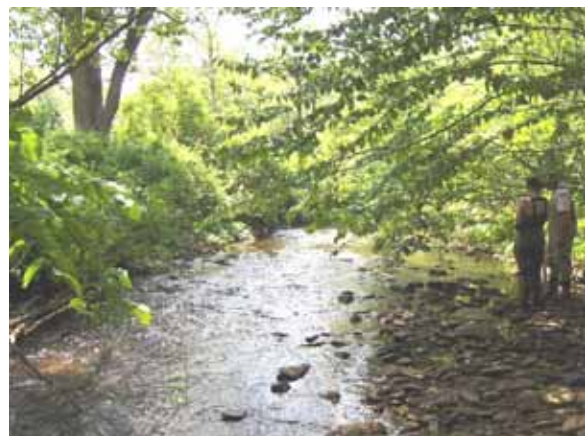
Figure 5.47: Healthy near bank vegetation downstream of Route 12A bridge near Potato Hill Road.

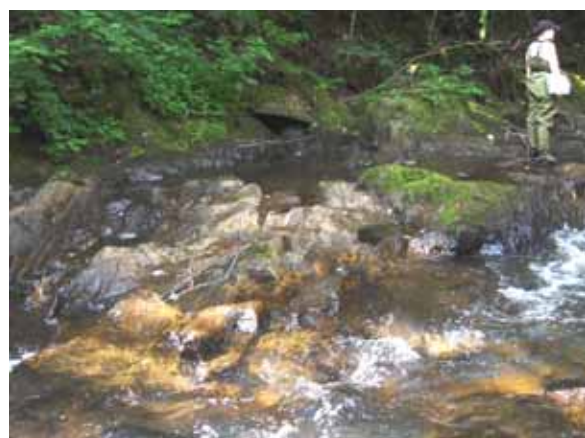
Figure 5.48: Bedrock stream banks in gorge segment near railroad bridge and Potato Hill Road.

greater than 100 feet. The banks are bedrock dominated and are in good shape (Figure 5.48). The railroad crosses the channel in this segment at a very high elevation that does not impact the channel as a constriction. This gorge-segment is an “F” stream type that does not have floodplain access by reference.

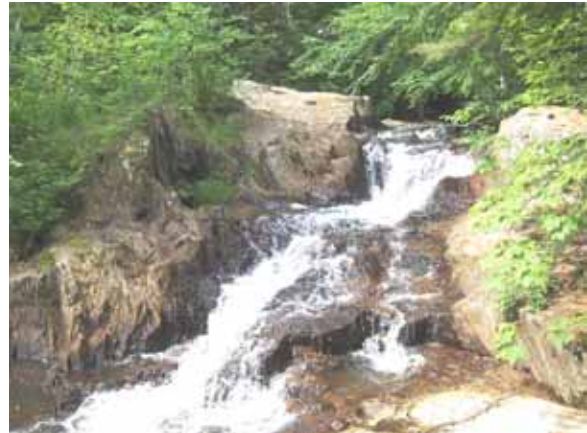
Segment M19-C begins above the bedrock gorge and continues to just upstream of the Beaudette Road Bridge. This segment has adequate riparian buffers on both sides of the channel with minimal residential land use within the corridor. The banks are healthy with no invasive species present, no bank armoring and minimal bank erosion. This segment had three bedrock grade controls (Figure 5.49).

Figure 5.49: Grade control near Beaudette Road Bridge

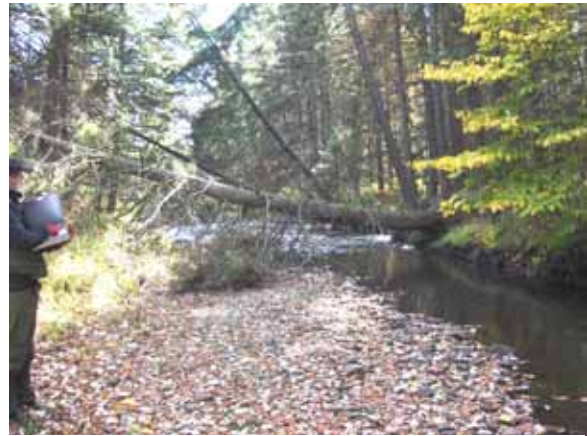
Figure 5.53: Straightened channel with stable banks and good vegetation above Roxbury town line

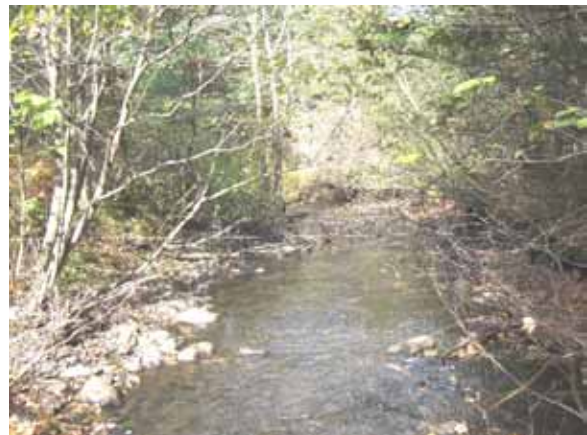
Segment M21-A begins just below a railroad bridge and continues upstream to just below the first Roxbury Road bridge. This segment generally has adequate riparian buffers with some localized areas on both banks near Roxbury Road that could use some buffer enhancement. Established alders are common along the banks and seem to be holding the banks together and preventing widening. There were some localized areas of bank erosion where adequate near bank vegetation is lacking. The channel is fairly straight but there is no direct evidence that the stream has been straightened where it runs away from Roxbury Road (Figure 5.54).

Figure 5.54: Naturally straight channel with stable bank vegetation near Roxbury Cemetery

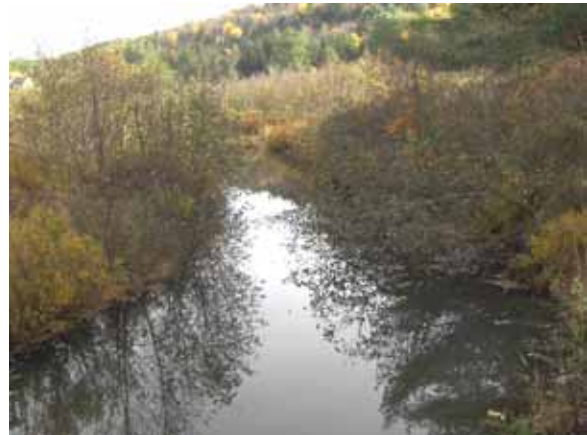
Segment M21-B was only partially assessed as it is a wetland. This segment begins just below the first Roxbury Road Bridge and continues to the end of the wetland where a recently excavated channel begins. Some clay is present in isolated areas of the lower bank. In general the riparian buffers on both banks are greater than 100 feet with some isolated exceptions near stream crossings. This segment had four undersized bridges crossing the wetland, and two beaver dams were observed. M21-B is an "E" wetland channel by reference that is in good condition (Figure 5.55).

Figure 5.55: Wetland channel downstream of second Roxbury Road Bridge

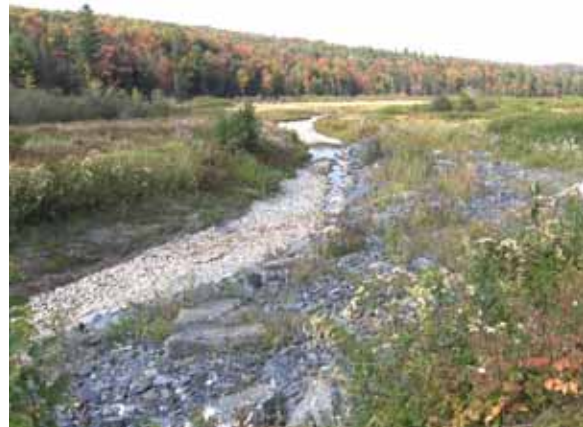
Segment M21-C was only partially assessed because the channel was dry. This segment begins at the end of the wetland and continues upstream to just below Warren Mountain Road. The stream is ephemeral in this segment with some isolated pools but over 90 percent of the bed was dry upon observation (Figure 5.56). The railroad runs along the east side of the channel and cuts off floodplain access. A portion of this channel has been recently relocated and channelized. This segment is lacking healthy riparian buffers on both sides of the channel and the east bank has been significantly armored. M21-C is a "C" channel that seems to be in fair condition.

Figure 5.56: Dry stream channel with pockets of groundwater seepage in channelized area near tennis camp on Roxbury Road

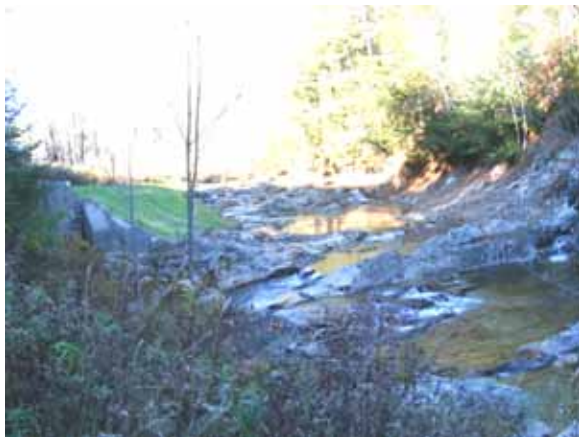
Figure 5.58: Location of removed dam along Cox Brook Road near Pierson Hill with bedrock grade controls and newly planted vegetation

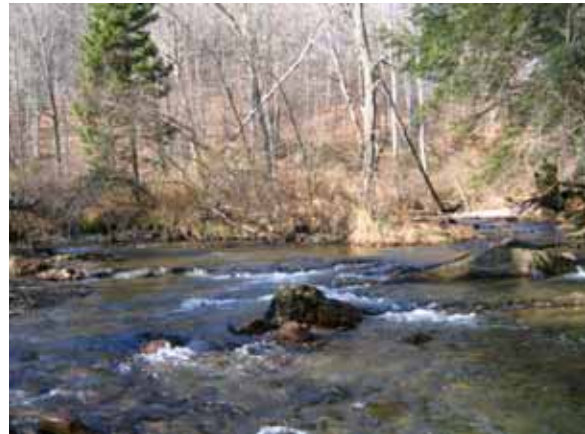
Reach T4.01 begins at the confluence with the Dog River near Bull Run Road and continues along Bull Run Road to just below Camp Wihakowi. Bull Run Road remains outside the valley wall on the east side of the channel for the most part with forested land dominating the corridor land use type. There are some isolated areas where the riparian buffer is less than 25 feet on the east side of the channel, but in general the riparian buffers are greater than 100 feet on both banks. The upper portion of this reach had a section with a slightly narrower valley width, but the valley width was consistent both above and below this narrower section. Three undersized bridges in this reach are causing deposition and scour problems within the channel. There is a fair amount of erosion and one mass failure on the east bank. Several flood chutes and one island indicate some major planform adjustment is occurring within this reach, much of this planform adjustment is confined to the area near the island (Figure 5.65).

Figure 5.65: Island in channel with healthy near bank and riparian vegetation downstream of Bull Run Road Bridge

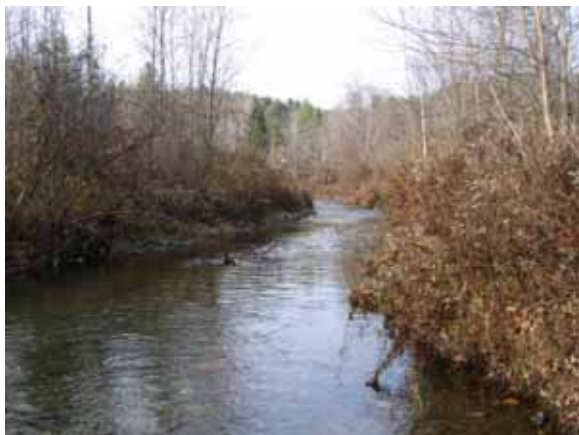
Segment T5.01-A begins at the confluence with the Dog River near Stony Brook Road and continues to just above a major channel avulsion above the intersection of Stony Brook Road and Smith Hill Road. This segment had variable issues and was difficult to characterize. The lower end of the segment was completely channelized and armored with the road and some residential properties within the north riparian corridor (Figure 5.66). There is a large waterfall above this channelized section and several ledge grade controls above the waterfall. At the upper end of the segment the channel has avulsed from its original location and Stony Brook Road now runs close to the north bank (Figure 5.67). The riparian buffer is less than 25 feet on the north side of the channel in this area near the channel avulsion. Aside from this localized area, the riparian buffers were generally healthy on both banks. The bankfull channel width is over-wide in this segment due to the channel avulsion.

Figure 5.66: Straightened portion of segment with bank armoring and near Stony Brook’s confluence with the Dog River

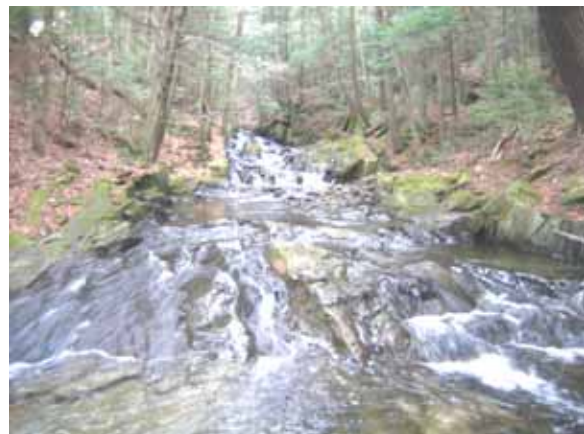
Segment T6.01-B was only partially assessed as it is a bedrock gorge. This segment begins above the agricultural land near the intersection of Little Northfield Road and Route 12A and continues to the end of the gorge. The gorge runs through a semi-confined valley that is entirely dominated by bedrock (Figure 5.71). Little Northfield Road runs along the east side of the channel but the road is outside of the valley wall. This segment is minimally impacted with dominant riparian buffers of greater than 100 feet on both sides of the channel. T6.01-B is an "A" stream type by reference and it appears to be stable and in good condition.

Figure 5.71: Downstream end of bedrock gorge near Little Northfield Road and Route 12A

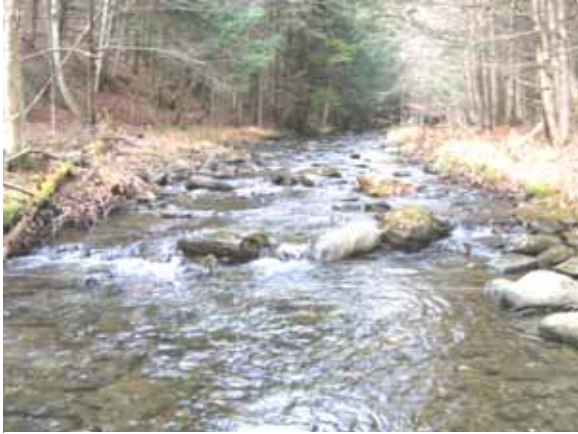
Figure 5.72: Channel with floodplain access and nice riparian vegetation above bedrock gorge

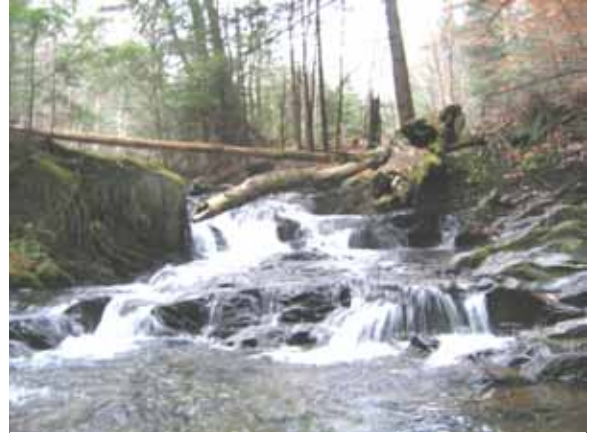
Figure 5.73: Bedrock waterfall with woody debris downstream of Murphy Road crossing

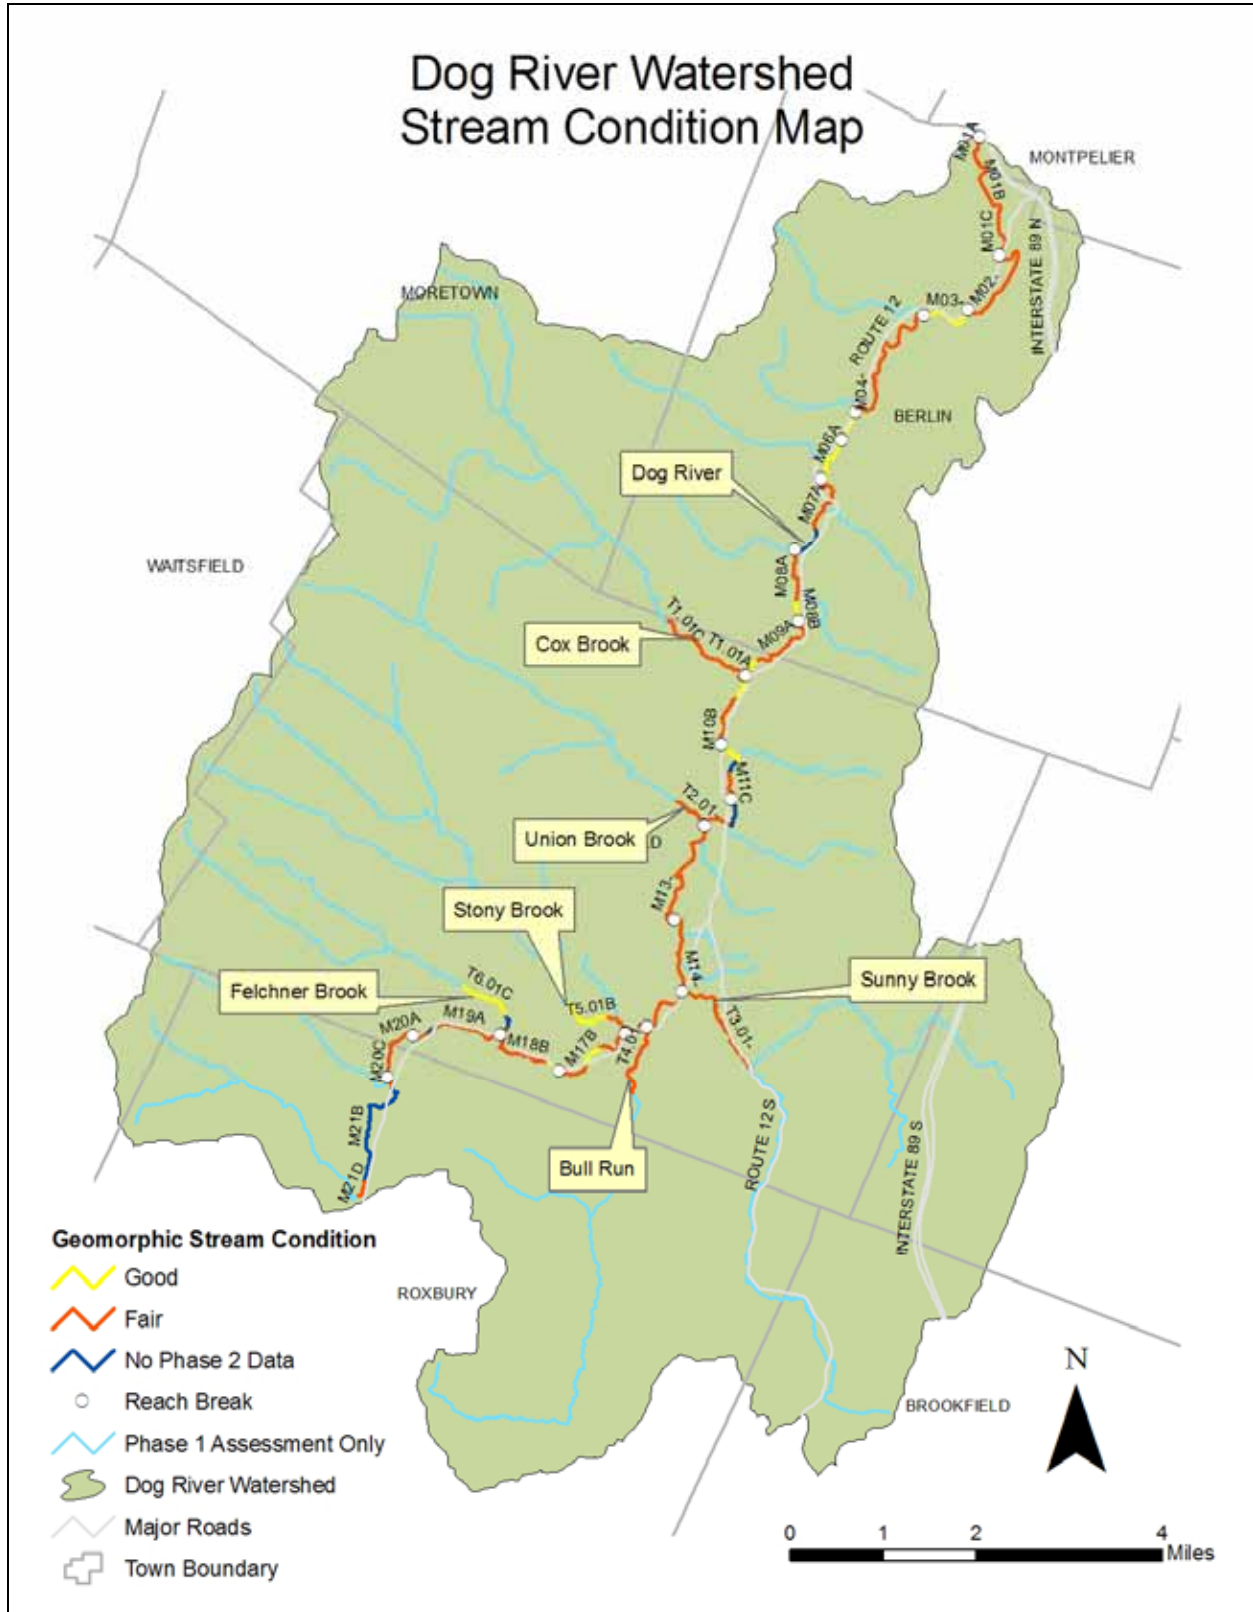
The geomorphic condition for each Phase 2 reach is determined using the rapid geomorphic assessment (RGA) protocol, and is based on the degree of departure of the channel from its reference stream type (Vermont Agency of Natural Resources, 2007b). The reference condition for each of the Phase 2 reaches was previously identified in Table 3.1. The 26 reaches of the Dog River watershed that were assessed were further broken down into 54 segments based on changing stream conditions. Of these 54 segments, Phase 2 RGAs were conducted on 45 segments, the remaining 9 segments were only partially assessed as they were either bedrock gorges or they were impounded due to dams or beaver activity. Of the 45 segments where RGAs were evaluated, 12 segments rated in the good category and 33 segments rated in the fair category. Figure 5.74 illustrates the geomorphic condition of the streams in relation to the watershed.

Figure 5.74. Reach Condition Map for the Phase 2 Geomorphic Assessment

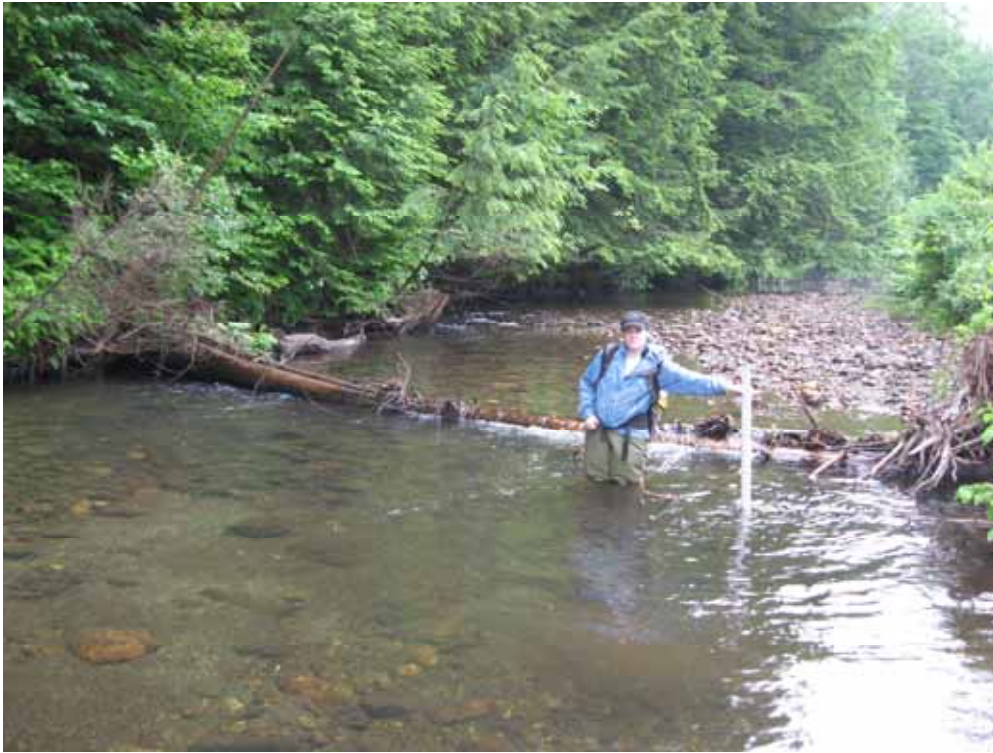
Figure 5.77: Segment M18-B received a habitat rating of good due to deep pools, stable banks, abundance woody debris cover and a high quality riparian zone.

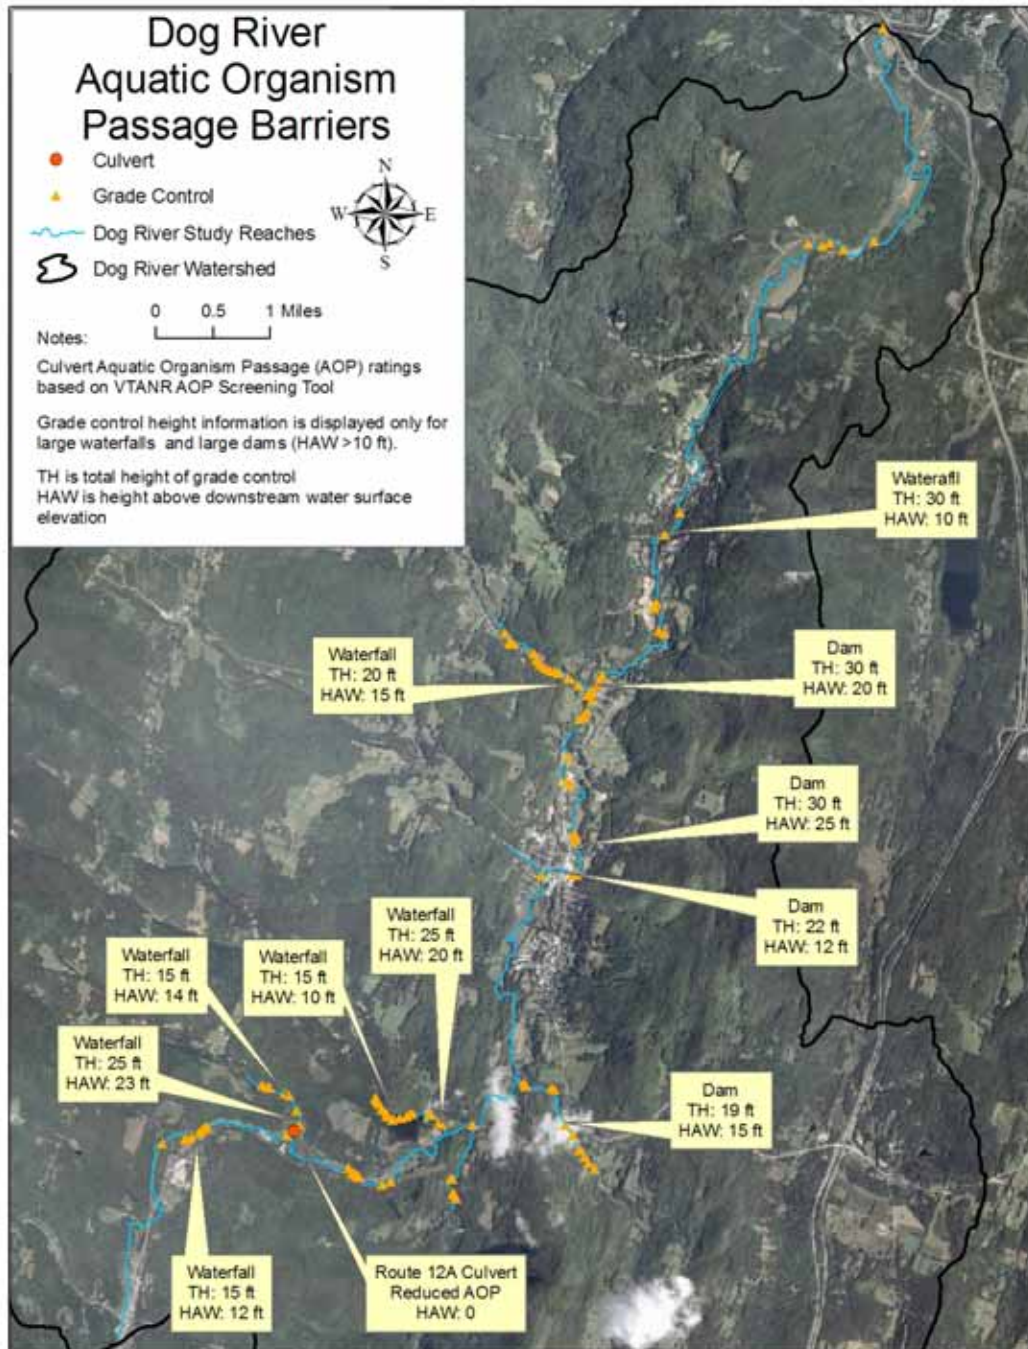
Natural and manmade obstructions are impeding passage of aquatic organisms. Figure 5.78 shows where there are culverts or natural barriers that are obstructions. Large waterfalls (higher than 10 feet) were found in segments M07-B, M19-C, T1.01-A, T5.01-A, T5.01-B, T6.01-B and T6.01-C. Large dams (higher than 10 feet) were found in segments: M09-B, M11-D, M12-A and T3.01. There is only one culvert within the study area on Felchner Brook at Route 12A.

Figure 5.79. Aquatic organism passage barriers map.

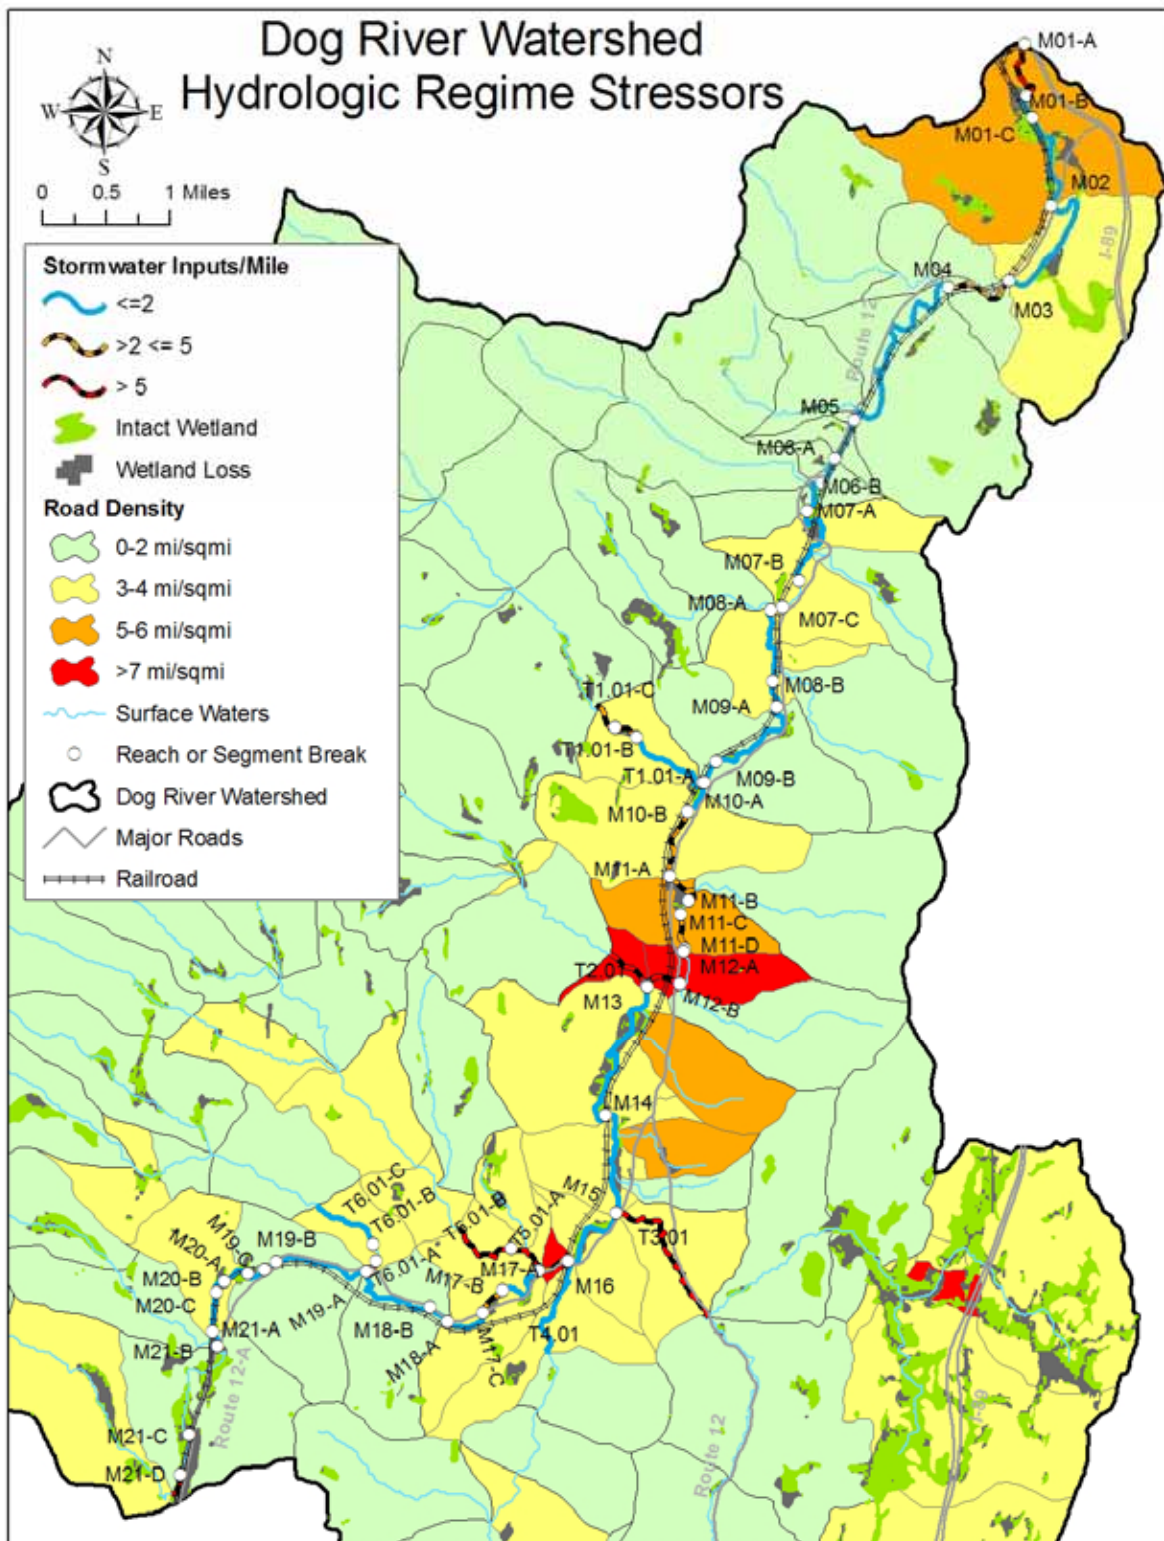
The Dog River watershed has a moderate network of roads as shown in Figure 6.1. Many stormwater inputs from encroaching roads were mapped in the field. These stormwater inputs are responsible for increasing peak flows and for contributing sediment to the Dog River watershed. Figure 6.1 shows segments in red where stormwater inputs per mile exceeded 5. Only three subwatersheds within the study area have road densities greater than 7 miles per square mile (M12, M16 and T2.01). This may contribute to localized increased flows resulting both from increased runoff

Figure 6.1. Land use map showing road density, stormwater influence, existing wetlands and lost wetlands

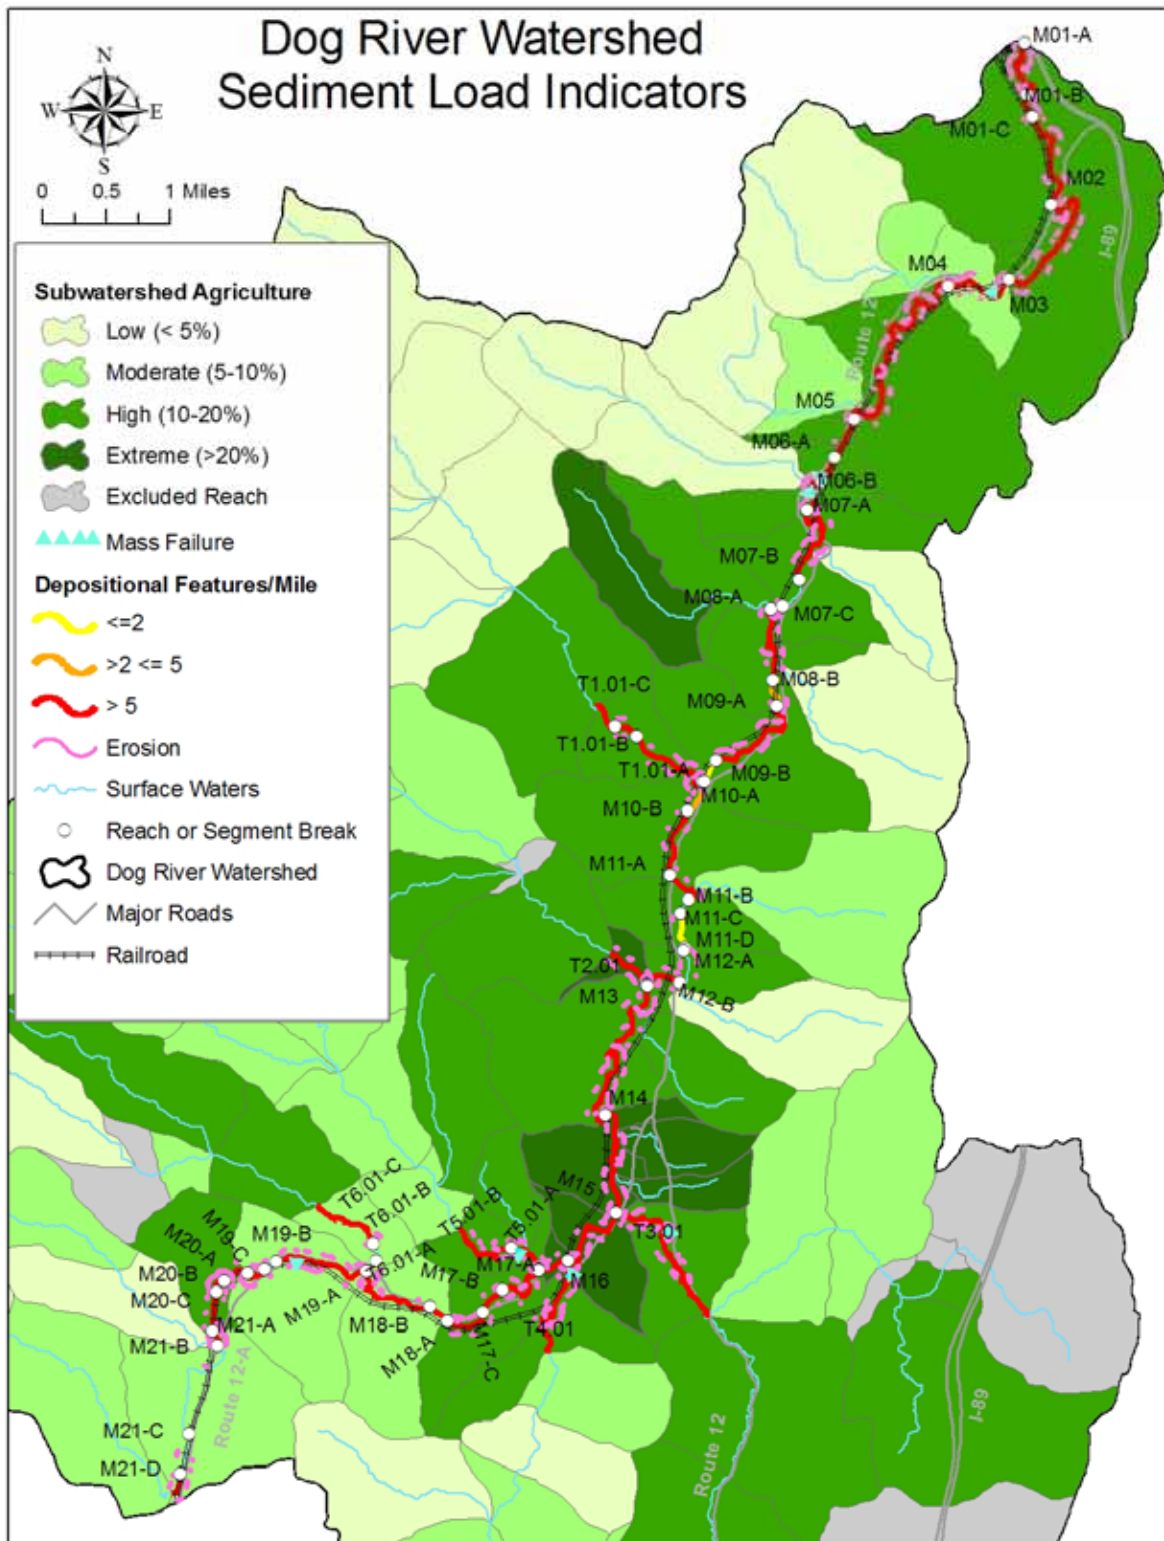
Mass wasting sites were observed on the Dog River mainstem (4 mass failures), Sunny Brook (one mass failure), Bull Run (one mass failure) and Stony Brook (one mass failure) during the Stream Geomorphic Assessment. The total length of mass failures on the Dog River is approximately 285 feet, 62 feet on Sunny Brook, 35 feet on Bull Run and 100 feet on Stony Brook. These mass failures represent a significant source of sediment within the Dog River watershed. Localized areas of bank erosion and depositional features (steep riffles, mid channel bars, delta bars, flood chutes, and/or avulsions) are prevalent. As shown below in Figure 6.2, the majority of the segments in the study area have moderate to high bank erosion (5 to greater than 20% of the length) and/or high depositional features (> 5 per mile).

Figure 6.2. Sediment load indicators map showing cumulative subwatershed % agriculture, depositional features per mile, bank erosion and mass failures
