Dog River

River Corridor Plan

Roxbury, Northfield, Berlin & Montpelier,
Vermont
April 8, 2009

Prepared by: Bear Creek Environmental, LLC

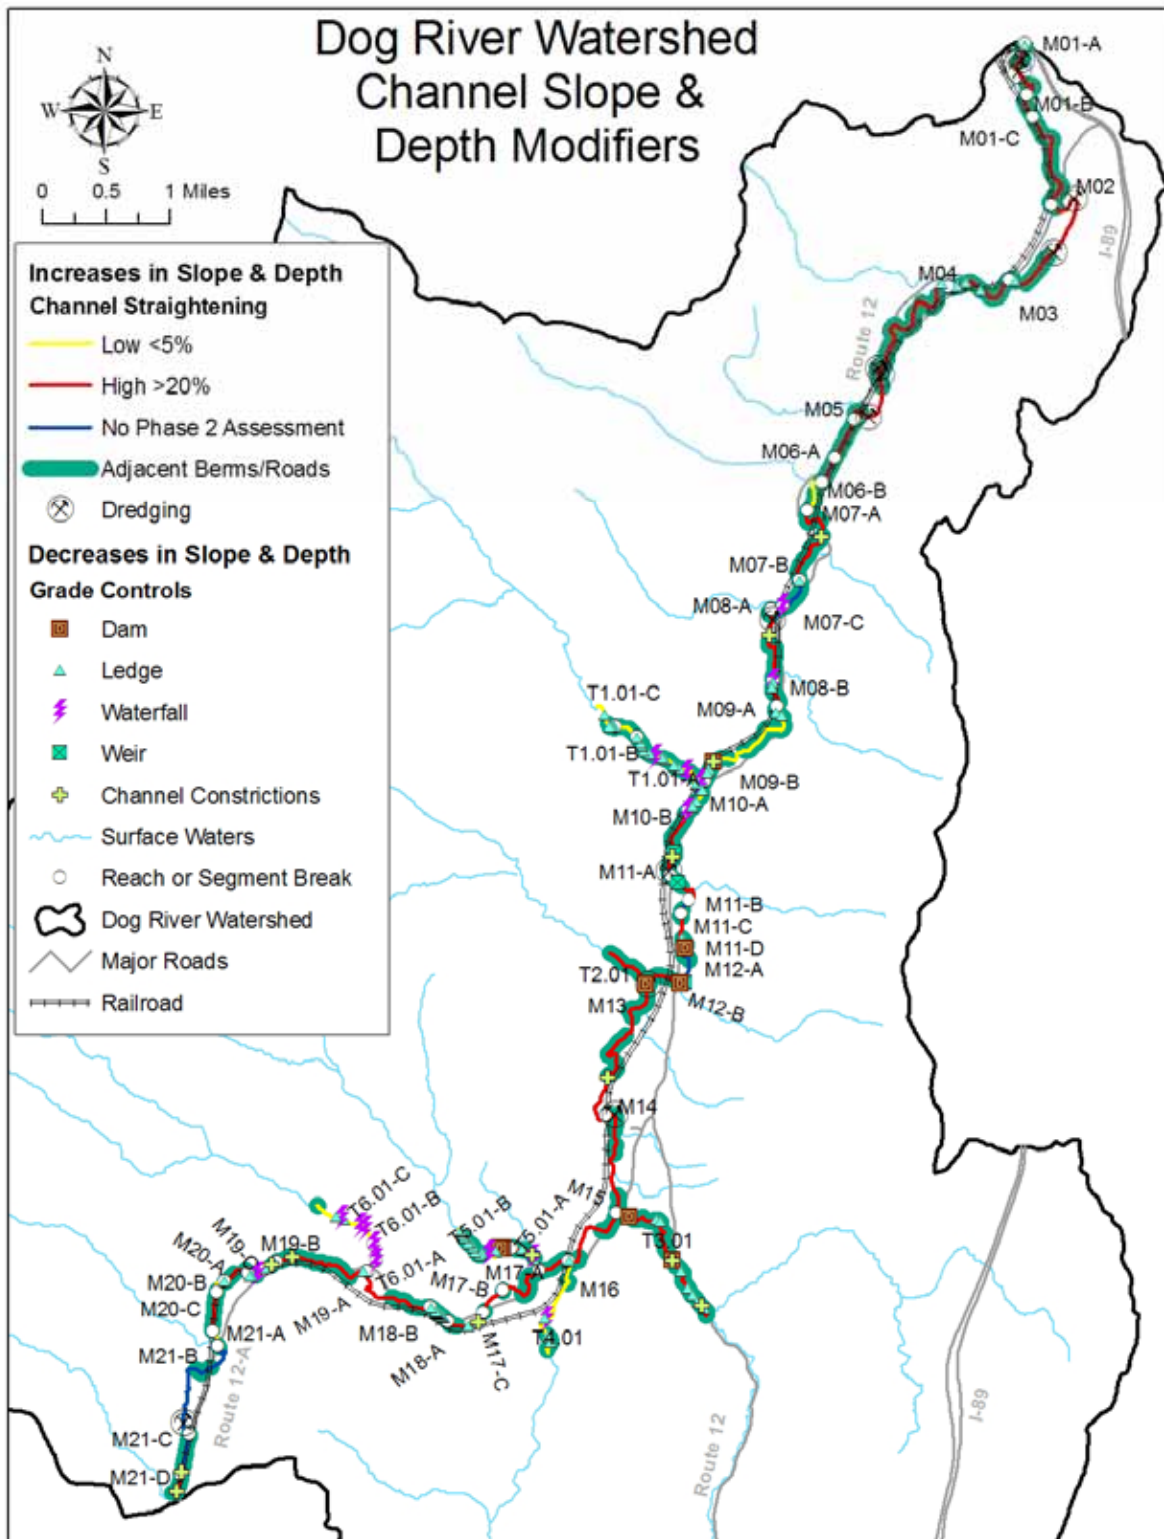
Results from the Dog River watershed indicate that primary stressors include straightening of the channel along with road and development encroachments (see Figure 6.3). Development along the length of the watershed has contributed to the loss of wetlands and increased runoff. Records at the Vermont Agency of Natural Resources and field observations indicate that gravel mining or dredging of the channel has occurred along the study reaches in segments M01-A, M02, M04, M08-A, M10-B, M12B, M14 and M21-B. These dredging activities generally appeared to be minor. Additionally, where the channel showed that it had been straightened, it is likely that some dredging may have occurred during the straightening process. Many bedrock and human constructed grade controls exist along the Dog River and its tributaries. These grade controls often control incision within the watershed. Numerous constrictions exist within the study area causing the width of the bankfull channel or floodprone area to be significantly less than it would be in the absence of such structures. These constrictions, including bridges, culverts, old abutments, breached dams and bedrock outcrops, can cause excessive sediment deposition and/or scouring of the channel bed upstream or downstream of the feature.

Figure 6.3. Channel slope and depth modifiers map showing stressors contributing to increases in slope and depth and stressors contributing to decreases in slope and depth

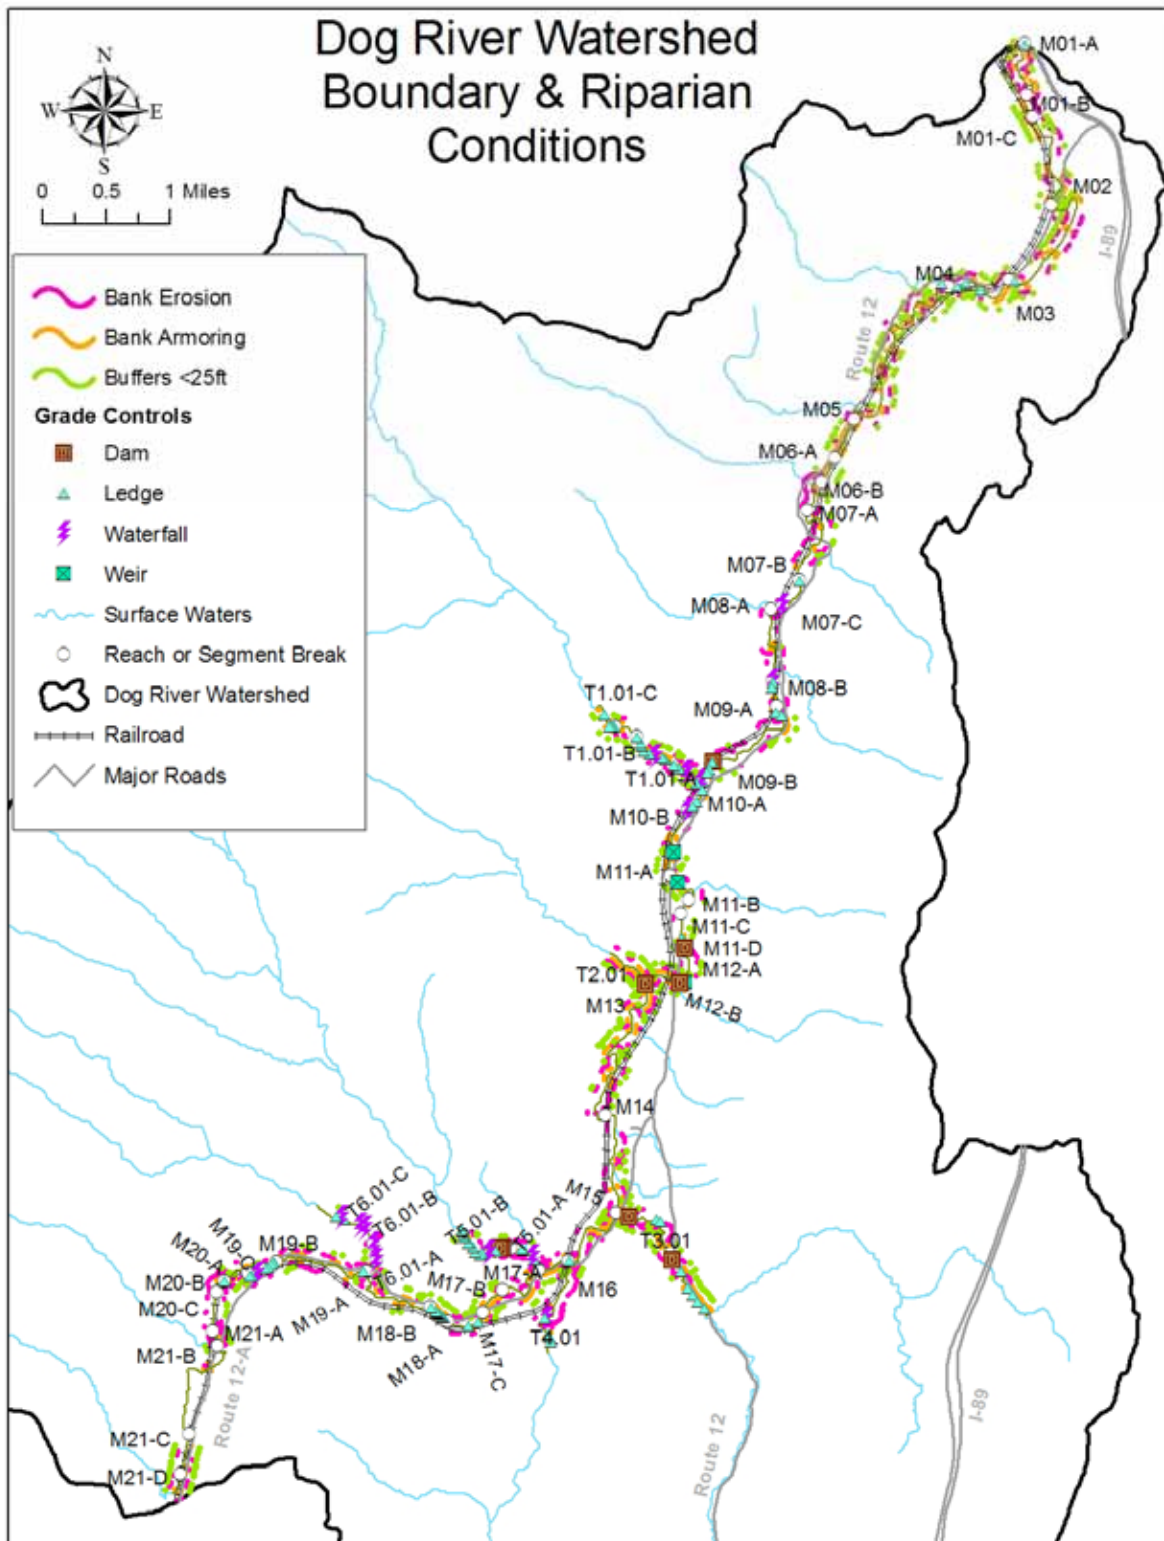
Riparian buffers provide many benefits. Some of these benefits are protecting and enhancing water quality, providing fish and wildlife habitat, providing streamside shading, and providing root structure to prevent bank erosion (see Figure 6.4). Much of the Dog River and its tributaries are lacking sufficient riparian buffers. Several segments in the watershed (M01-A, M01-B, M01-C, M02, M03, M04, M05, M06-A, M09-B, M11-A, M11-C, M11-D, M12-B, M13, M14, M16, M17-B, M18-A, M20-A, M21-A, M21-C, M21-D, T1.01-A, T1.01-C, T2.01, T3.01 and T6.01-A) have 40 percent or more of the reach with little or no buffer on at least one bank. These stream reaches which lack a high quality riparian buffer are at a significantly higher risk of experiencing high rates of lateral erosion. Consequently, many segments have stream banks that are stabilized with rip rap or hard bank armoring where they are adjacent to human constructed infrastructure.

Figure 6.4. Boundary and riparian conditions map showing areas of buffers less than 25 feet, bank erosion, bank armoring, dredging and grade controls

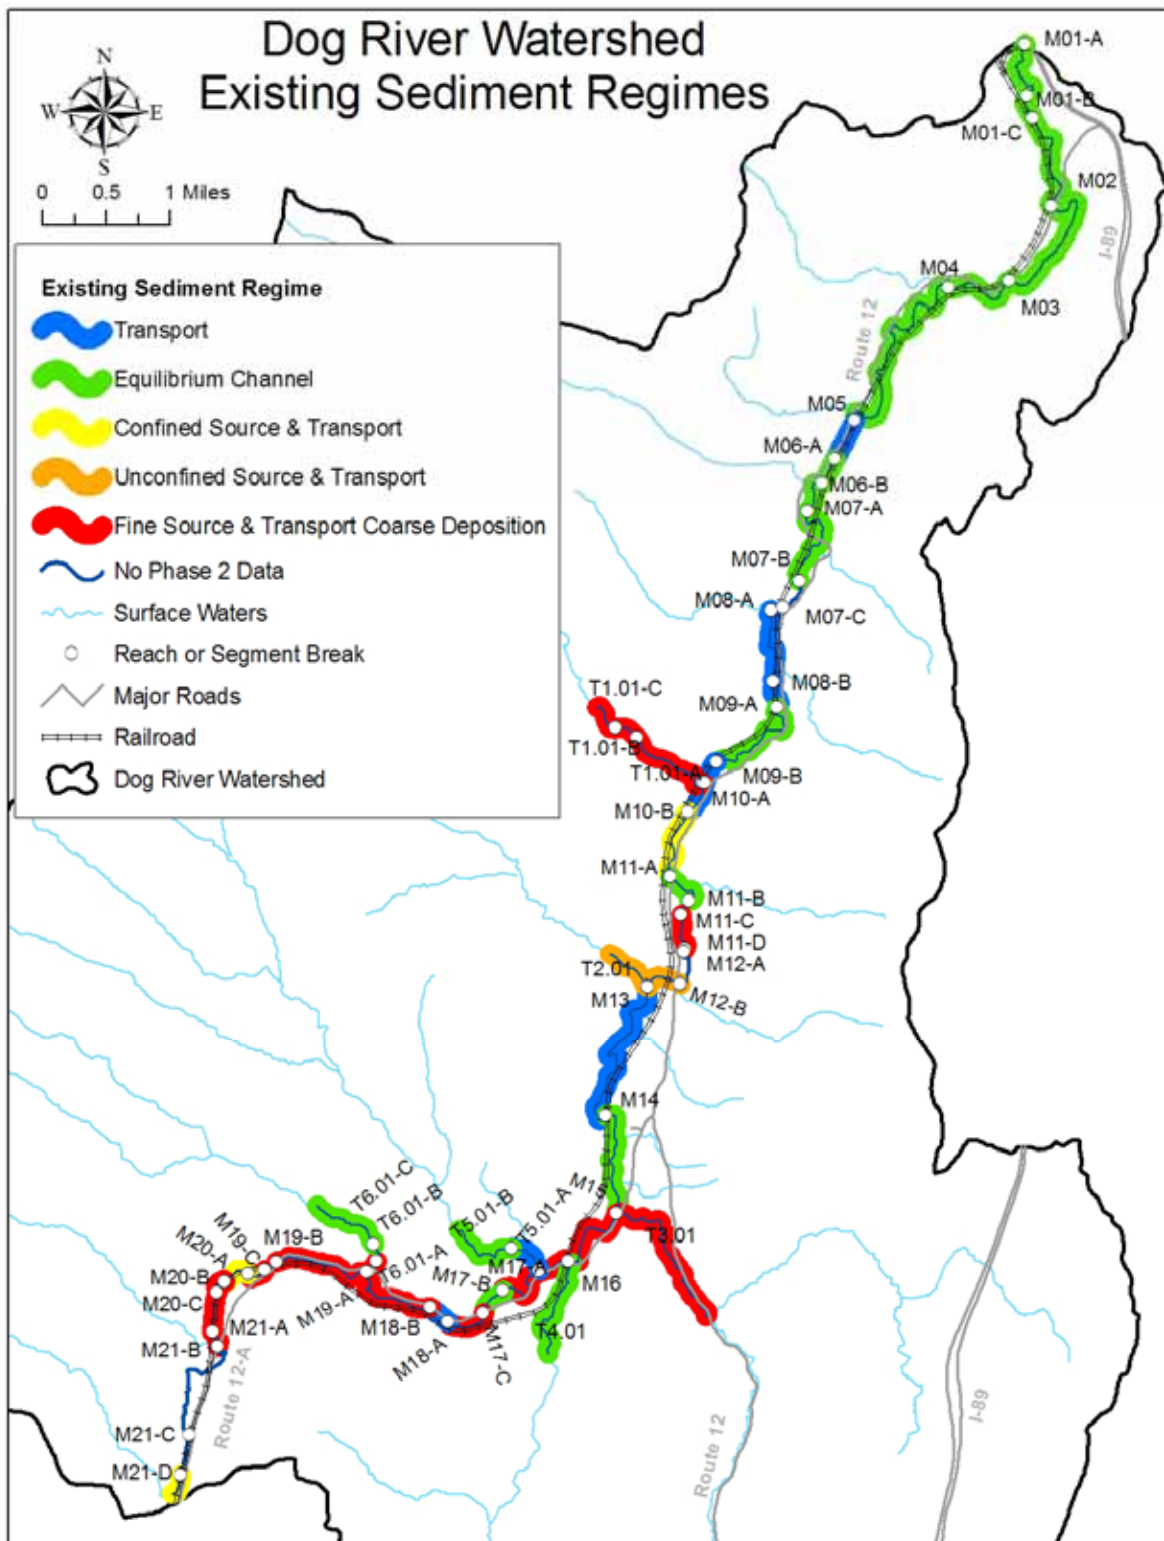
Changes in hydrology (primarily development within the riparian corridor) and sediment storage within the watershed have altered the reference sediment regime types for some reach segments (Figure 6.6). Sediment regime departures were derived from the sediment regime criteria established by the Vermont Agency of Natural Resources (2007c). Sixteen segments (M11-C, M15, M16, M17-A, M17-C, M18-B, M19-A, M19-C, M20-B, M20-C, M21-A, T1.01-A, T1.01-B, T1.01-C, T3.01 and T6.01-A) that were *Equilibrium Channel* type segments by reference have been converted to *Fine Source and Transport & Coarse Deposition* sediment regimes based on the Phase 2 Stream Geomorphic Assessment data. This means that most fine sediment entering the stream is either being transported through without being deposited as a result of channel incision and reduced floodplain access.

Figure 6.6. Existing Sediment Regime Map

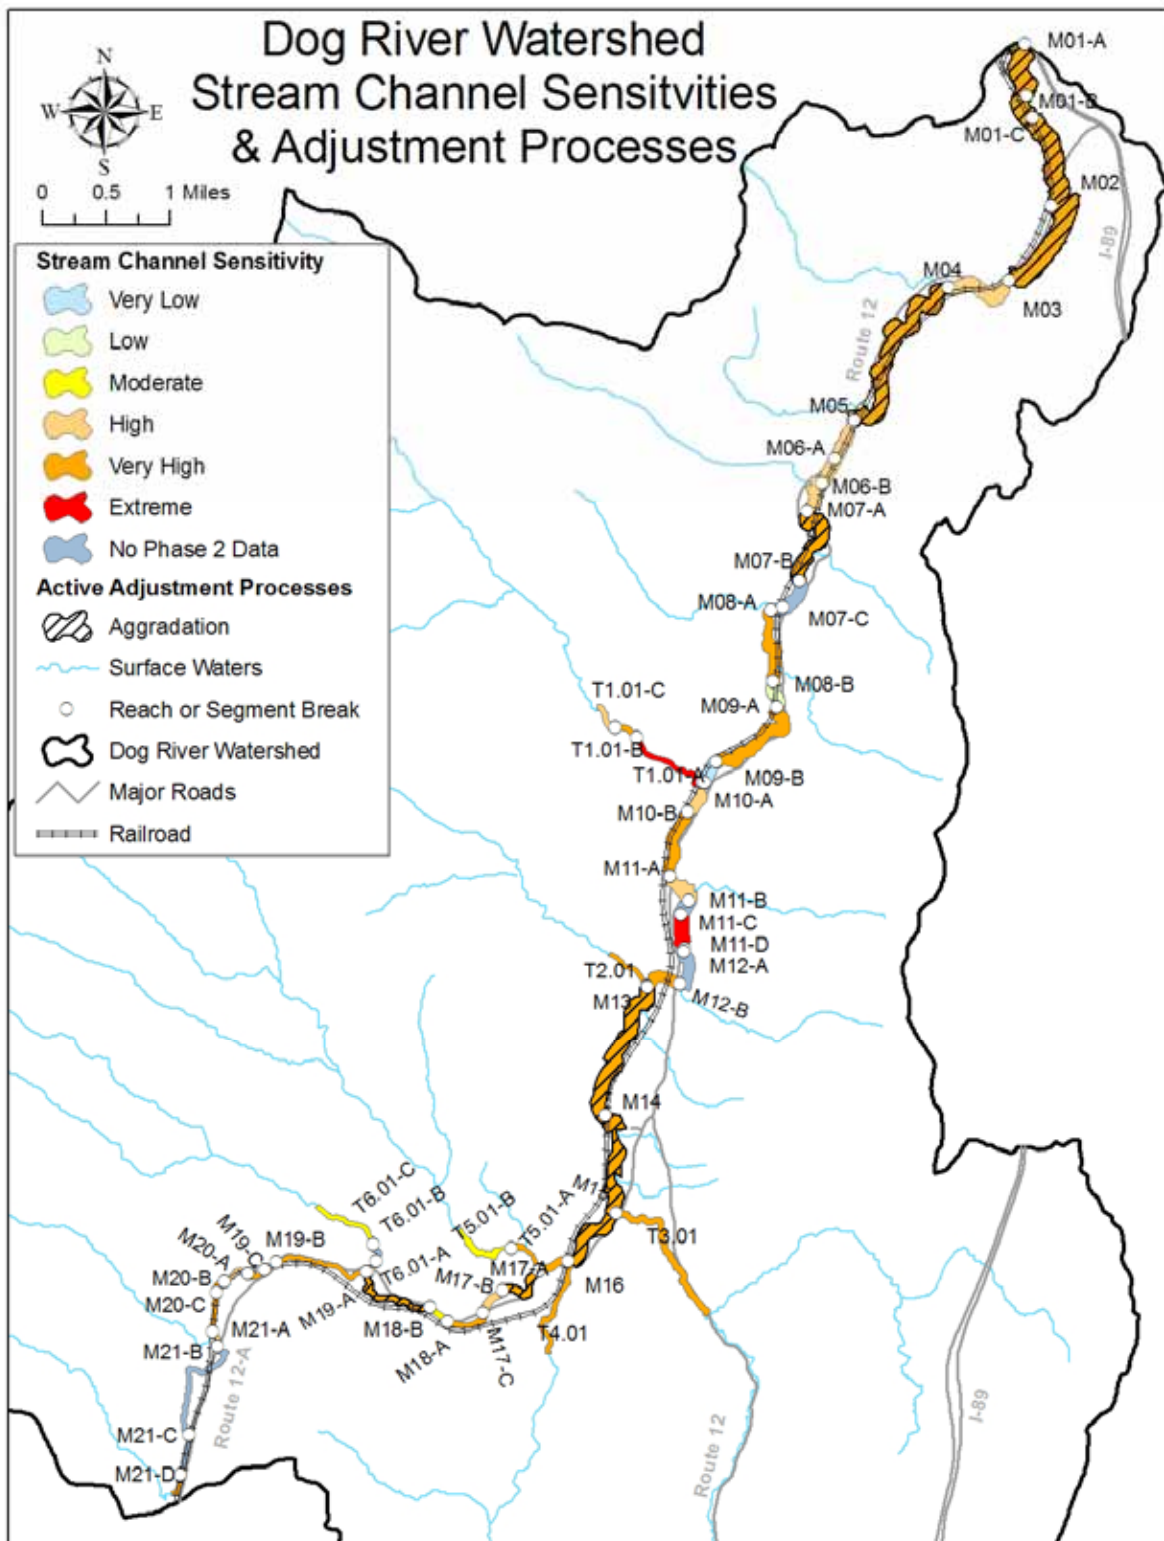
Additionally, flow regime and floodplain constrictions may be affecting the sensitivity of some Dog River stream reaches. Changes in land use and land cover that increase impervious cover, peak discharges, and/or the frequency of high flows will heighten a stream's sensitivity to change and adjustment. Confinement becomes a significant sensitivity concern when structures such as roads, railroads, and berms significantly change the confinement ratio, reduce or restrict a stream's access to floodplain, and result in higher stream power during flood stage. Figure 6.7 is a map presenting the stream sensitivity, generalized according to stream type and condition as per the ANR protocol, and active adjustments for each reach segment in the Dog River watershed. The stream sensitivity map also documents vertical channel adjustments currently going on within a reach segment. Major aggradation adjustment processes are displayed on the corridor where they were found to be actively occurring and not evaluated as historic. This information is helpful in prioritizing the implementation of the projects identified in section 7 of this report, as certain management actions may be influenced by these active adjustment processes. Current vertical channel adjustments exist in the following reaches:

Figure 6.7. Dog River Watershed Stream Sensitivity and Current Adjustment Map
