TOWN OF NORTHFIELD, VERMONT SELECT BOARD REGULAR MEETING Tuesday, June 23, 2026 COMMUNITY ROOM - 6:00 P.M.

Draft Scoping Report Upper Cox Brook Covered Bridge Town Highway 3 Bridge 10 over Cox Brook

Draft Scoping Report Lower Cox Brook Covered Bridge Town Highway 3 Bridge 11 over Cox Brook

Draft Scoping Report Northfield Falls Covered Bridge Town Highway 3 Bridge 15 over Dog River

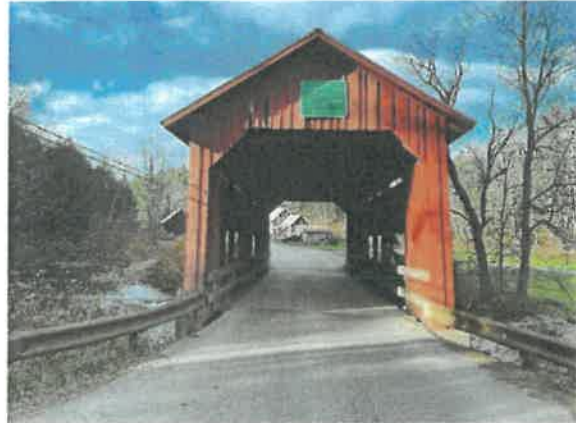
South Portal Looking North

- The bridge lacks fire protection.
- The vertical clearance is substandard and there is evidence of vehicular damage at each portal.

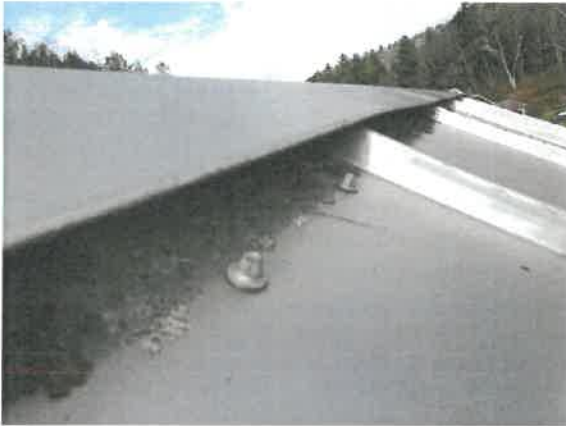
Roof Ridge Cap

- The metal roof ridge cap is attached to the roof boards with nails and screws and is not mechanically field-seamed or watertight. There is some moss growth under the roof ridge cap.
- The roof boards and rafters exhibit through splits, breaks, rot and insect damage. Rafters sit on a 3"x7" rafter support beam.
- The siding boards exhibit areas of faded paint. The siding is in good condition; however, removal and replacement will likely be required to provide access for the extensive superstructure member replacements.

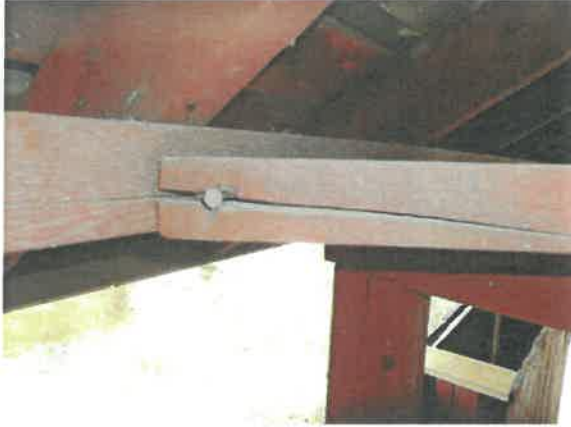
Split in Cross Bream

- Two cross beams exhibit splits. One of the split cross beams is also broken at a connection to a diagonal bracing member.
- Cross beams have been previously damaged from oversized vehicles and are not well connected to the vertical truss members.
- Some of the steel knee braces on the east truss have moderate section loss.

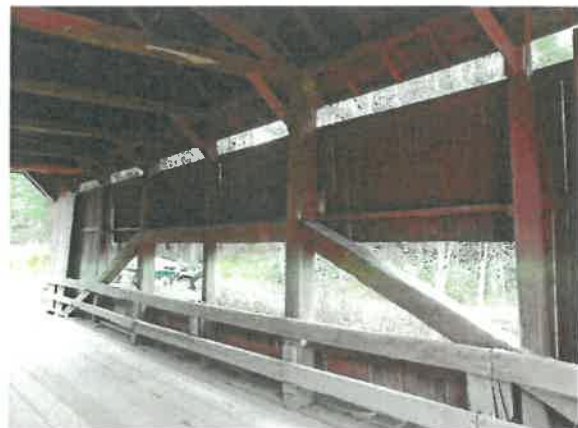
West Queenpost Truss

The truss members are generally considered to be in poor condition with the following deficiencies noted:

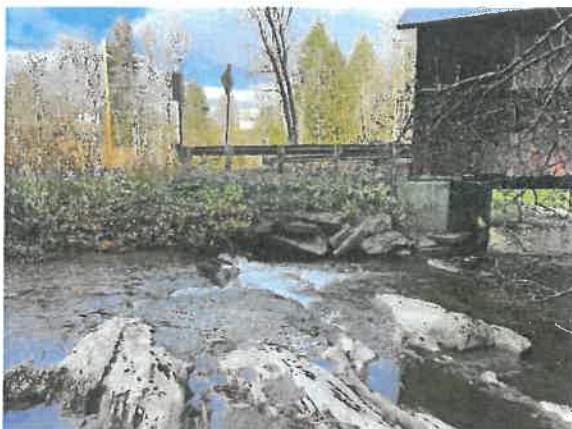
Upstream Channel with Exposed Bedrock

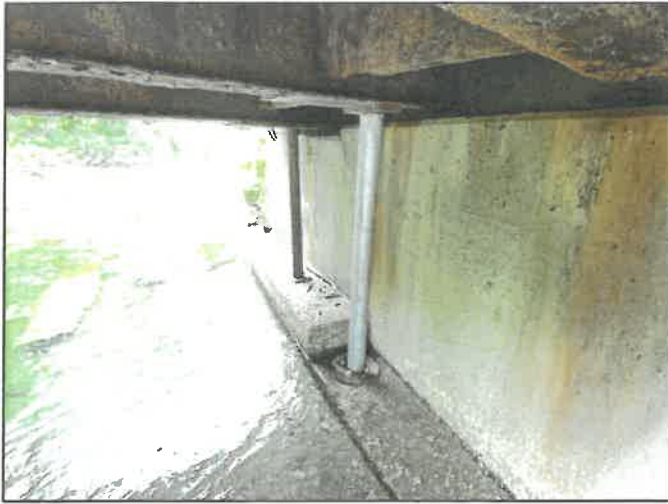
Abutment 2 beam ends

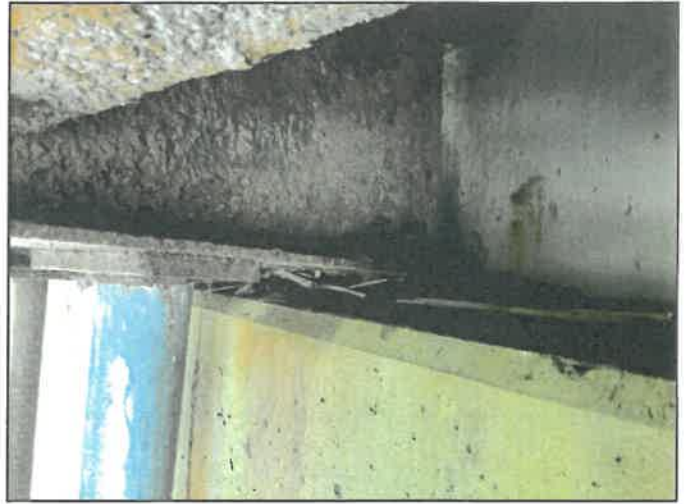
- The western interior beam (B2) has heavy laminar corrosion at both faces of the bottom flange along the entire length of the beam. There is a hole in the web at the south abutment up to 18" wide x 4" tall.

Beam 2 abutment 2 end

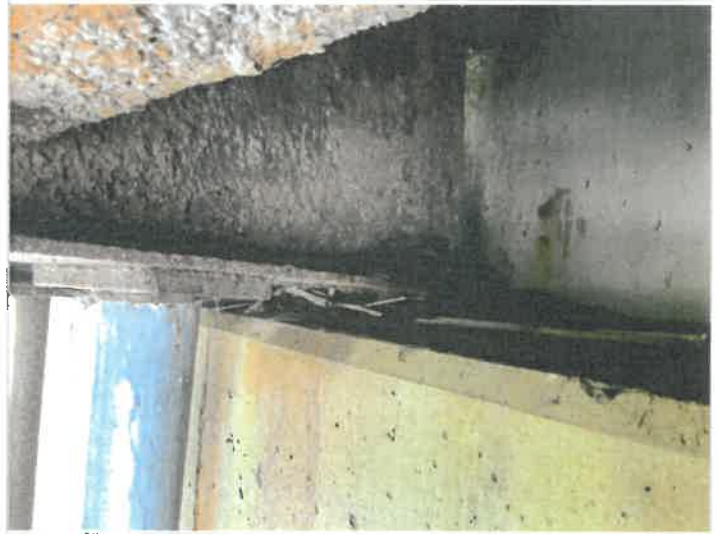
Beam 2 abutment 2 end

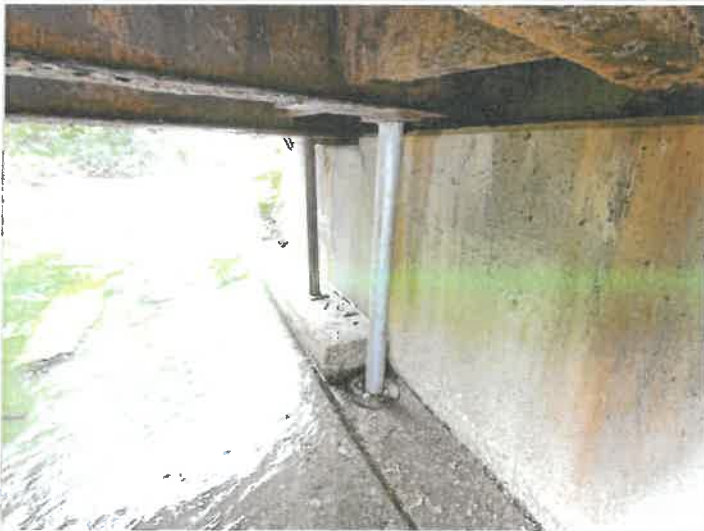
Beam 2 abutment 2 end

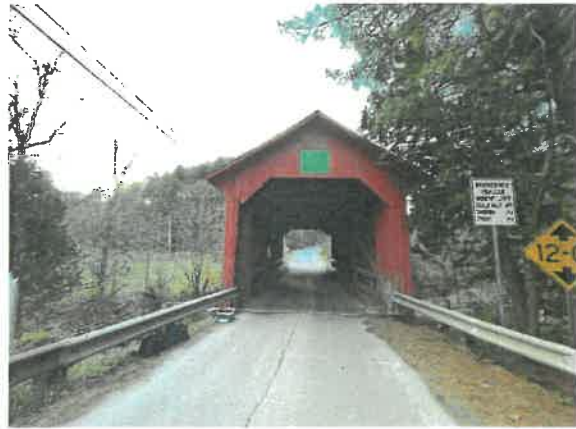
East Portal Looking West

There is load restriction posted for the bridge of 12-Ton for a Single Axle, 15-Ton for a Tandem, and 21-Ton Gross weight. The bridge provides a horizontal clearance of 15'-5" between the trusses and 12'-11" maximum vertical clearance, with vertical clearance at the edges of the travel lane of approximately 10'-3". The vertical clearance signs on each approach to the bridge indicate a height restriction of 12'-0".

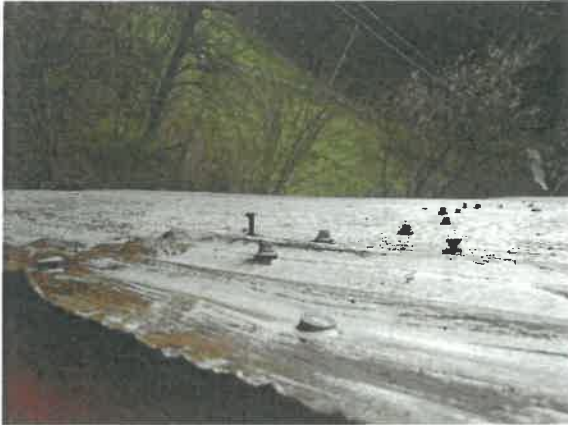
Metal Roof

- The metal roof is attached with nails, which allow water penetrations to underlying members.
- The roof boards and rafters exhibit through splits, breaks, insect damage, and rot. Rafters sit on two 2"x6" rafter support beams.
- The siding boards exhibit areas of faded paint. The siding is in good condition; however, removal and replacement will likely be required to provide access for the extensive truss member replacements.

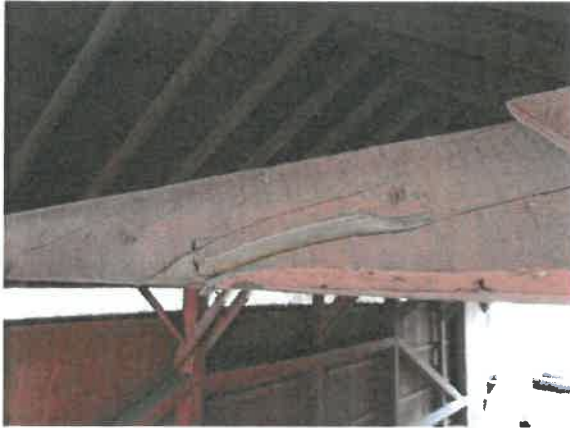
Split in Crossbeam

- Two crossbeams are split and show signs of impact damage. The cross beam at the south portal is broken.
- Crossbeams have been previously damaged from oversized vehicles and are not well connected to the vertical truss members.
- Some of the timber knee braces on the west truss have impact damage and splits.

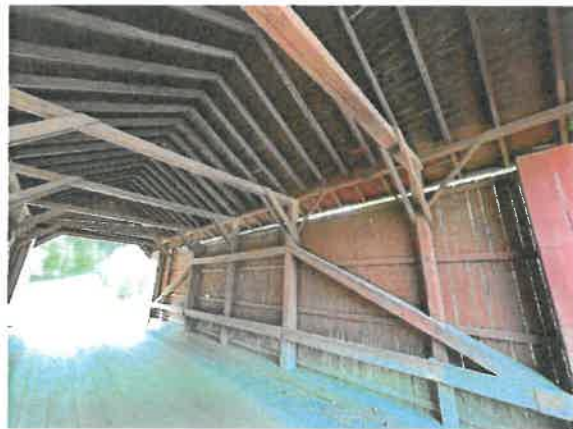
North Queenpost Truss

The truss members are generally considered to be in poor condition with the following deficiencies noted:

- There were no deficiencies noted at the time of inspection at bottom chord of the north truss.
- There is checking in the bottom chord of the south truss between nodes 5 and 6.
- There is a large gap of 2½" in Ply A of the bottom chord of the south truss at the splice location. Ply B is broken at the splice location, and the broken chord at Ply B has been repaired with an L-shaped steel plate and several bolts connecting both sides.

- The interior verticals in the south truss are out of plane up to 1½" over 2'.
- There is insect damage to one of the verticals in the north truss.
- Several of the nailers are not connected to the vertical members and are loose.
- Many of the knee braces are not connected to the vertical members and are loose.

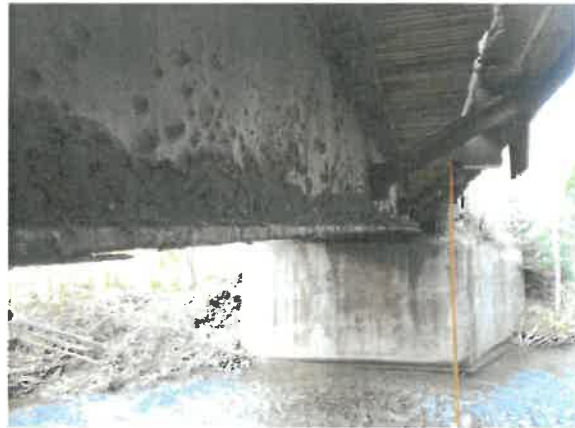
- The diaphragm between the northern interior and exterior beams (B3 and B4) at the east abutment has 100% section loss.
- The exterior beams had section loss that reduced flange thickness to $\frac{7}{16}$ " typical, with isolated areas only $\frac{3}{8}$ " thick. The top flange also had areas of section loss with a flange thickness of $\frac{1}{2}$ " throughout. The webs were in fair condition with some areas of rust and section loss. By inspection, it appears the web had approximately $\frac{1}{16}$ " section loss on both sides of the web.

Exterior Stringer

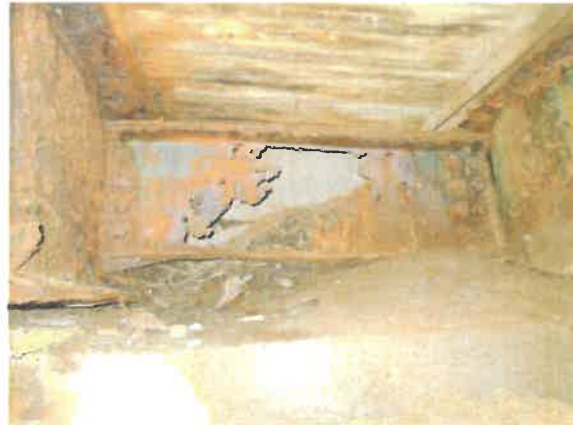
100% Section Loss in Diaphragm

This structure should be considered for a paint project with extensive cleaning of the beams. Steel repairs are needed as well as channel beam diaphragms have extensive section loss and some members have failed. Further section loss in the abutment beam ends will result in more steel repairs or full replacement.

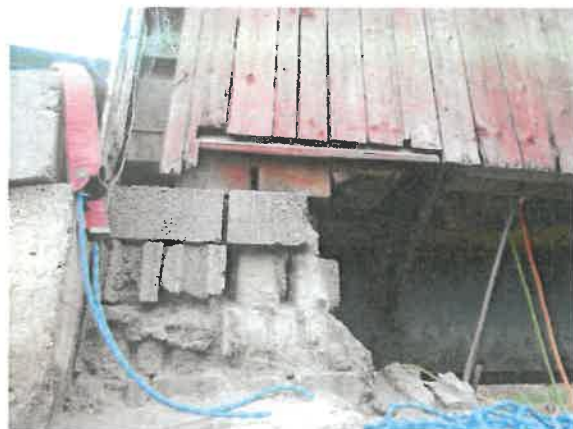
The truss bearing blocks are in poor to serious condition with the following deficiencies noted:

- The wooden bearing blocks exhibit extensive rot and need to be replaced.
- The CMU blocks are in poor condition and need to be replaced.

Timber Bearing and CMU Blocks

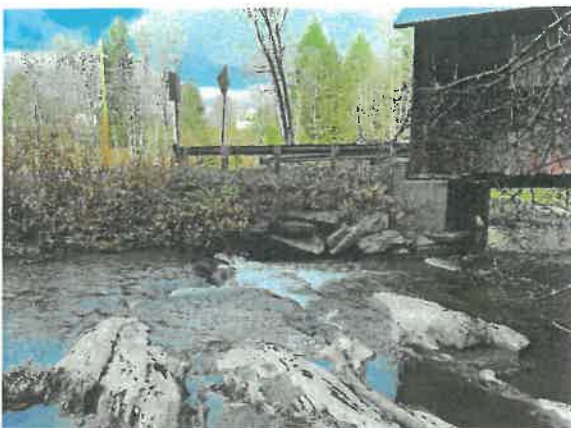
Upstream Channel with Exposed Bedrock

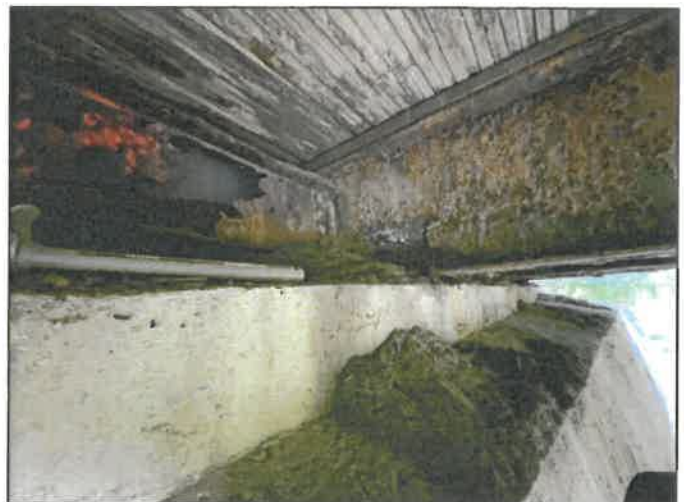
Abutment 2 beam ends

A project to clean and paint the beams should be considered as section loss in the beams continues increase.

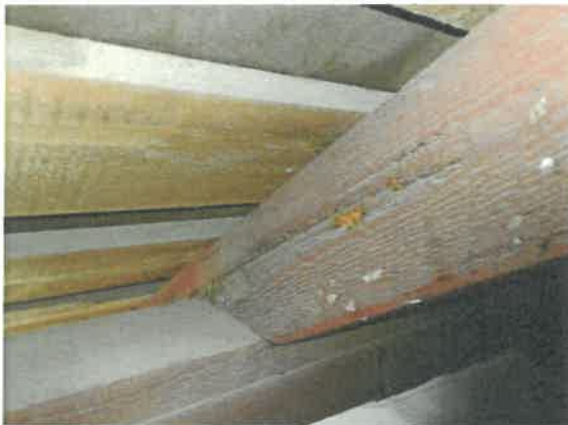
- Metal roof is in fair condition. Replacement of the roof will be required for access for repairs to the truss members.
- The roof boards and rafters exhibit through splits, breaks, insect damage, and rot.
- The siding boards are in good condition; however, removal and replacement will likely be required to provide access for the extensive truss member replacements.

Split in Rafter

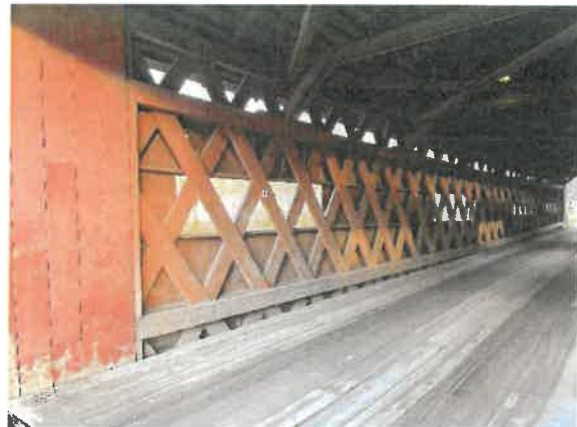
North Truss Looking East

The truss members are generally considered to be in poor condition with the following deficiencies noted:

- The upper chord members of the South truss exhibit plies split up to 4' long at various locations and one location of surface dry rot up to 1½" deep.
- The upper chord members of the North truss exhibit breakage, splitting up to 4' long, waning, buckling and gaps at joints.
- The lower chord members of the South truss exhibit multiple locations of splitting and rotting.
- The lower chord members of the North truss exhibit plies split up to 2' long at various locations, holes up to 5" in diameter, rotting, lifting, waning, and gaps at joints. Multiple locations on chord 4 of the North truss have supplemental boards spliced to ply D.
- At the time of inspection, the lower chord members had a moisture content up to 50 percent.

- Many lattice members exhibit splitting, checking, full width section loss, cracks around trunnels, impact damage, insect infestation, and rot.
- Multiple top lattice tails are split with varying lengths. Multiple tail splits extend past the trunnel connections in chord 1.
- Multiple lattice bottom tails are split and extend past the trunnel connections in chord 4.
- The lattice lower tails are cut at the pier and abutments for the sleeper beam and bearing.

To prevent the spread of the splits in the tails we recommend that wood epoxy be applied to the splits and through bolts be added to prevent further splitting for all alternatives (PTN 1).

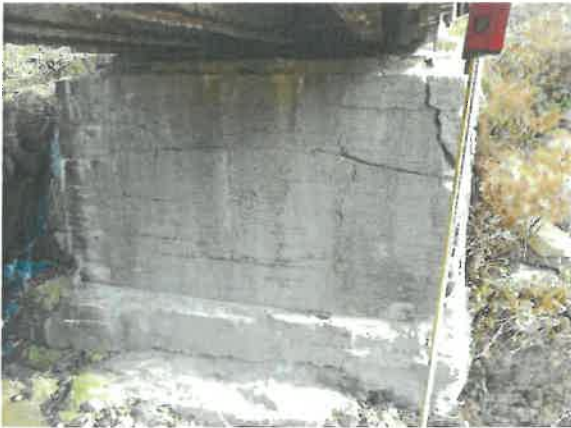
East Abutment Elevation

The abutments are considered to be in poor condition with the following deficiencies noted:

- The east abutment exhibits significant concrete spalling, efflorescence staining, delamination, and vertical, horizontal, and map cracking. The southeast beam seat corner has a large spall, and the concrete is coming loose from the structure. The concrete appears to be of poor quality with large round aggregates used.
- The west abutment masonry exhibits voids up to 5' deep. The concrete beam seat cap concrete has significantly deteriorated.
- The southwest wingwall is comprised of dry laid stacked stones which have failed, and the wall is no longer vertical.
- At the spalled areas, the concrete was observed to contain round river stones with no fractured faces, which significantly reduces the concrete strength and durability.
- The east abutment is in poor condition and needs to be replaced. The west abutment beam seat and backwall is in poor condition and needs to be replaced.

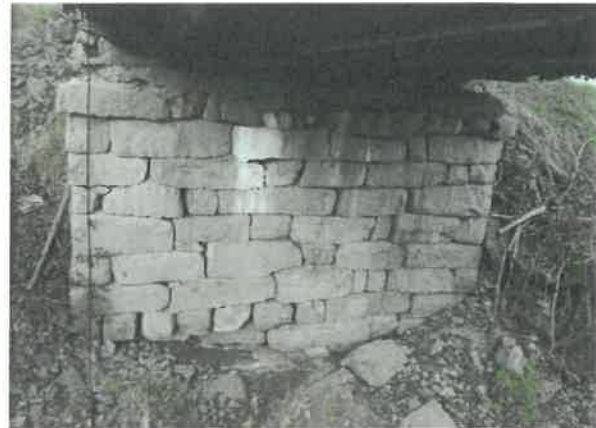
West Abutment Elevation

The bridge substructure consists of a concrete abutment on the east side, dry laid masonry abutment with a concrete cap on the west side, and a concrete pier at the center of the bridge. It is not clear if the original east abutment was constructed with stone masonry and encased with concrete during previous undocumented rehabilitations. Both abutments have exposed ledge in front and below them, so it is likely the abutments bear on ledge. The channel bed consists of ledge and large cobbles.

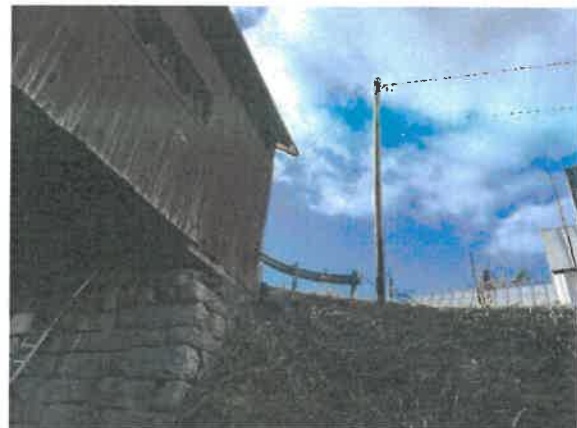
Guy Wire Attached to NW Corner of Bridge

An aerial utility relocation will be needed. Utility relocation plans will be determined once design plans are available.

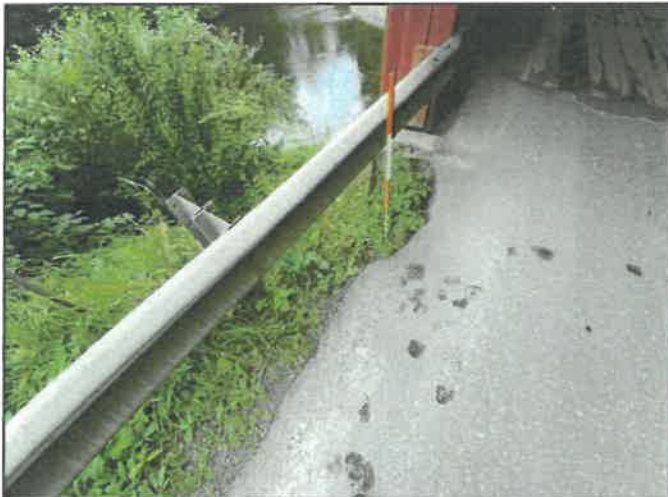
Upstream abutment 1 shoulder area

A means of retaining the approach roadway should be considered with added roadway fill.
