Upper, Lower, and Northfield Falls Covered Bridges

Northfield BO CVBR(7)(8)(9)

Bridges No. 10 and 11 over Cox Brook
Bridge No. 15 over Dog River

Alternatives Presentation

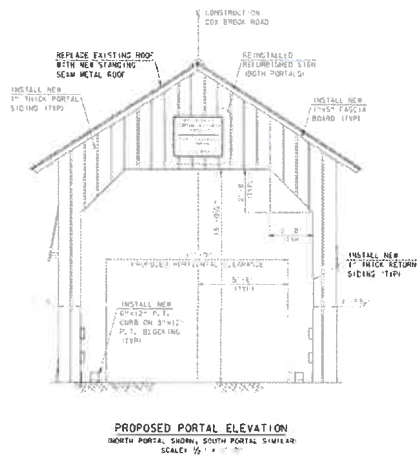
Recommended Work: Fascia & Portal Siding

- Existing
 - 1" Thick Boards
- Recommended Work
 - Replacement of all Existing Siding Boards, Eastern White Pine

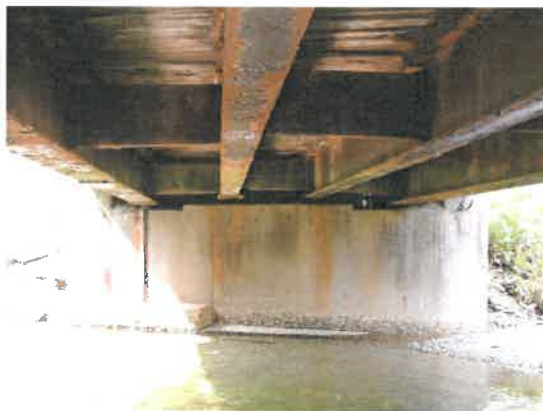
Existing Conditions: Floor System

- Existing:
 - 24WF100 and 21WF62 Steel Beams
 - C15x33.9 Steel Diaphragms
 - 2"x6" Nail Laminated Deck, Southern Yellow Pine
 - 1½" Thick Runner Boards, Eastern Pine

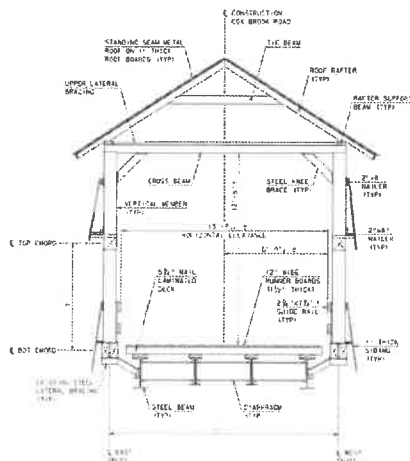
Existing Vertical Clearance
12'-8"

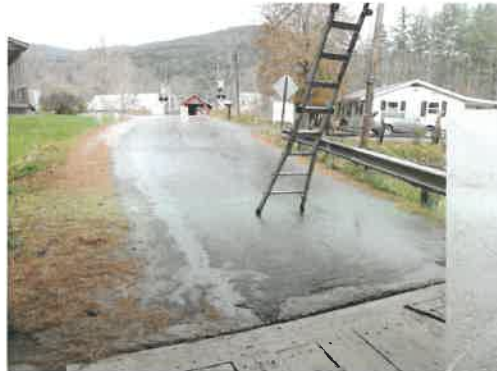
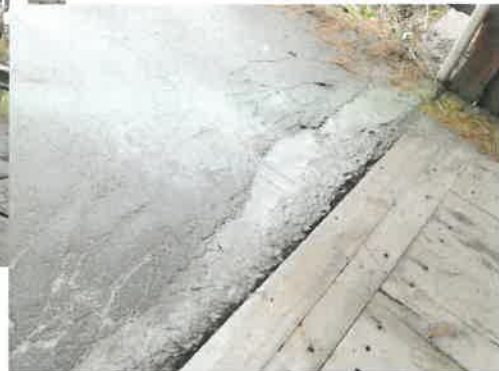
- Drainage Issues
- Ponding

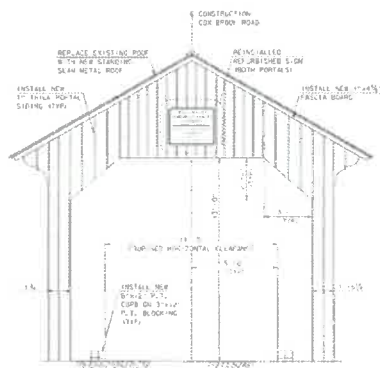
PROPOSED PORTAL ELEVATION
 WEST PORTAL SIMILAR, EAST PORTAL SIMILAR
 SCALE: 3/4" = 1'-0"

- Existing
 - 1" Thick Boards
- Recommended Work
 - Replacement of all Existing Siding Boards, Eastern White Pine

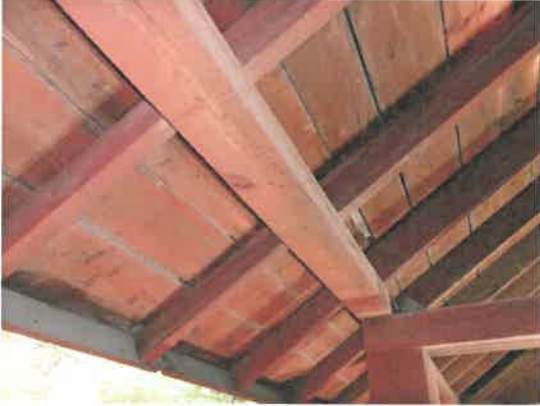
Recommended Work: Roof Members

- Existing
 - Standing Seam Metal Roof
 - 2"x6" Rafters, Eastern Spruce
 - 1"x8" Roof Boards, Eastern Spruce
 - 2"x6" Rafter Support Beam, Eastern Spruce
- Recommended Work
 - New Standing Seam Metal Roof
 - Replacement all Existing Roof Boards
 - 5 Rafters (5%) to be Replaced In-Kind
 - 1 Rafter Support Beam (8%) to be Replaced In-Kind

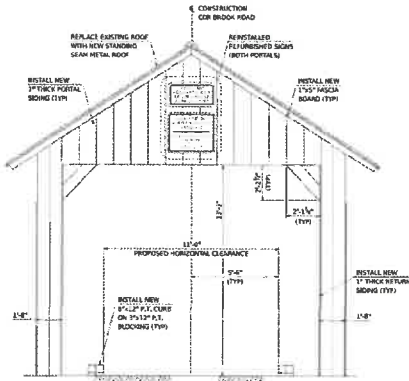
PROPOSED PORTAL ELEVATION
(WEST PORTAL SHOWN, EAST PORTAL SIMILAR)
SCALE: 1/2" = 1'-0"

- Existing
 - 1" Thick Boards
- Recommended Work
 - Replacement of all Existing Siding Boards, Eastern White Pine

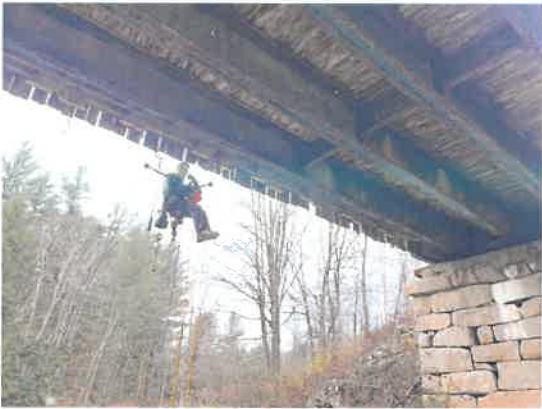
Recommended Work: Floor System

- Existing:
 - 33WF118 Steel Beams
 - C18x42.7 Steel Diaphragms
 - 2"x8" Nail Laminated Deck, Southern Yellow Pine
 - 1½" Thick Runner Boards, Eastern Hemlock
