Draft Scoping Report Northfield Falls Covered Bridge Town Highway 3 Bridge 15 over Dog River

Northfield BO CVBR(9)

January 24, 2026

Prepared for:
Vermont Agency of Transportation

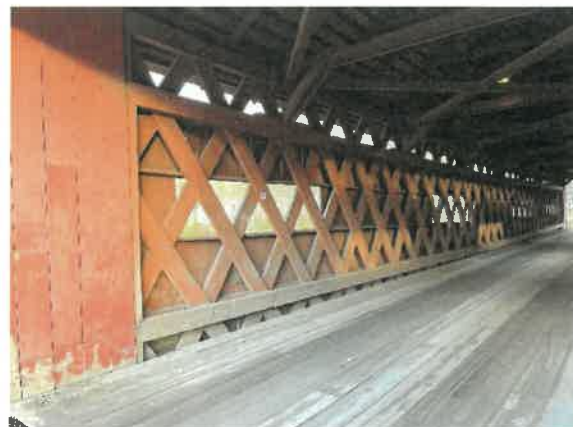
North Truss Looking East

The truss members are generally considered to be in poor condition with the following deficiencies noted:

- The upper chord members of the South truss exhibit plies split up to 4' long at various locations and one location of surface dry rot up to 1½" deep.
- The upper chord members of the North truss exhibit breakage, splitting up to 4' long, warping, buckling and gaps at joints.
- The lower chord members of the South truss exhibit multiple locations of splitting and rotting.
- The lower chord members of the North truss exhibit plies split up to 2' long at various locations, holes up to 5" in diameter, rotting, lifting, warping, and gaps at joints. Multiple locations on chord 4 of the North truss have supplemental boards spliced to ply D.
- At the time of inspection, the lower chord members had a moisture content up to 50 percent.

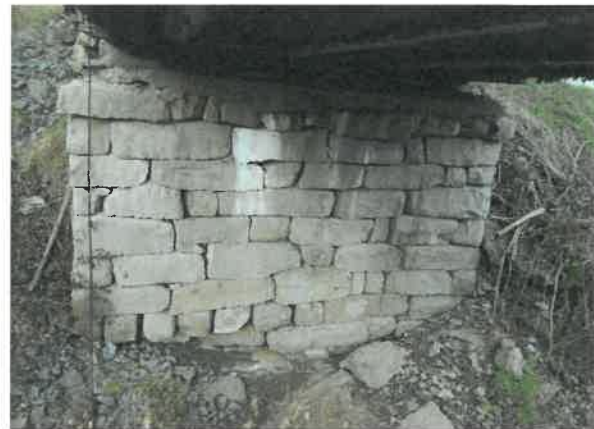
West Abutment Elevation

The abutments are considered to be in poor condition with the following deficiencies noted:

- The east abutment exhibits significant concrete spalling, efflorescence staining, delamination, and vertical, horizontal, and map cracking. The southeast beam seat corner has a large spall, and the concrete is coming loose from the structure. The concrete appears to be of poor quality with large round aggregates used.
- The west abutment masonry exhibits voids up to 5' deep. The concrete beam seat cap concrete has significantly deteriorated.
- The southwest wingwall is comprised of dry laid stacked stones which have failed, and the wall is no longer vertical.
- At the spalled areas, the concrete was observed to contain round river stones with no fractured faces, which significantly reduces the concrete strength and durability.
- The east abutment is in poor condition and needs to be replaced. The west abutment beam seat and backwall is in poor condition and needs to be replaced.

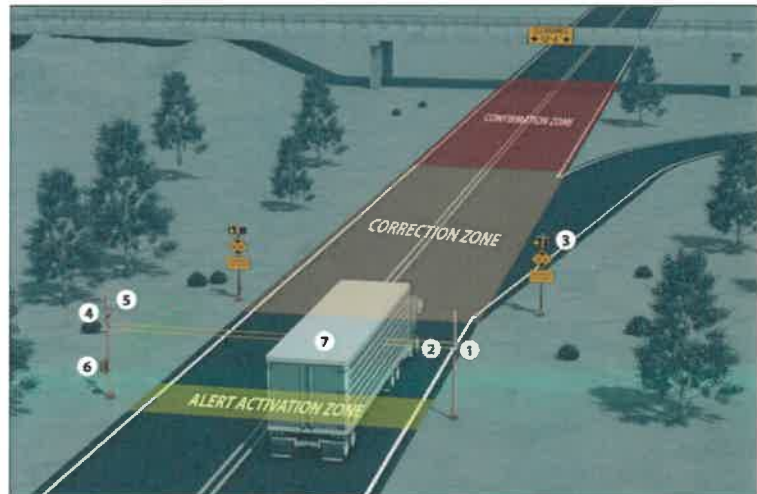
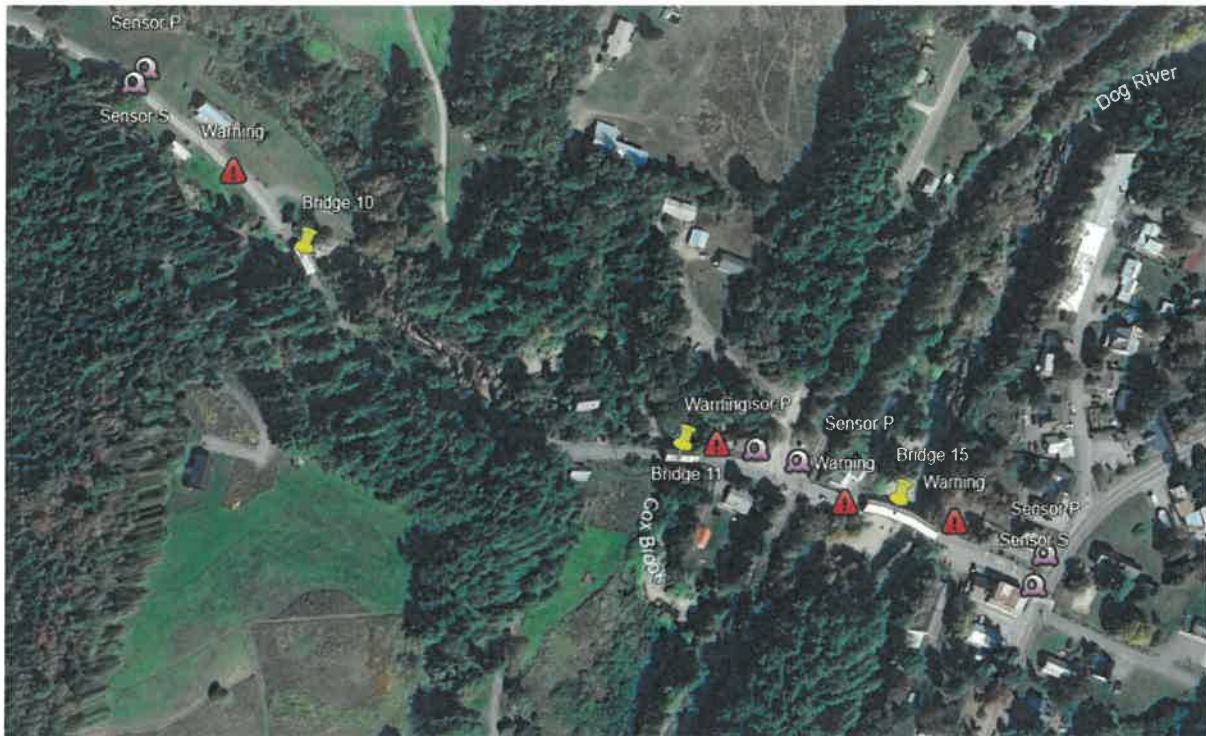
Additionally, early detection and vehicle warning systems can be incorporated into the project. These systems use sensors within an "activation zone" to identify vehicles that exceed the clearance height of an upcoming structure and alert drivers to the restriction. Drivers are then guided toward a safe alternate route within the "correction zone". The system also collects data, such as license plate information, for vehicles that trigger the warning and notifies local authorities when a vehicle enters the "confirmation zone". A potential layout

of this system for the three covered bridges along Cox Brook Road is shown below. The associated cost, estimated at approximately \$125,000, is not included in the Cost Matrix in Section 6, as the system is proposed as an optional enhancement.

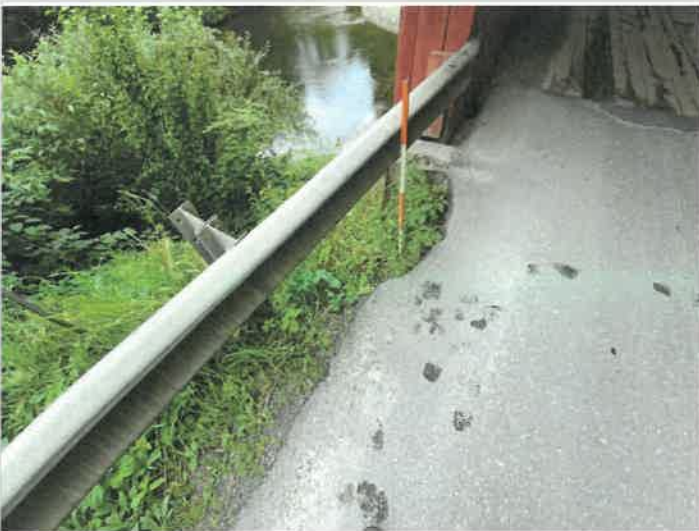
Erosion of the upstream embankment along the abutment 1 approach has caused the erosion of the asphalt in the shoulder area. Preventive repairs are needed so erosion doesn't extend further into the roadway. The structure should be considered for a paint project with extensive cleaning of the beams. Abutment 1 and the pier cap are in need of concrete repairs due to cracked and spalled out areas that extend up to and have undermined small portions of the neighboring bearings; see maintenance reports.

Upstream abutment 1 shoulder area

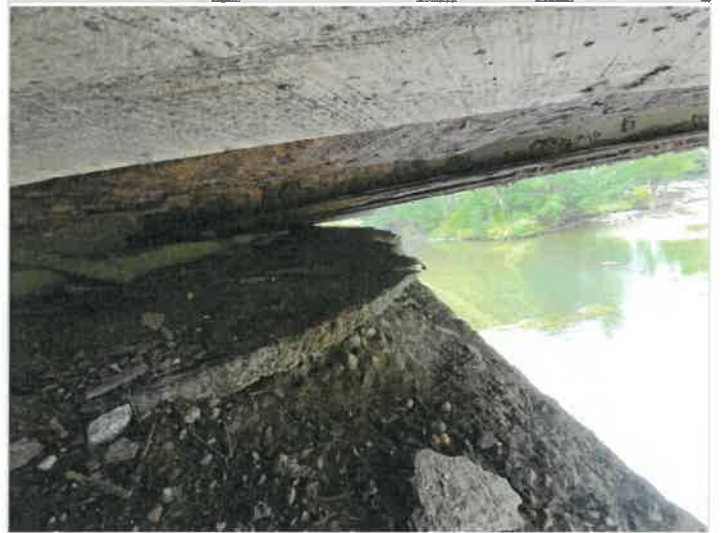
Abutment 1 beam ends
