Draft Scoping Report Upper Cox Brook Covered Bridge Town Highway 3 Bridge 10 over Cox Brook

Northfield BO CVBR(7)

January 24, 2026

Prepared for:
Vermont Agency of Transportation

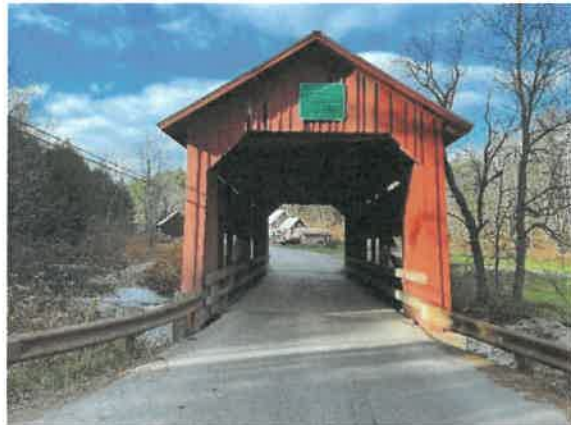
South Portal Looking North

There is load restriction posted for the bridge of 6-Ton for a Single Axle, 8-Ton for a Tandem, and 11-Ton Gross weight. The bridge provides a horizontal clearance of 13'-7" between the trusses and 12'-6" maximum vertical clearance, with vertical clearance at the edges of the travel lane of approximately 9'-10". The vertical clearance signs on each approach to the bridge indicate a height restriction of 12'-0".

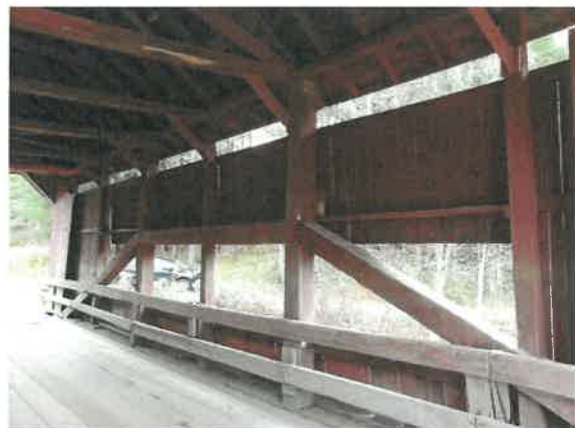
West Queenpost Truss

The truss members are generally considered to be in poor condition with the following deficiencies noted:

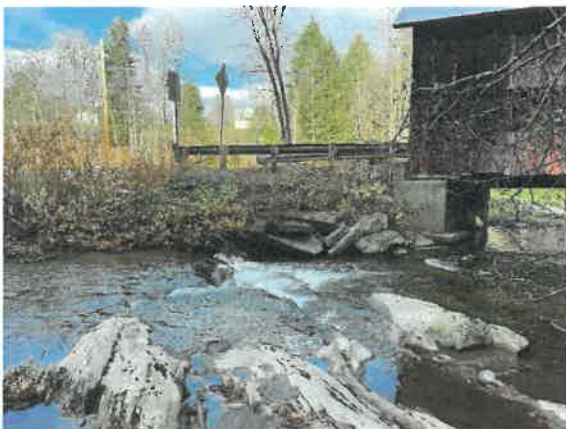
Upstream Channel with Exposed Bedrock

The bridge crosses over the Cox Brook which flows primarily west to east at the bridge site. A hydraulic study at this location was completed on February X, 2026 by Hoyle Tanner. The preliminary findings indicate that under the current conditions, there is XX.X' and XX.X' of freeboard during the 4% (Q_{25} flood event) and 1% (Q_{100} flood event) storm event, respectively. The Q_{100} storm event is defined as a flood having a one percent (1%) chance of being met or exceeded in any given year (base flood designation Q_{100}). The Q_{25} storm event is defined as a flood having a four percent (4%) chance of being met or exceeded in any given year (base flood designation Q_{25}). The existing bridge opening has sufficient hydraulic capacity to pass the 1% storm

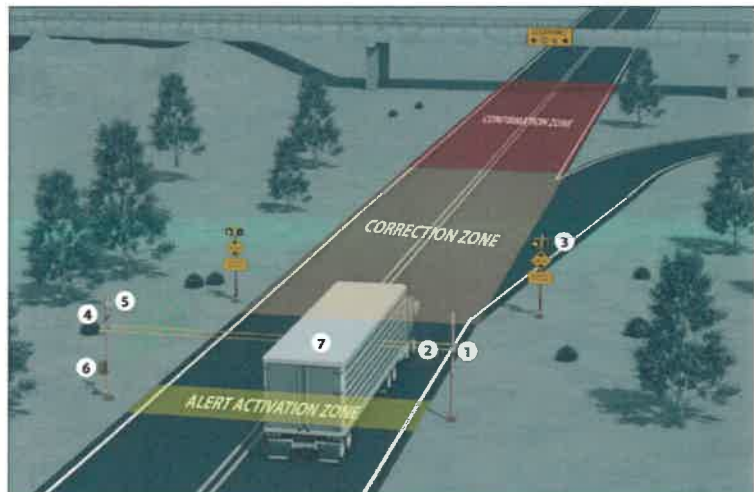
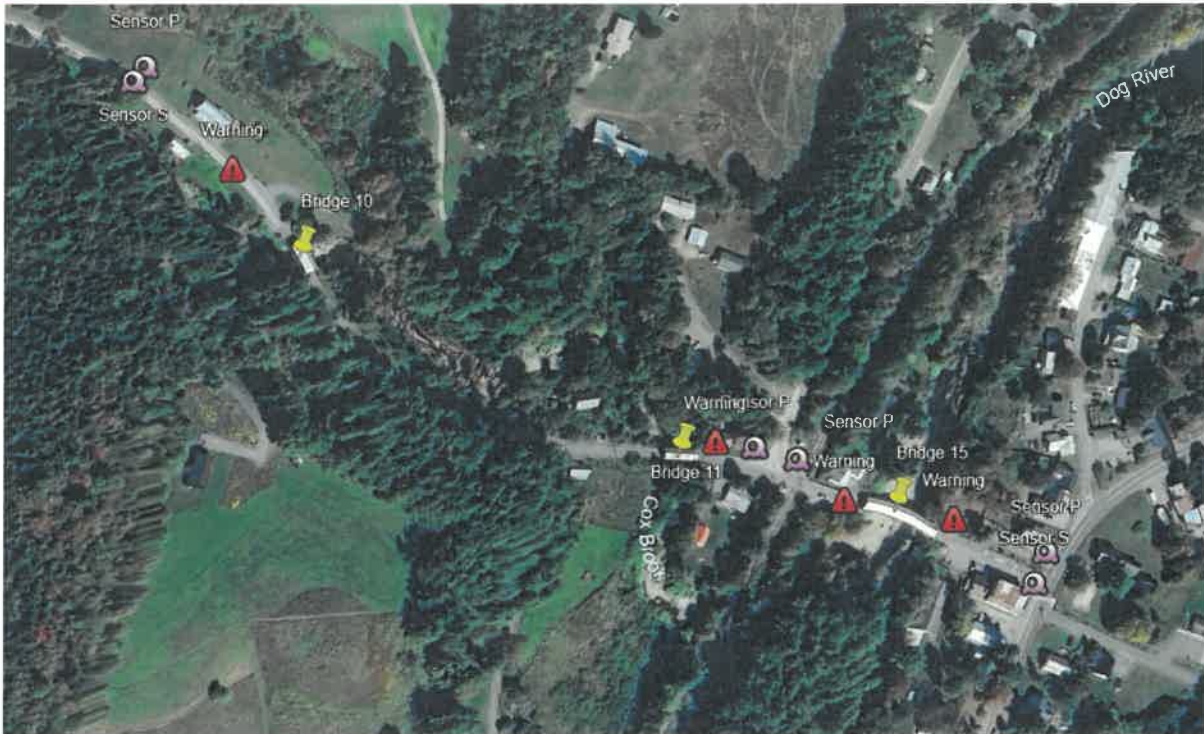
Additionally, early detection and vehicle warning systems can be incorporated into the project. These systems use sensors within an "activation zone" to identify vehicles that exceed the clearance height of an upcoming structure and alert drivers to the restriction. Drivers are then guided toward a safe alternate route within the "correction zone". The system also collects data, such as license plate information, for vehicles that trigger the warning and notifies local authorities when a vehicle enters the "confirmation zone". A potential layout

of this system for the three covered bridges along Cox Brook Road is shown below. The associated cost, estimated at approximately \$125,000, is not included in the Cost Matrix in Section 6, as the system is proposed as an optional enhancement.

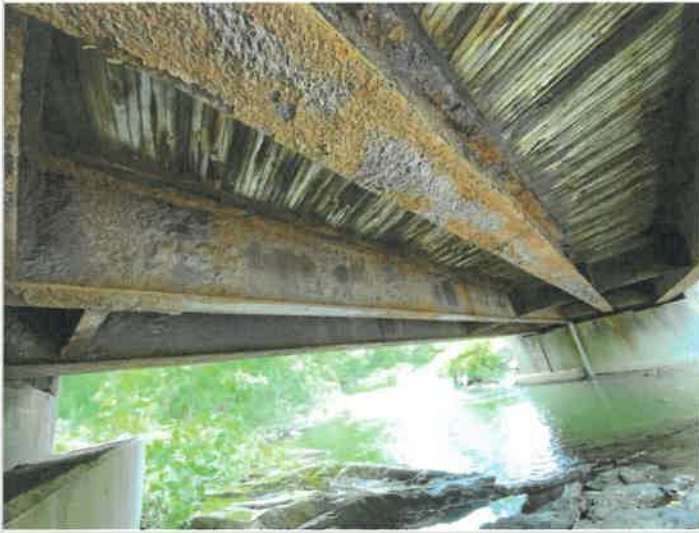
Superstructure

The steel beams have rust scale throughout with developing section loss and the deck has moderate saturation throughout with scattered mildew staining. The boards are starting to split and check apart from decaying wood in the surrounding areas of the beams. The beams should be considered for extensive cleaning and painting and the deck will need replacing within the next few years.

Due to the continued section loss across the length of the beams a future project to replace the beams should be considered.

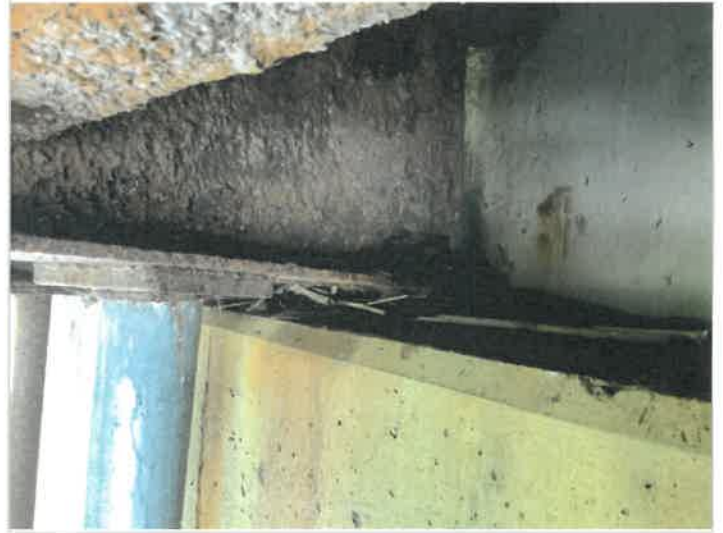
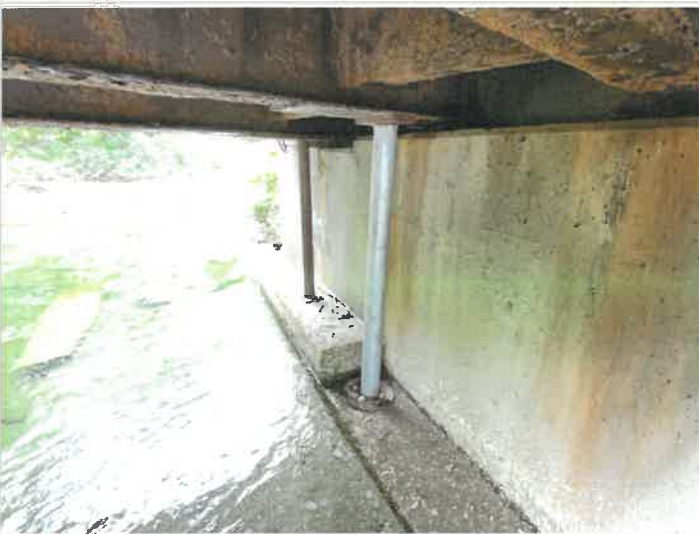
Beam 2 abutment 2 end

- The western interior beam (B2) has heavy laminar corrosion at both faces of the bottom flange along the entire length of the beam. There is a hole in the web at the south abutment up to 18" wide x 4" tall.

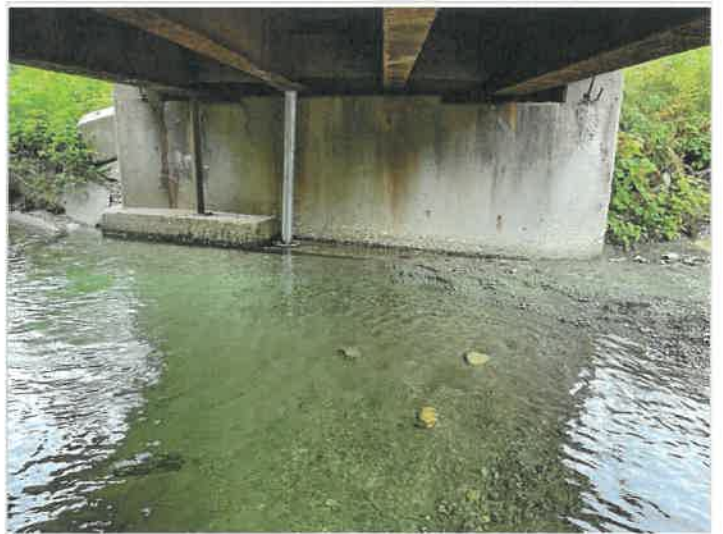
Abutment 2

- Both abutments exhibit some areas of concrete spalling, delamination, exposed rebar, efflorescence staining, and vertical, horizontal, and map cracking.
- At the spalled areas the concrete was observed to contain rebar.
